# **REHABILITATION OF RUNWAYS, TAXIWAYS AND ASSOCIATED AIRSIDE INFRASTRUCTURE TO ICAO STANDARDS AT THE EAST LONDON AIRPORT – A PROJECT NARRATIVE**

**Authors : Simon Tetley<sup>1</sup> ; Arvind Jeewan<sup>2</sup> ; Michael Kernekamp<sup>3</sup> ; Samkelo Luyenge<sup>4</sup> ; Paullin Naidoo<sup>5</sup>**

<sup>1</sup> Senior Associate, Roads, Highways & Airports Sector, GIBB (Pty) Ltd

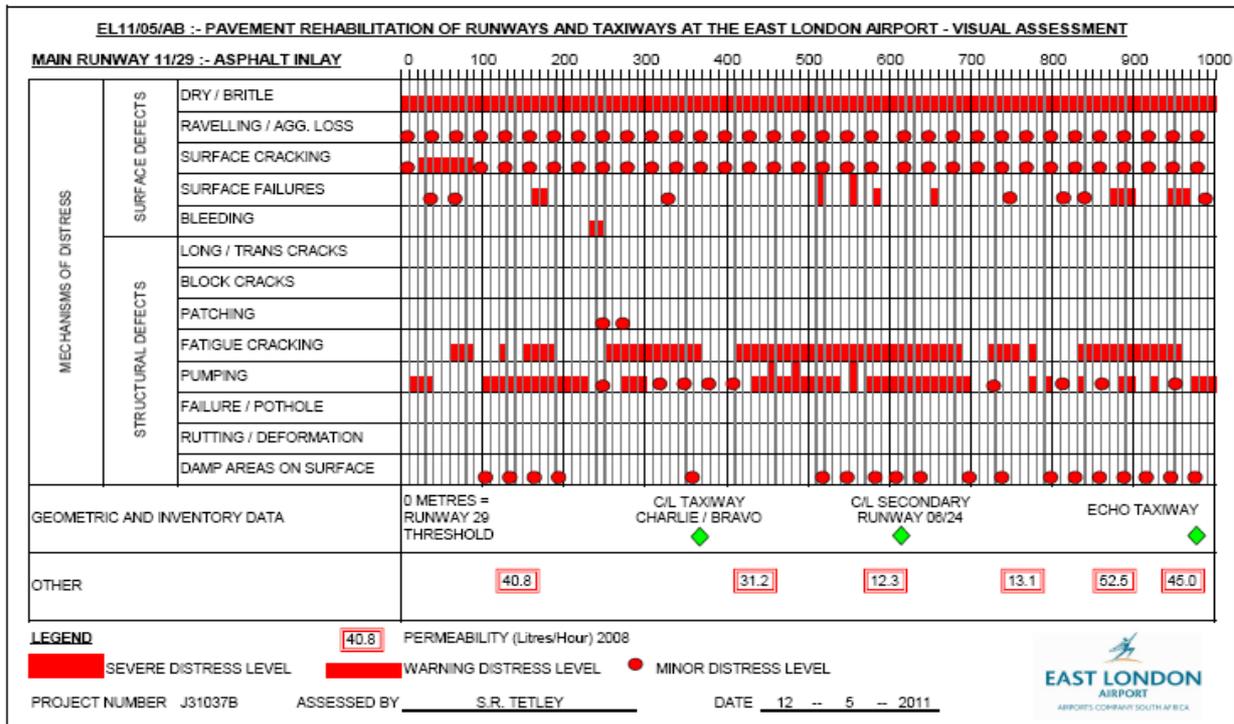
**Figure 3 : Visual Assessment Sheet – Runway 11/29 Centre Section**

The asphalt on the middle portion of 11/29 was placed circa 2003, as can be seen from the Figure 3, the main mechanisms of distress on this critical area were aged binder (Dry/Brittle) and warning level fatigue cracking with associated pumping of fines. Marvel permeability testing was also carried out and, as may be observed, the results were also a cause for concern.

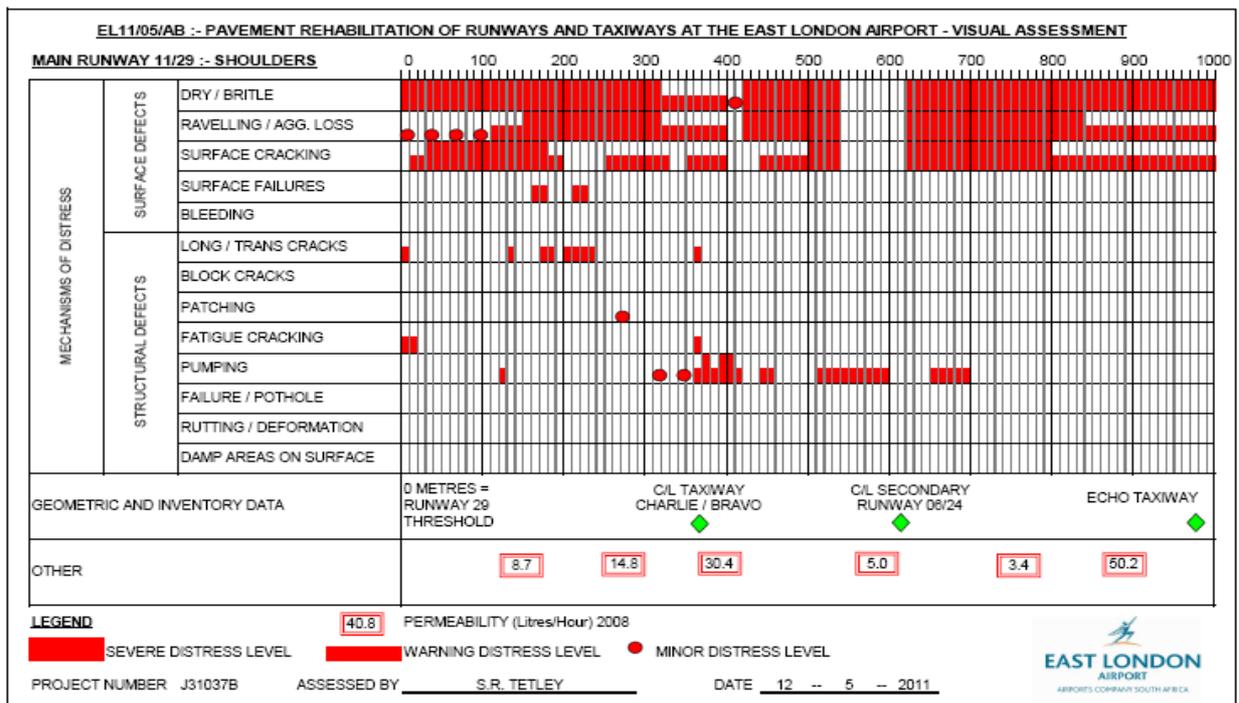
**Figure 4 : Visual Assessment Sheet – Runway 11/29 Shoulders**

The shoulders of the main runway consisted of open textured “popcorn” asphalt which was found to be almost completely devoid of any active bituminous binder, this is illustrated by the severe rating of binder condition, raveling and surface cracking on the assessment sheet for the shoulders of 11/29.

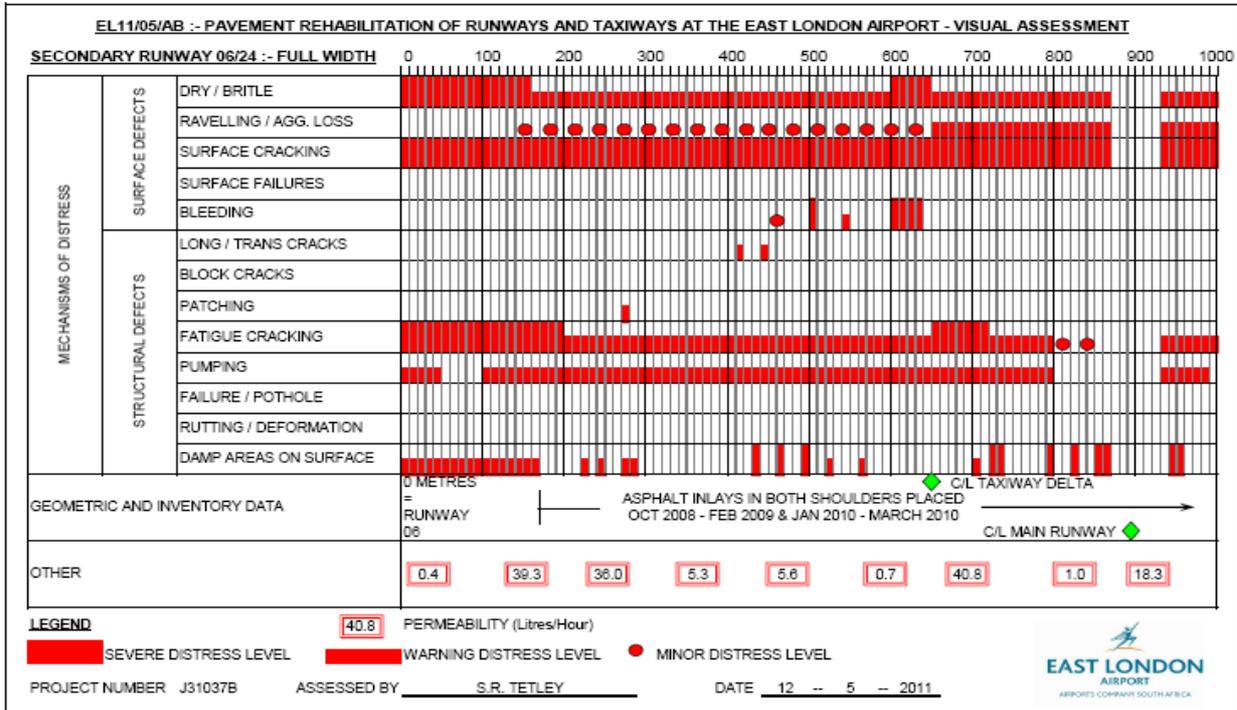
Figure 5 : Visual Assessment Sheet – Runway 06/24 Full Width

Distress on runway 06/24 was limited to the centre, “keel” portion of the runway 06/24, this as the shoulders were repaired with a “mill and fill” intervention in 2010. Figure 5, below, presents the findings of the visual assessment for runway 06/24 between the threshold of 06 and +1000 metres.

As may be observed from Figure 5, the centre portion of the runway was exhibiting severe surface cracking, brittle binder, fatigue cracking and pumping. Permeability results which, whilst generally better than found on runway 11/29, were also not good.

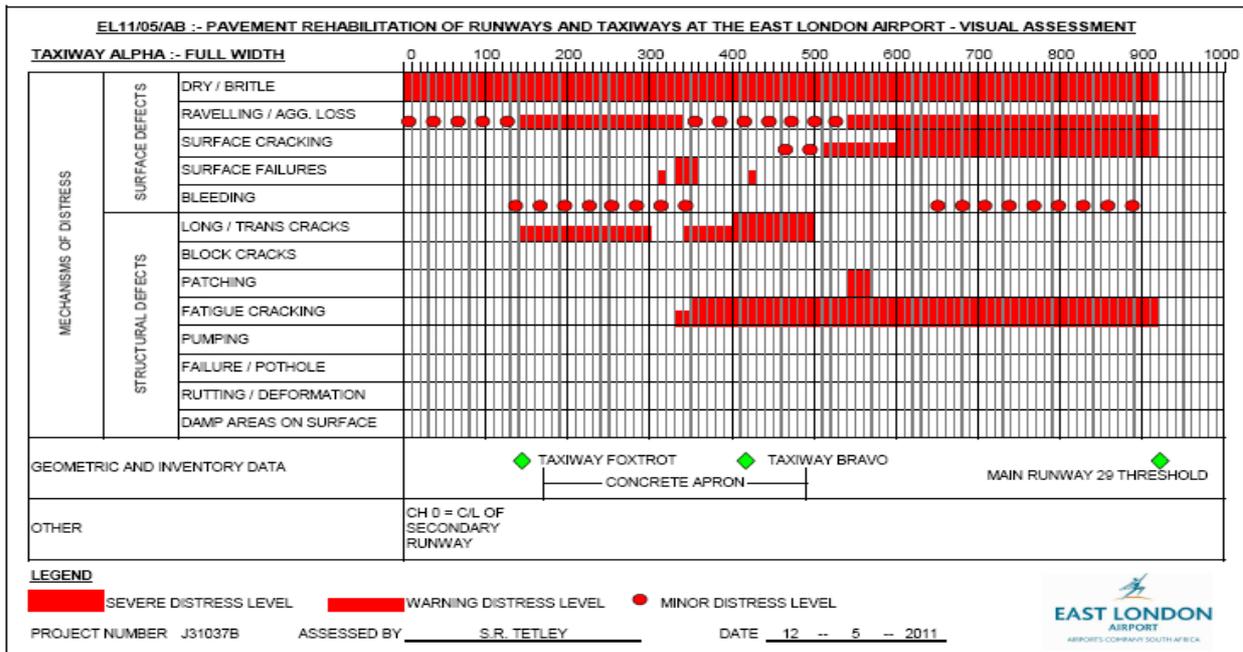
Figure 6 : Visual Assessment Sheet – Alpha Taxiway

The taxiways were found to be in varying stages of deterioration, with Alpha taxiway being in the worst condition as illustrated in Figure 6

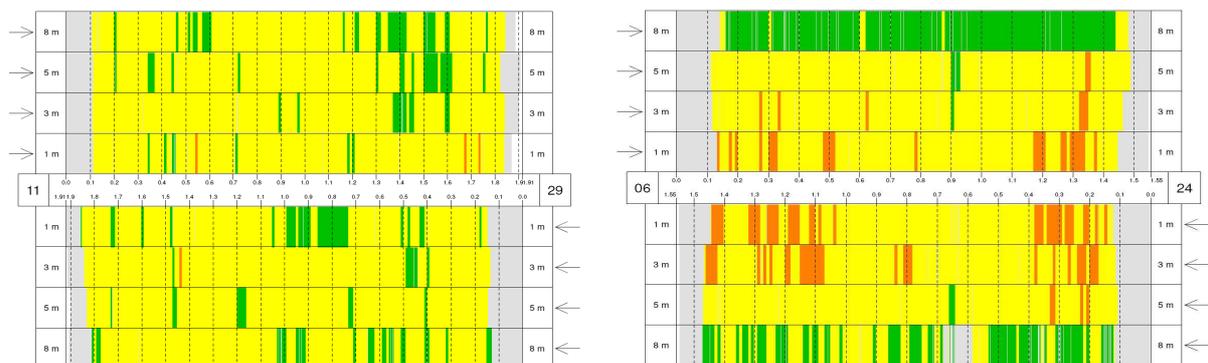
**Figure 8 : Friction Testing Results Runway 11/29 (Left) and Runway 06/24 (Right)**

Figure 8 indicates that friction levels, prior to the rehabilitation, were predominantly between “design” and “maintenance” levels (yellow) with areas between “maintenance” and “minimum” values (orange)

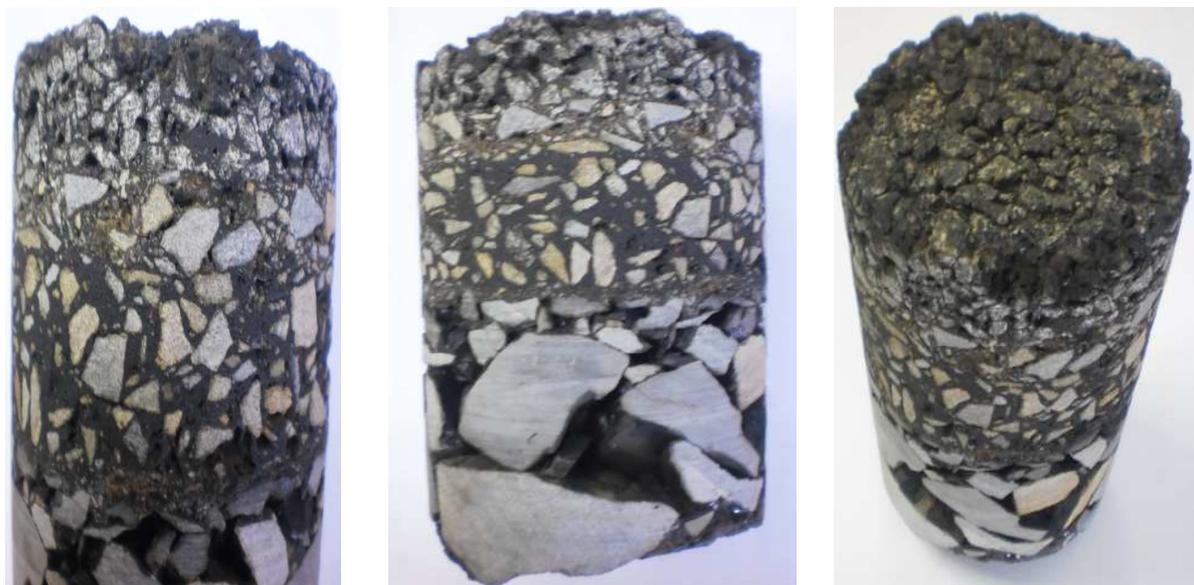
**Figure 10 : Example of Asphalt Cores**

Figure 10, below, presents some typical photographs of cores extracted from the shoulders of runway 11/29 and the centre portion of runway 06/24.

From Figure 10, the friable, oxidised, open textured surfacing can clearly be seen, as can the underlying asphalt layers and the large aggregate tar bound macadam base

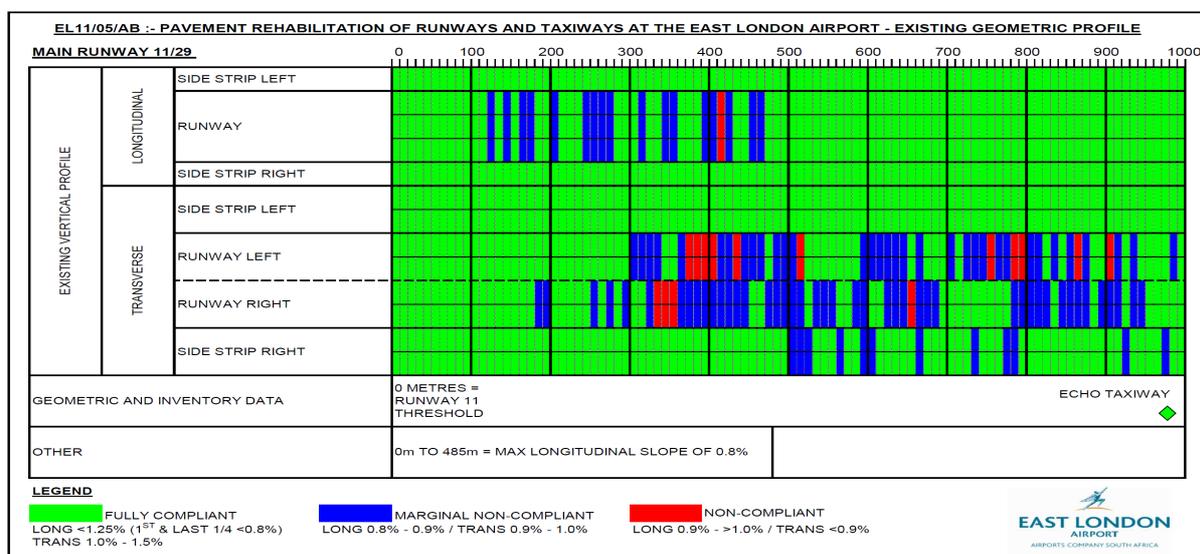
**Figure 12 : Existing Longitudinal and Transverse Grades**

As can be observed from Figure 12, the cross slopes on the runways, in particular, whilst being generally either fully or marginally ICAO compliant, were very variable and this added to the complexity of the geometric design process. The original design solution for rectification of the variable cross falls (not only varying per 20 metres, but also different right and left slopes at the same chainage) was to utilise variable asphalt thickness for the structural/geometric overlay. In reality, once construction commenced, this approach was modified to using a combination of 3D milling and varying asphalt thickness.

The rationale for the new runway cross fall design was to create – wherever practicable – a slope of at least 1.2%. The exception to this rule was at the 06/24 and 11/29 intersection and at the intersections of Charlie/Bravo and Alpha taxiways, where a “graphical grading” was undertaken to ensure smooth transitions over these areas whilst still providing adequate stormwater drainage away from the respective runways. A typical illustration of the existing runway cross falls and longitudinal grades is presented in Figure 12

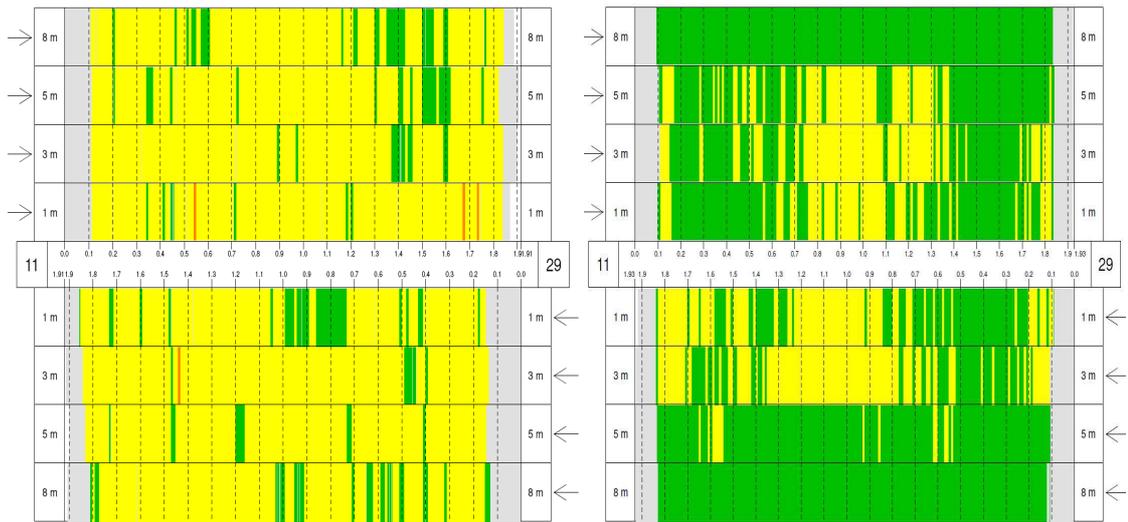
**Figure 22 : Friction Map for Runway 11/29 Before (Left) and After (Right) Construction**

As can be observed from the above, there has been a dramatic improvement in the friction values (particularly on runway 06/24) as denoted by the “green” areas which denotes a friction value in excess of the design level

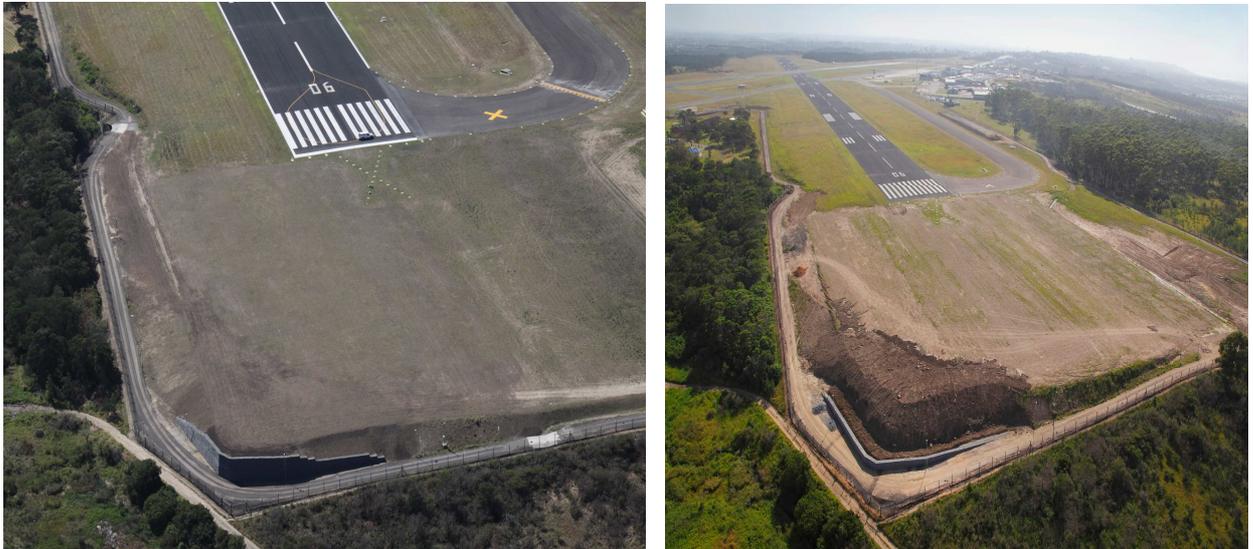
**Figure 24 : Retaining Wall at RESA 24**

One geometric aspect that was addressed was the extension of the north western corner to create a “square” shape. Due to the fact that the level of the RESA was around 8 metres higher than the perimeter road, a retaining structure was required as illustrated in Figure 24 below.

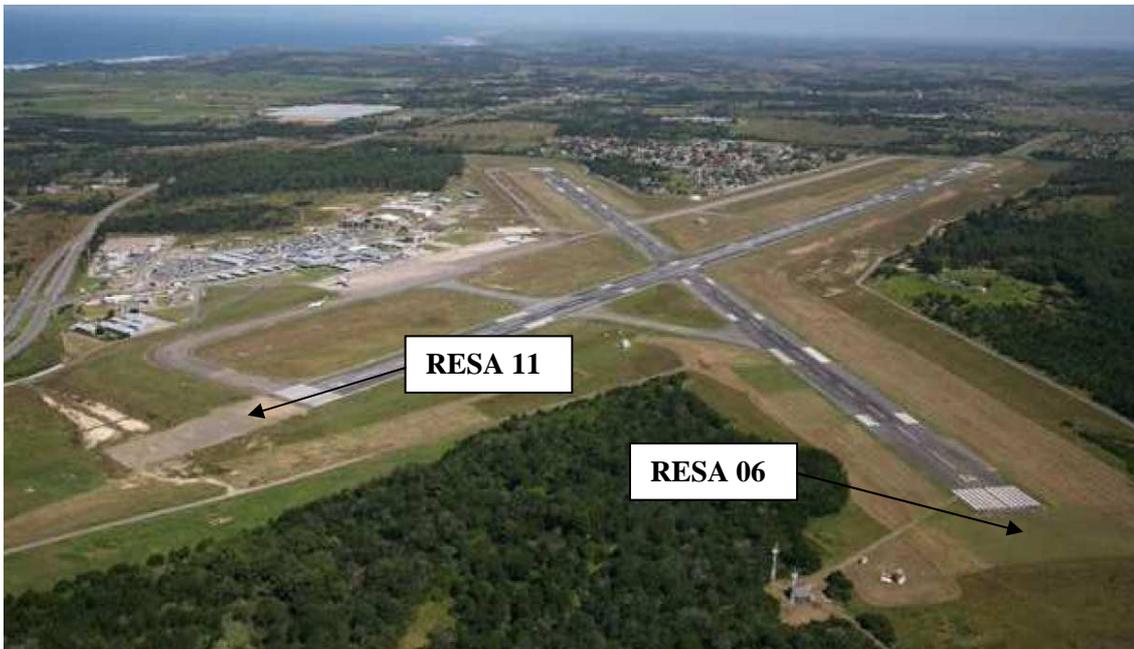
**Figure 26 : RESA 11 Before Upgrade**

Figure 26 shows the RESA before construction whilst Figure 27 illustrates the post construction RESA . (The pre-extension RESA 06 is also indicated in Figure 26)

The upgrading of RESA 11 entailed not only strengthening and shaping of the existing RESA, but also widening and lengthening and extending a culvert. A further constraint was the necessity to work between lighting and ILS antennae.

Whilst undertaking the mass earthworks, saturated sub-soil conditions were encountered and a dump rock pioneer layer was required to provide stability for the platform construction.

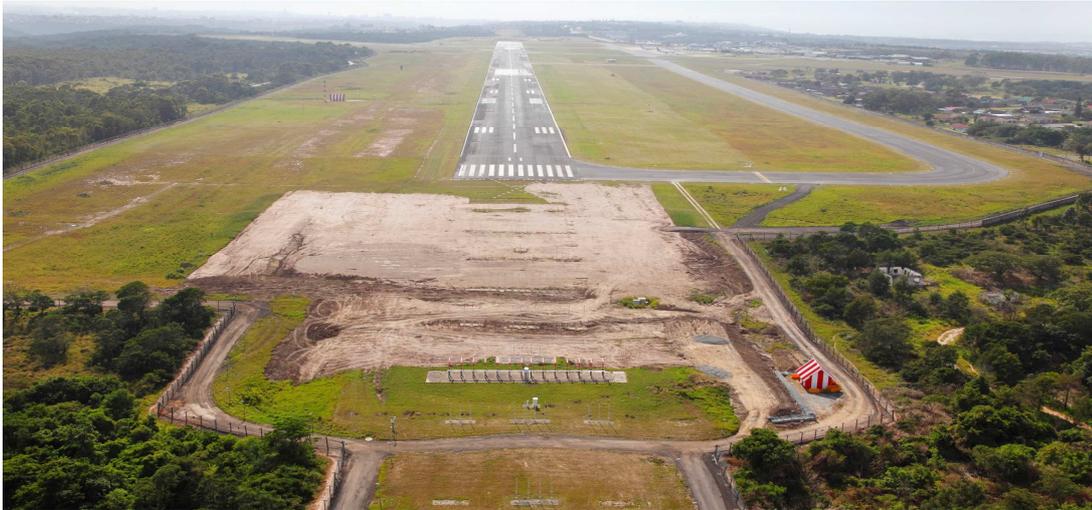
**Figure 28 : RESA 29 During Construction**

As for the other areas, RESA 29 required strengthening of the material between 0-150mm and, in addition, also required significant cut to fill earthworks to eradicate a large hollow in the middle of the RESA. Figures 28 and 29, over leaf, illustrate the during and after construction conditions
