# **EVALUATION OF THE DURABILITY OF EMULSION BASED AC MIXTURES FOR WEARING COURSES**

**XAVIER CARBONNEAU, COLAS**

# SELECTED JOBSITES MAINE AND LOIRE (49)

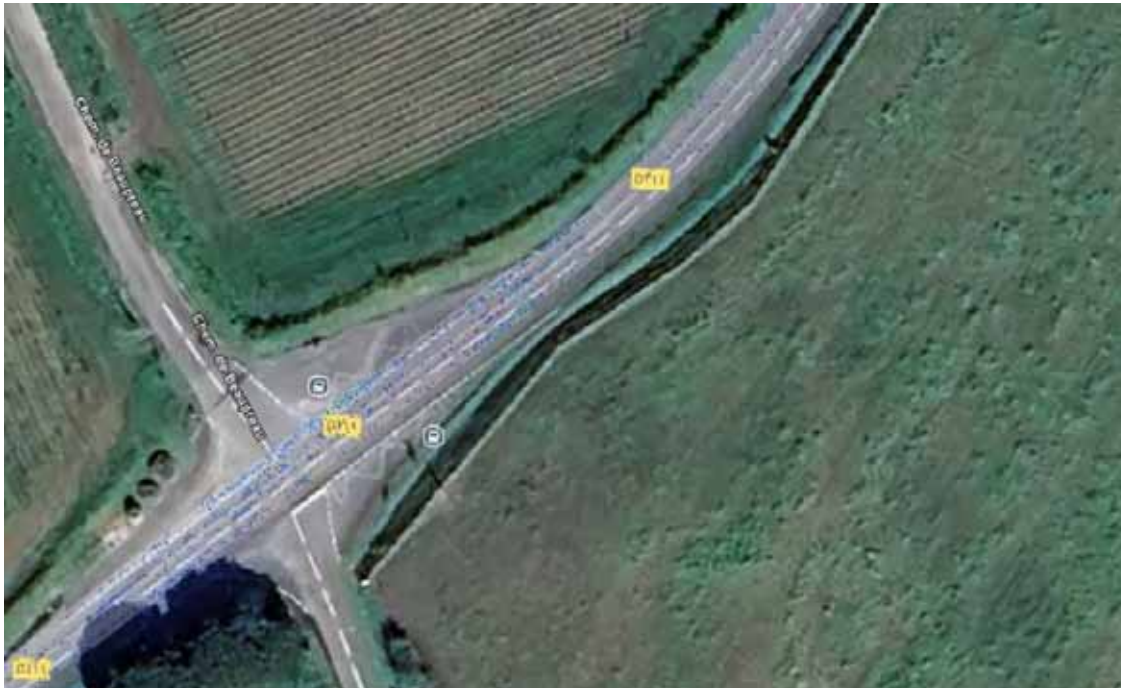
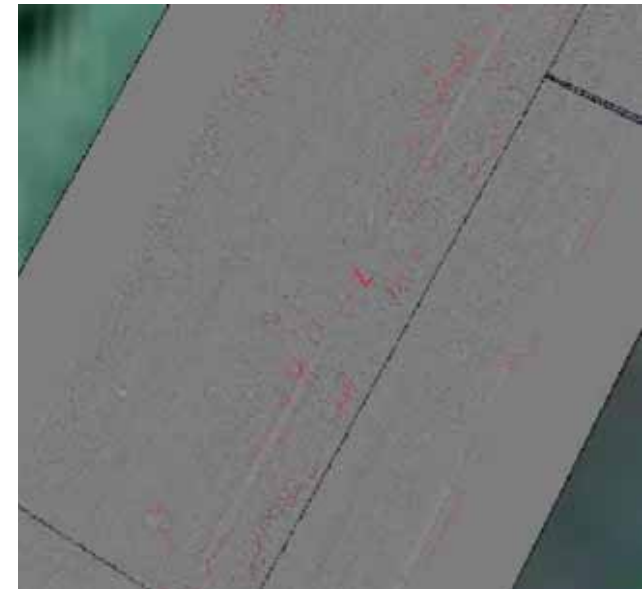
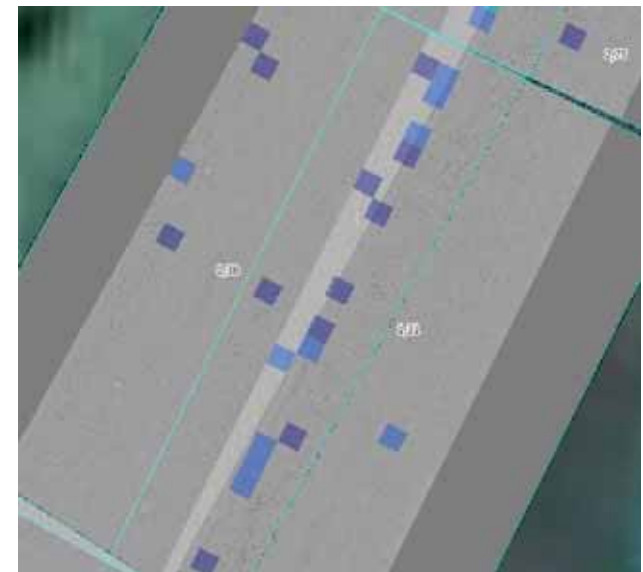
Detection limits

Possible confusions small ravelling/crack ?

Adaptation on algorithms – Ongoing  
localised damage
