AAPA 14th INTERNATIONAL FLEXIBLE PAVEMENTS CONFERENCE

PREVENTION OF CRACK PROPAGATION SIXTH AVE TRIAL

Con Rimpas FIEAust CPEng.

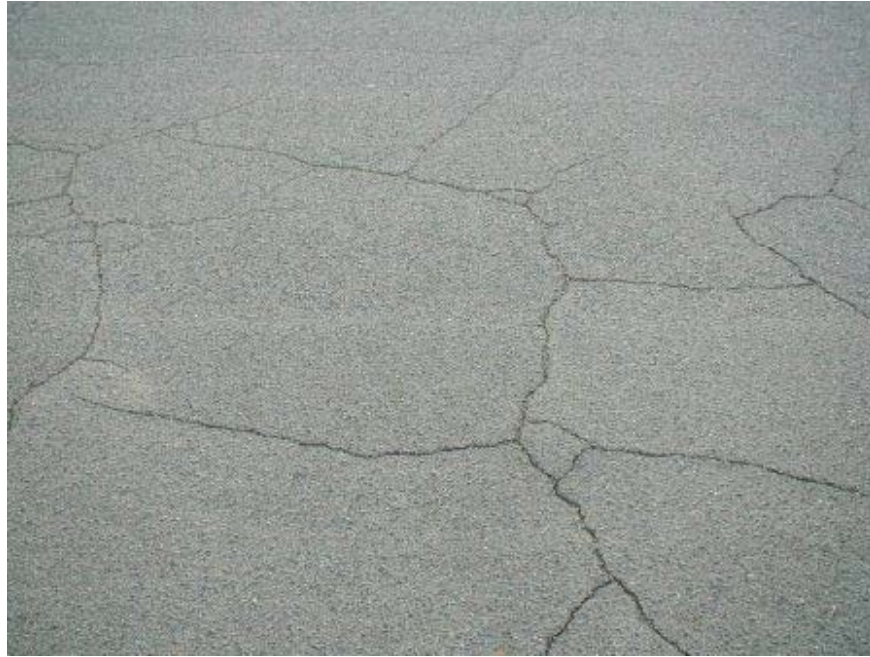
The photograph below shows the original cracking on Sixth Ave prior to construction.

Typical block cracking

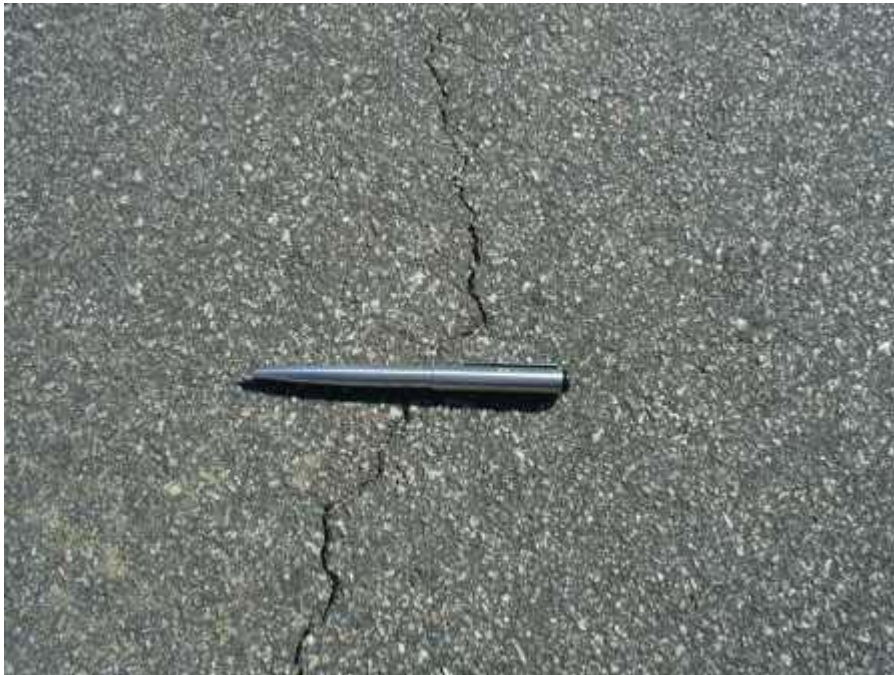
The cracking in the gap-graded asphalt had reflected to some 60% of the cracking of the host surface cracking prior to the overlay. The severity was slight, i.e. approximately 1 to 2 mm whereas the cracking prior to the overlay was 5mm in width.

Cracking in Section 1, gap-graded AC (after 2 years)

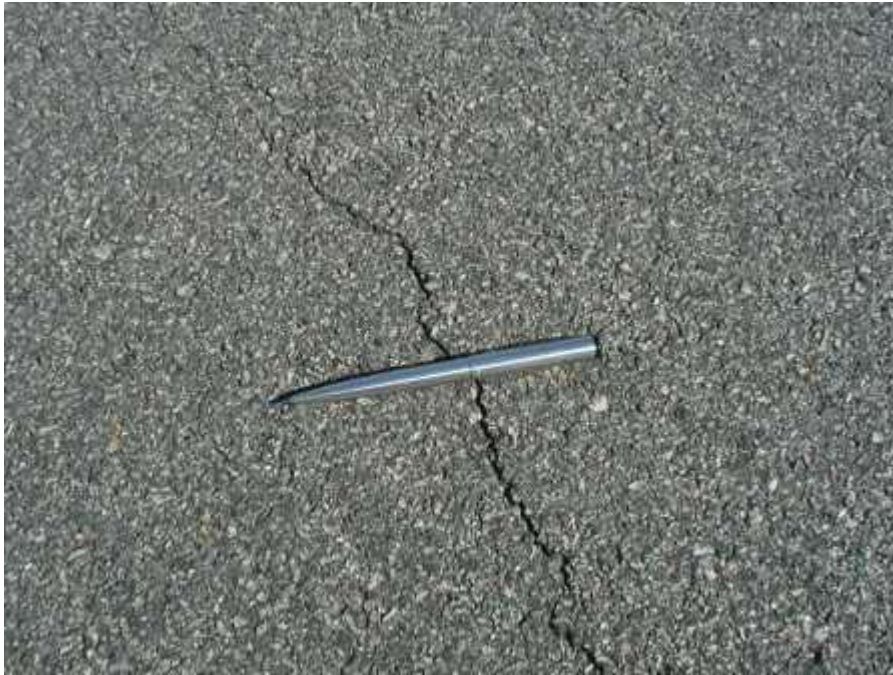
The cracking in the dense-graded asphalt had reflected to some 15% of the extent of the host surface cracking and severity was slight, i.e. approximately 1 to 2 mm.

Cracking in section 1, dense-graded AC (after 2 years)

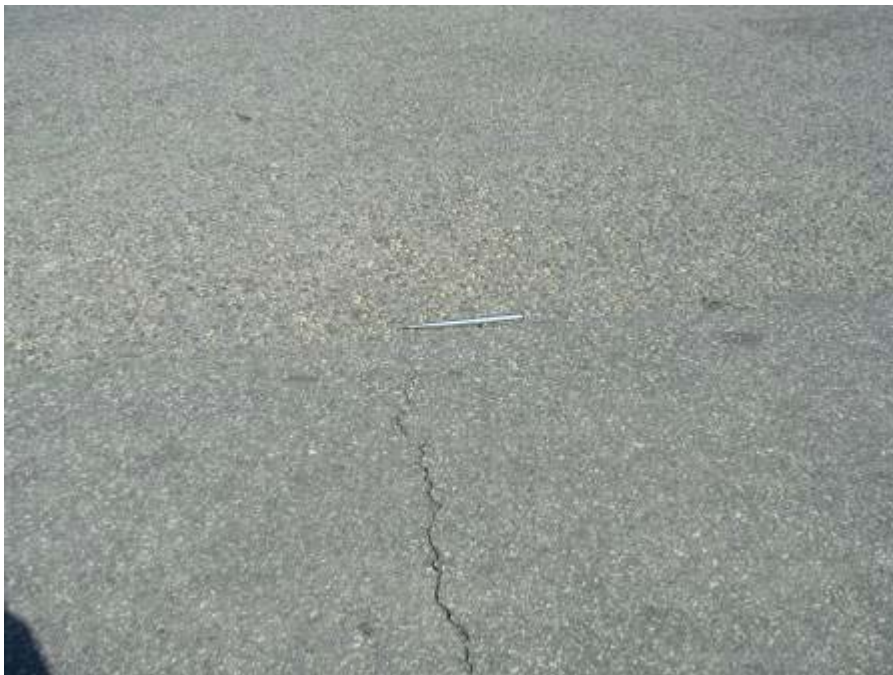
There was no cracking in the SMA. The photograph below shows a crack in the gap-graded asphalt extending to and stopping at the SMA.

Cracking in Section 1 GG but not in SMA (after 2 years)

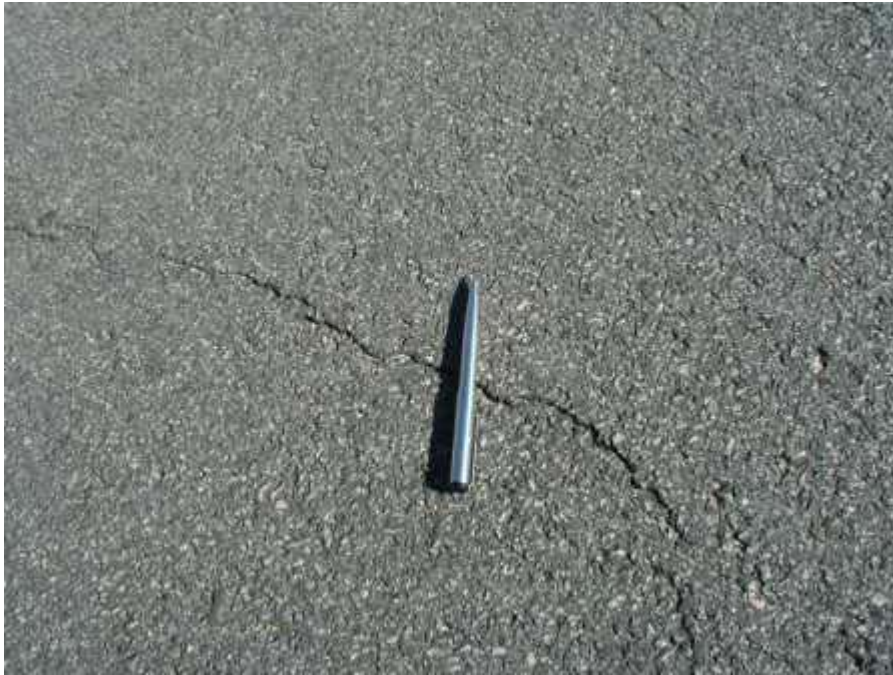
Cracking was evident in both the gap-grade and dense-graded asphalt and was estimated to have an extent of some 10% of the host surface cracks prior to overlay. The severity of the cracks was slight.

Cracking Section 2, dense graded AC (after 2 years)

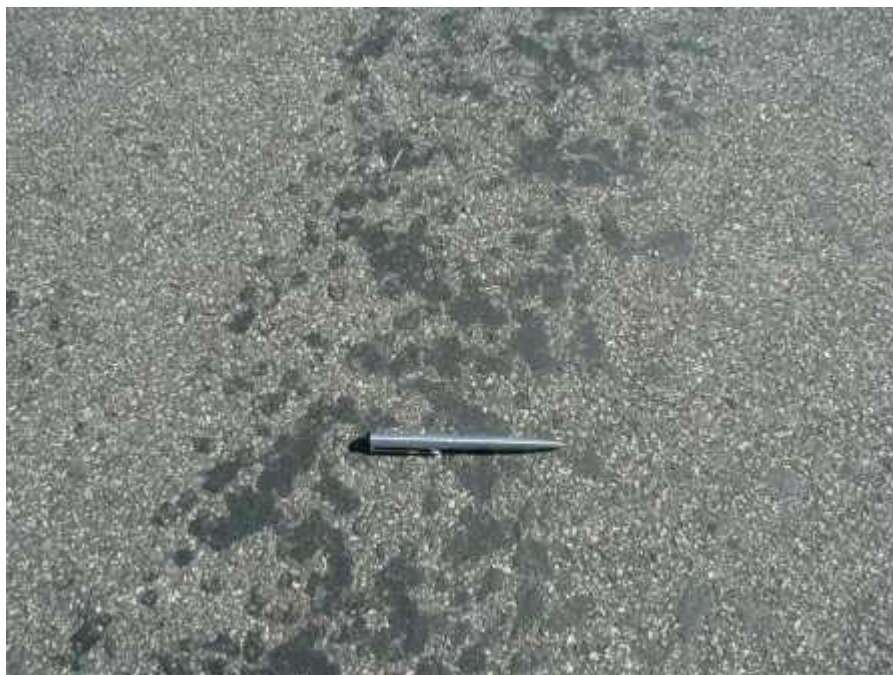
The gap-graded asphalt had quite heavy flushing in the wheel paths. The flushing is believed to be as a result of migration of binder from the SAMI to the surface. Photograph No 7 shows the flushing.

Flushing in Section 2, GG AC (after 2 years)

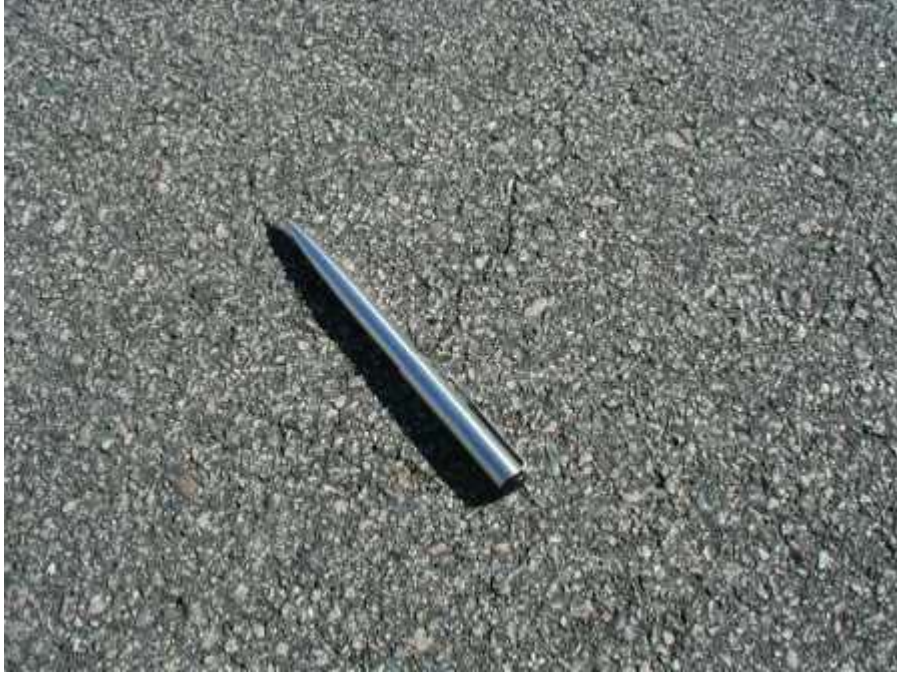
Cracking was evident in both the gap-graded and dense-graded asphalt and was estimated to have an extent of some 10% to 15% of the host surface cracks prior to overlay. The severity of the cracks is slight.

Cracking in Section 3, DG AC (after 2 years)

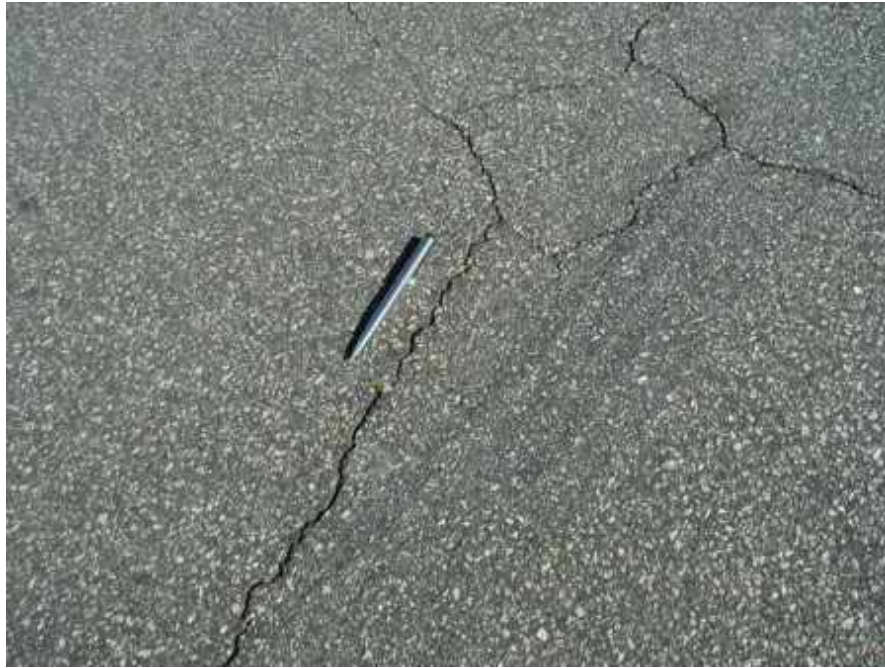
The cracking in the gap-graded asphalt has reflected to some 75% of the cracking of the host surface cracking prior to the overlay. The severity is slight, i.e. approximately 2 to 3 mm whereas the cracking prior to the overlay was 5mm in width. The photographs below show the cracking in the gap-graded asphalt.

Cracking in Section 1, gap-graded AC (severity after 4 years)

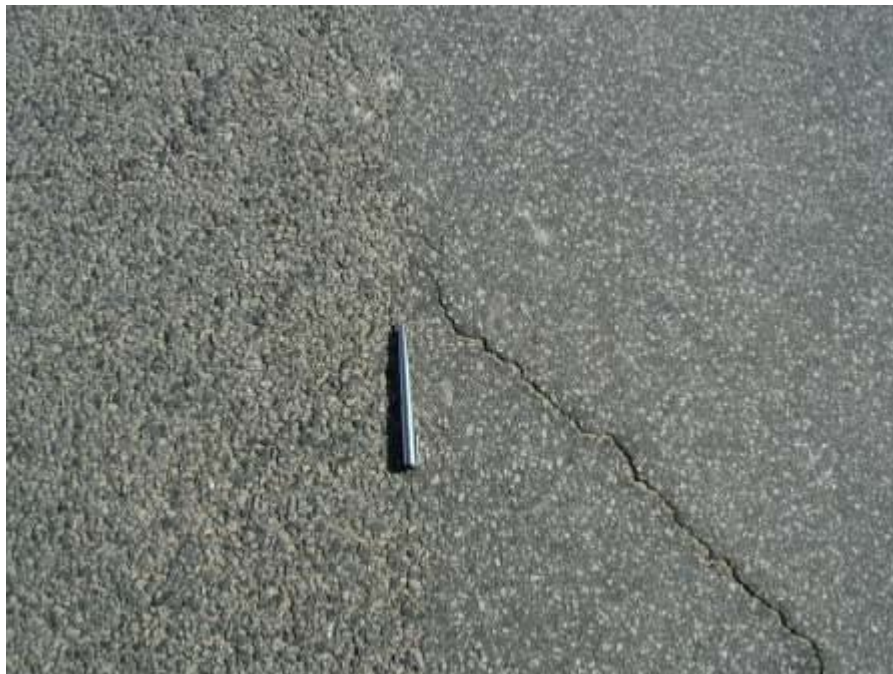
There is no cracking in the SMA. The photograph below shows cracks in the gap-graded asphalt extending to and stopping at the SMA.

Cracking in Section 1 GG but not in SMA (after 4 years)

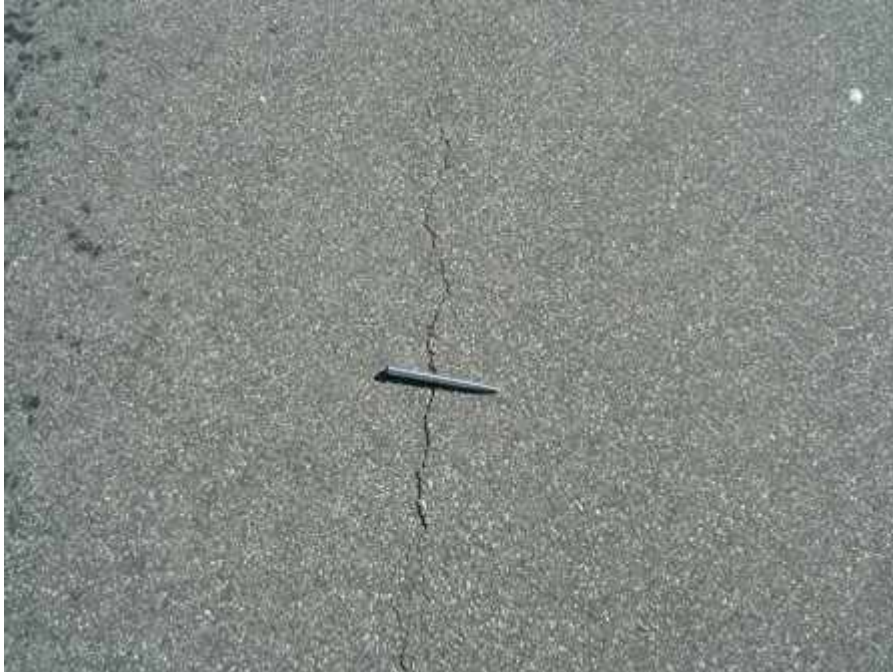
Cracking was evident in both the gap-grade and dense-graded asphalt and was estimated to have an extent of some 10% of the host surface cracks prior to overlay. The severity of the cracks was slight. The severity and extent do not seem to have changed a great deal in the last two years.

Cracking Section 2, GG AC (after 4 years)

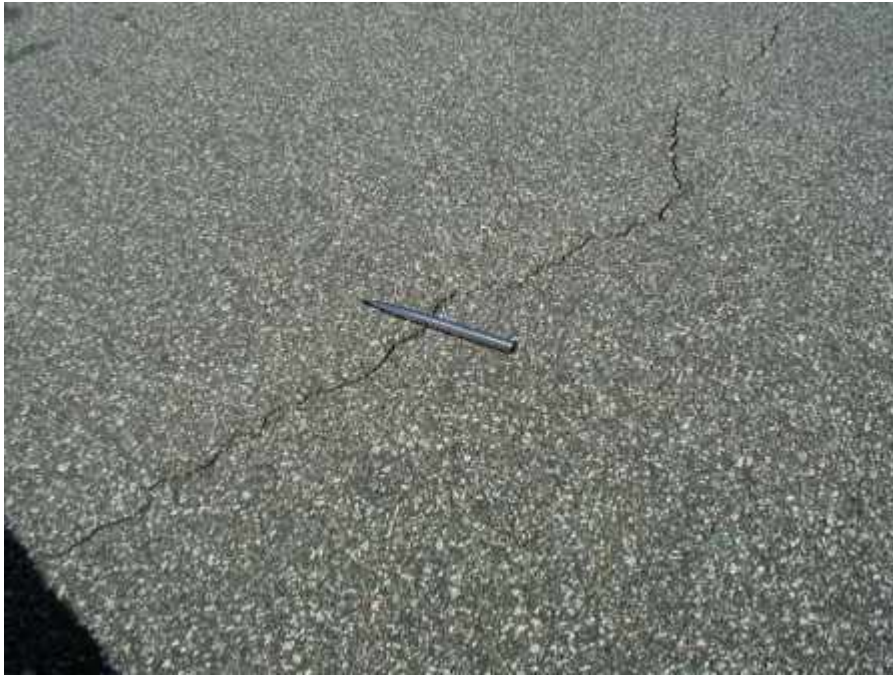
After 4 years and somewhat surprisingly, this section is now showing cracking. The cracking is evident to some 10% of the pavement and the severity is slight.

Cracking in Section 12, GG AC on new ESL base (after 4 years)

After 4 years the section that had been milled 100mm and replaced with emulsion stabilised limestone had cracked. However the curvature showed a marked improvement in strength. This would indicate that the bitumen in the ESL had broken and cured and the pavement strength had increased. Unfortunately the pavement strength may have reached a stage that it was as strong as the gravel base course that it replaced and that thermal movement was causing the pavement to crack.

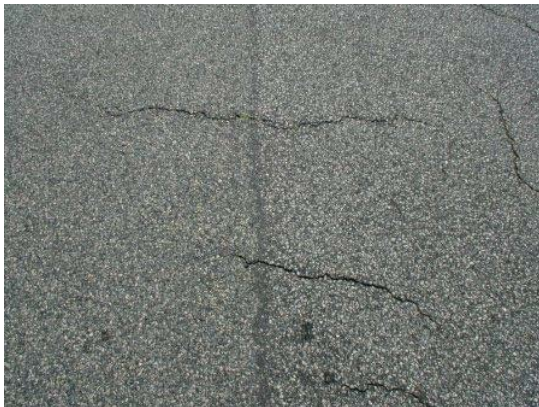
**GG on right & DG on left
(No host surface preparation)**

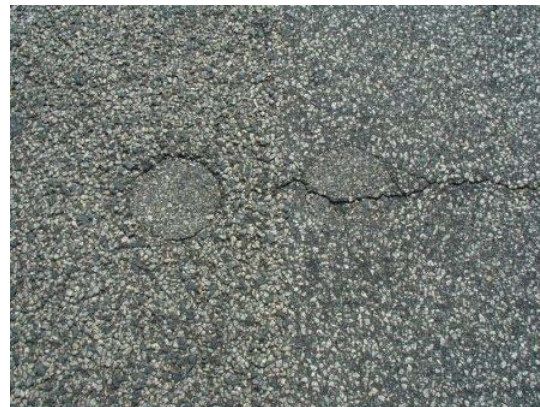
**GG on right & SMA on left cored 05
(No host surface preparation)**

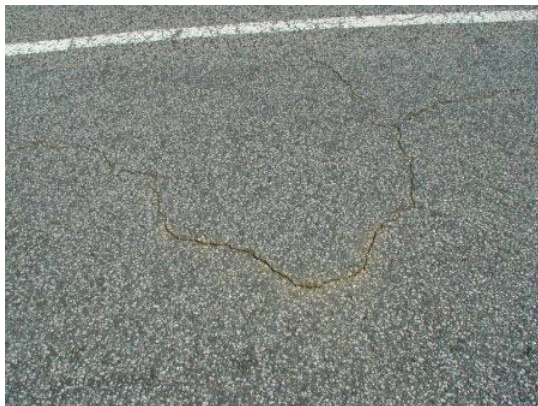
**Pumping from base course
(No host surface preparation)**

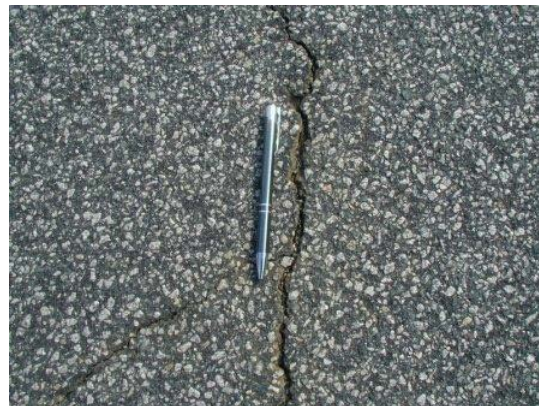
**Crack at same width as host - 6mm
(No host surface preparation)**

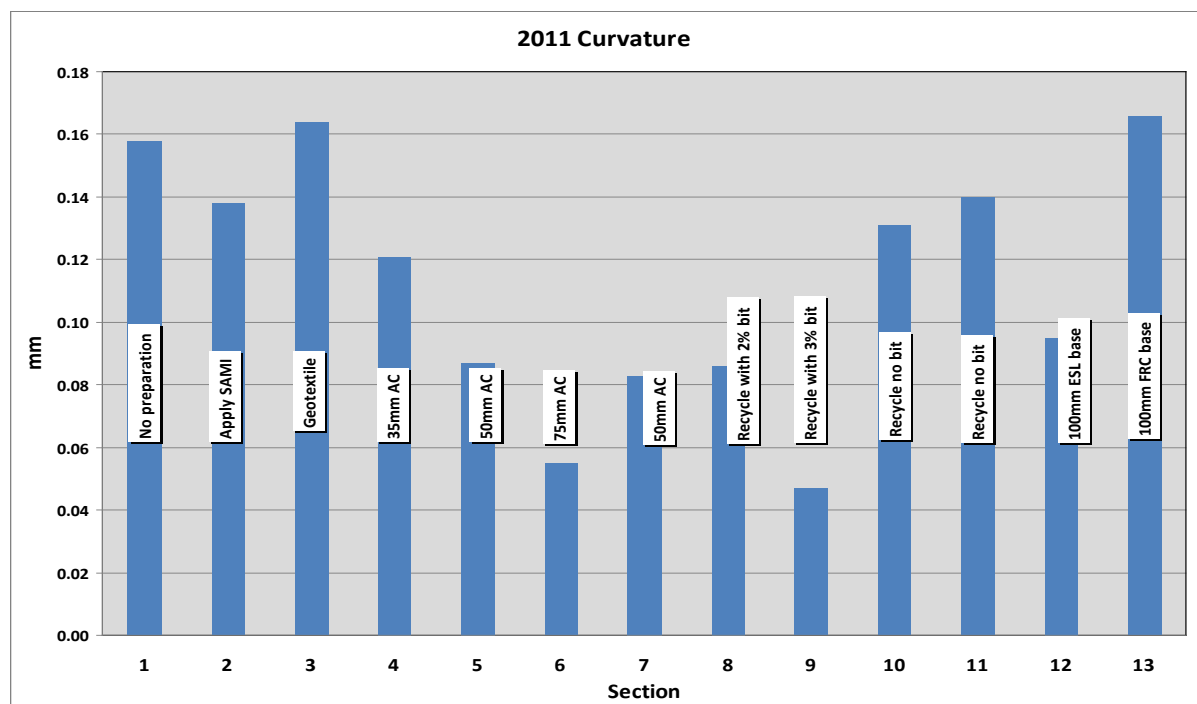
FIGURE 1 – CURVATURE AS TESTED IN JUNE 2011

Figure 1 clearly shows that in sections 6, 7, 8 & 9 the pavement structural capacity as at a level more depicting expectation of pavement strength of a distributor road with 35,000 vehicles per day (VPD) than a residential street with less than 2000 VPD.

The strongest of the pavements is the in situ recycled with 3% residual bitumen. However the visual assessment reveals that some cracking has occurred in the gap graded and dense graded but not in the SMA mix.

At about the same structural capacity of the in situ recycled with 3% binder is the 75mm + 25mm of asphalt Section 6 which has not cracked, followed by the 50mm + 25mm of asphalt Sections 5&7, together with the in situ recycled with 2% binder.

Whilst sections 1, 3 & 13 show a greater strength than prior to construction, the improvement is minimal.

The most surprising finding is the lack of strength improvement in Section 3 with geotextile.

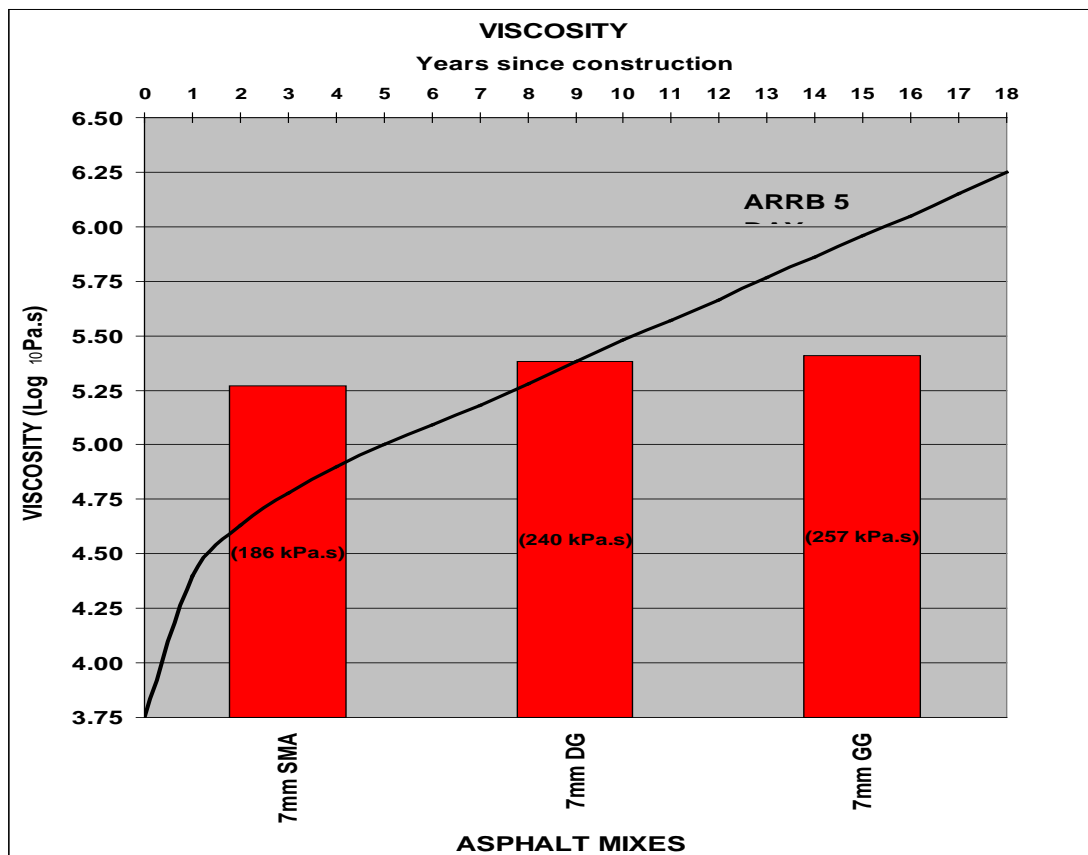
FIGURE 2 – BINDER VISCOSITY AFTER 10 YEARS OF SERVICE

Figure 2 above also shows an overlay plot of the ARRB 5 day bitumen hardening curve for Melbourne that has been lifted from ARRB Research Report ARR 326 – “The performance of Sprayed Seals” by John Oliver 1999. This figure shows that the hardening of binder in the SMA is less than or slower than the other two mix types. It was surprising, in fact somewhat disappointing to see that the hardening in the gap graded asphalt was no better than that in the dense graded asphalt. However after checking the original test reports of the gap graded mix for this Section, it was found that the air voids were excessively high and accordingly it can be accepted that the binder hardening performance would not be any better. For the same reasoning, it is also somewhat surprising that the SMA binder hardening is less than the other two mixes as the in situ air voids in this mix are around the 8% mark, whereas current European specifications are asking for in situ voids of less than 6%. It is hypothesised that the reason for the superior performance is purely the fact that the SMA has a higher binder and or mastic film thickness.
