The influence of asphalt workmanship on pavement service life

Joralf Aurstad, NPRA

**Međunarodni seminar ASFALJNI KOLNICE 2017
International seminar ASPHALT PAVEMENTS 2017**

Durable roads

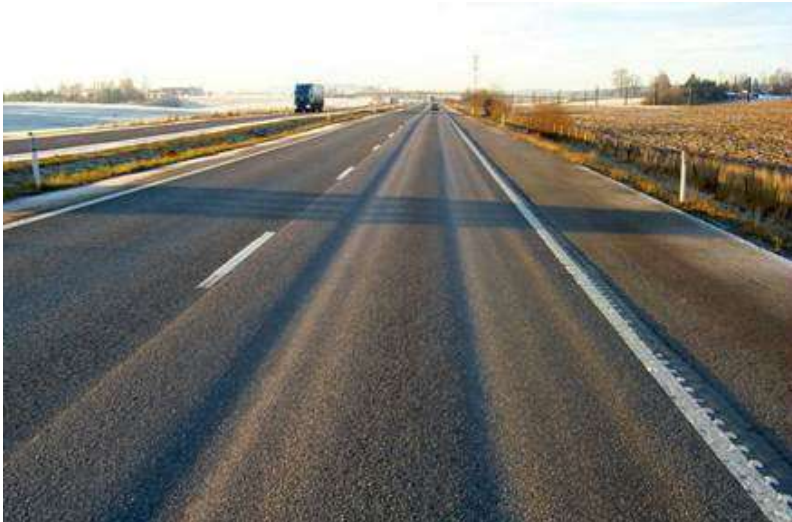
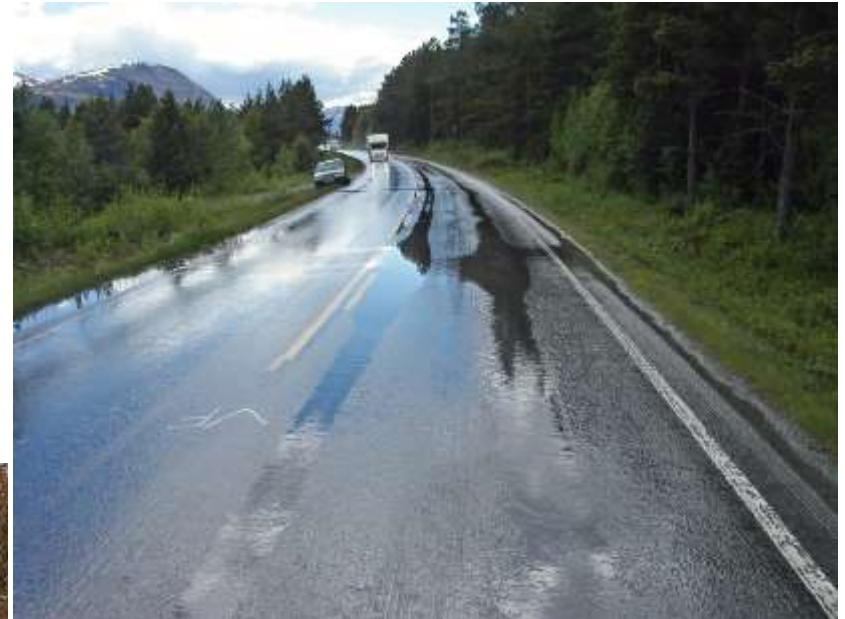
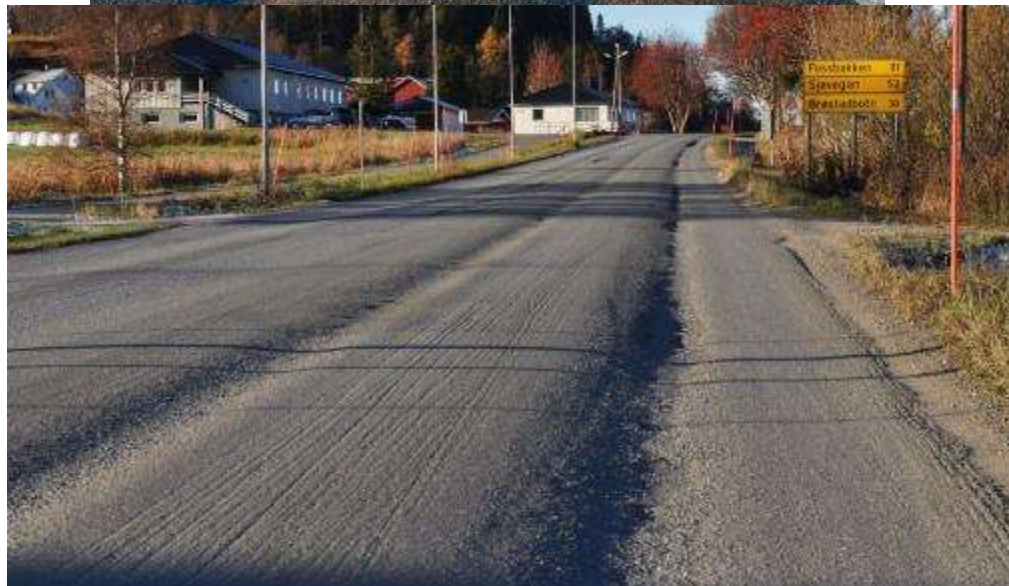
Studded tires → asphalt surface wear

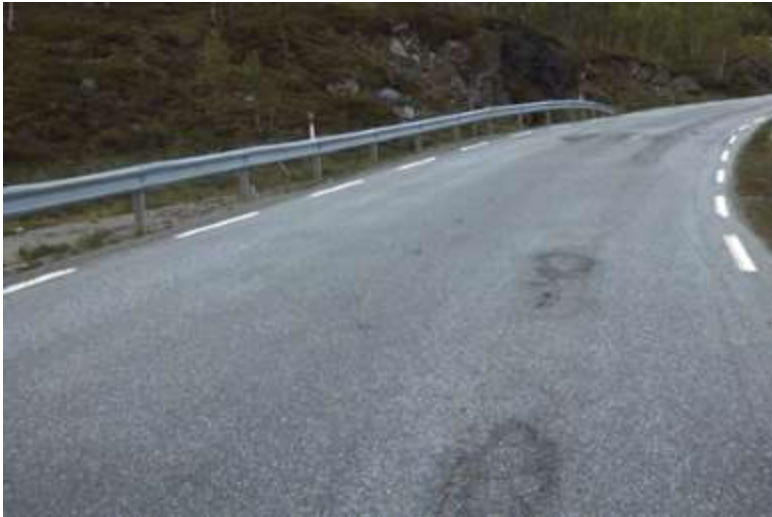
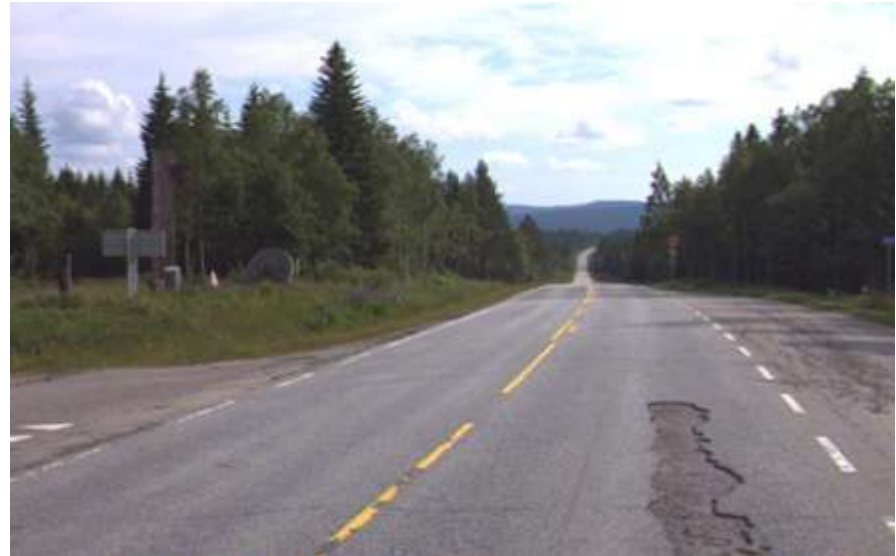
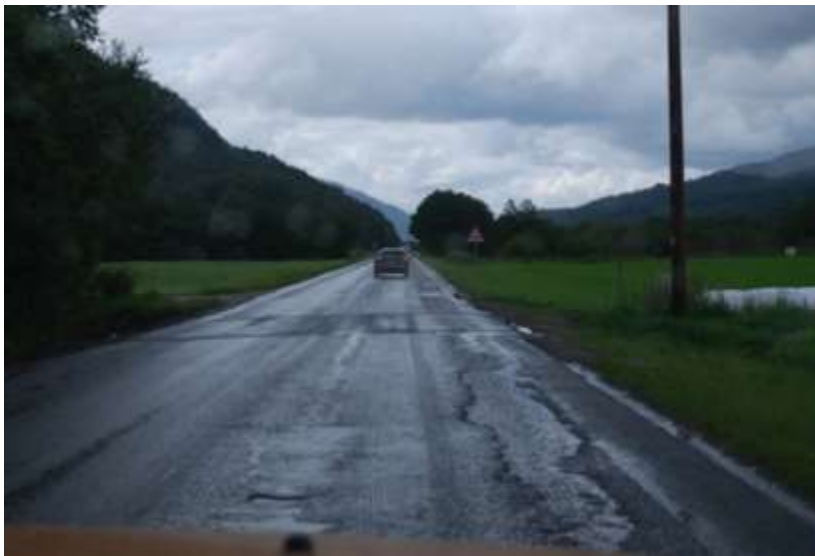
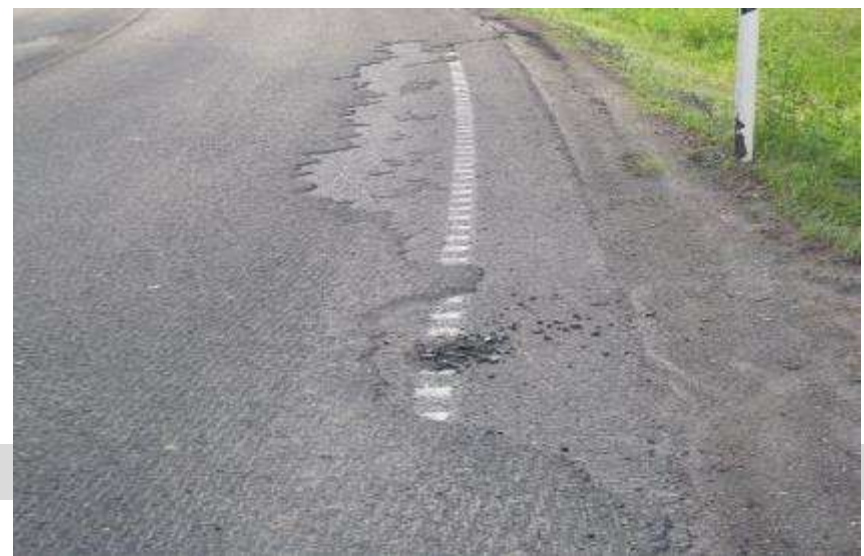
Many distresses because of lack of bonding

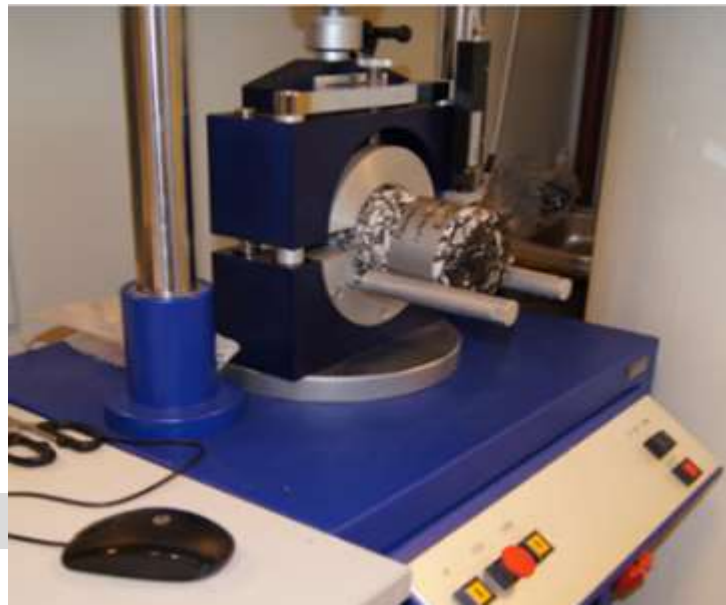
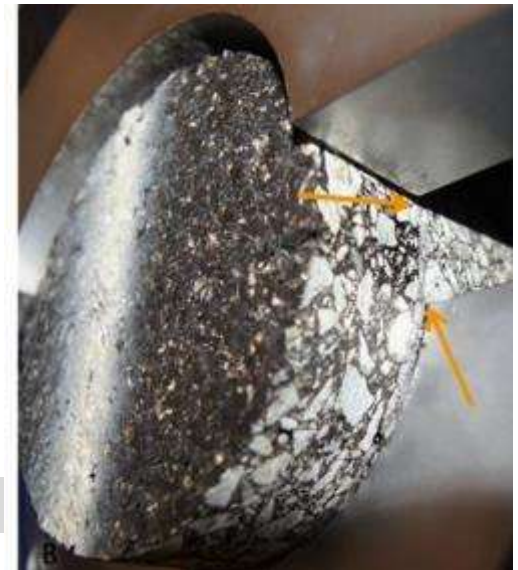
«shear bond test»

Actions regarding bonding:

- Improved contract descriptions
 - Area to be covered by tack coat, minimum amount of bitumen pr m²
- Improved control procedures
- Introduced new laboratory methods/procedures

shear bond
test

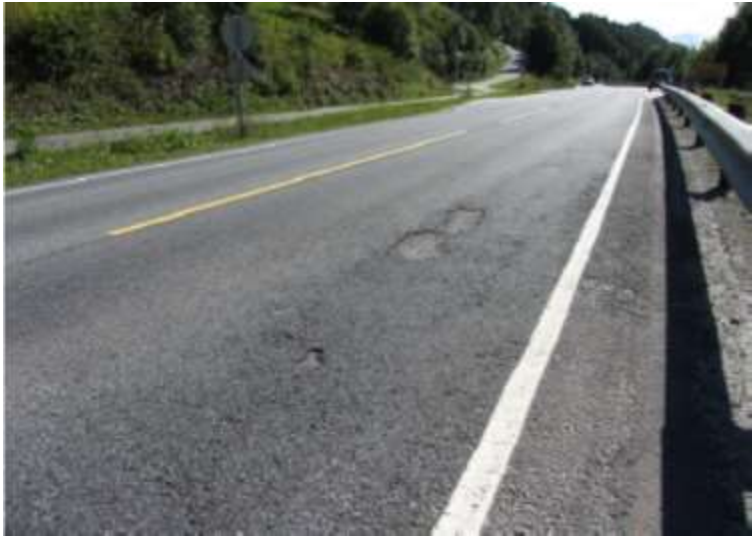
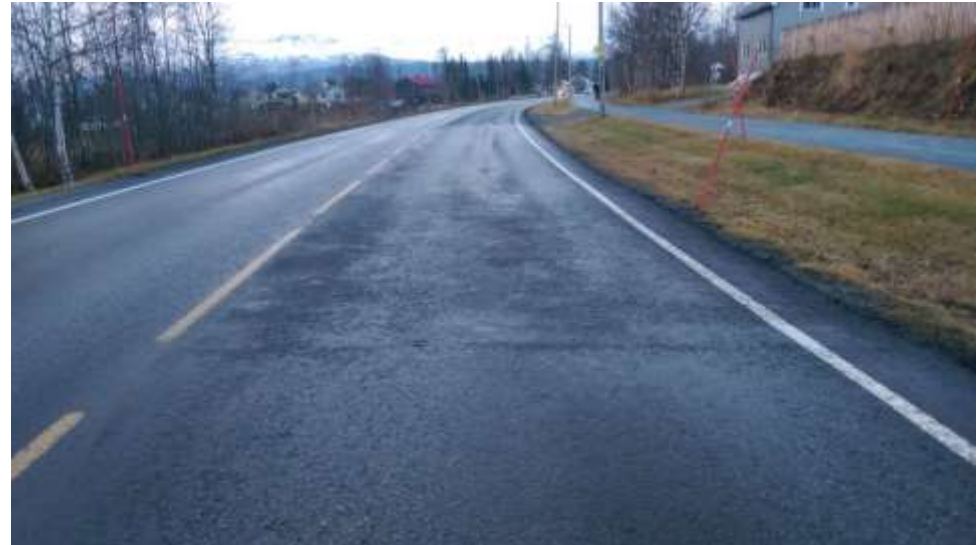
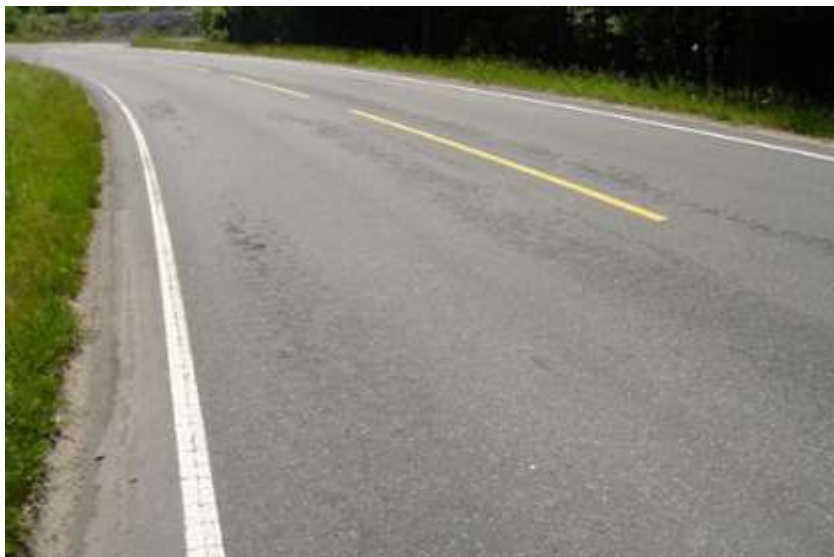
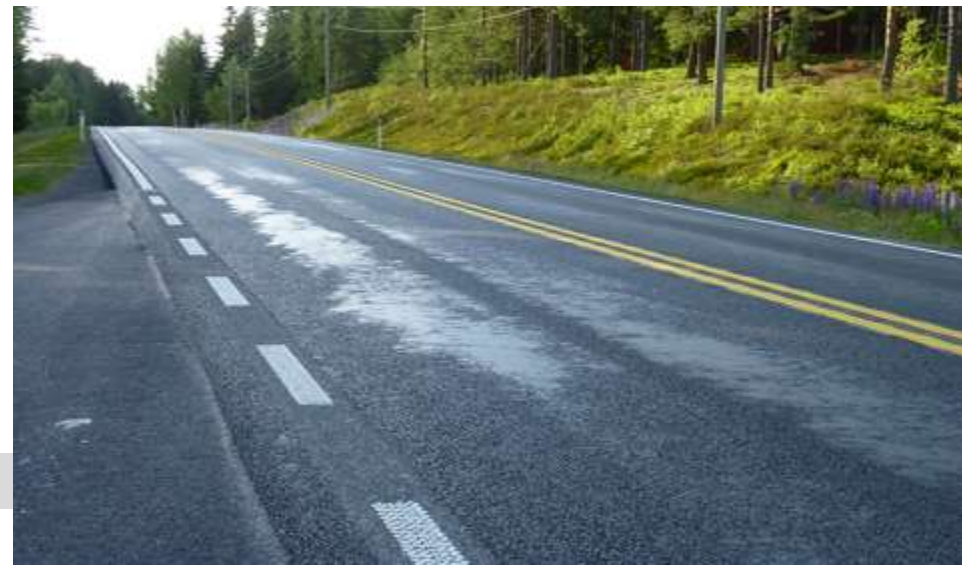
Many distresses because of non-homogeneous asphalt

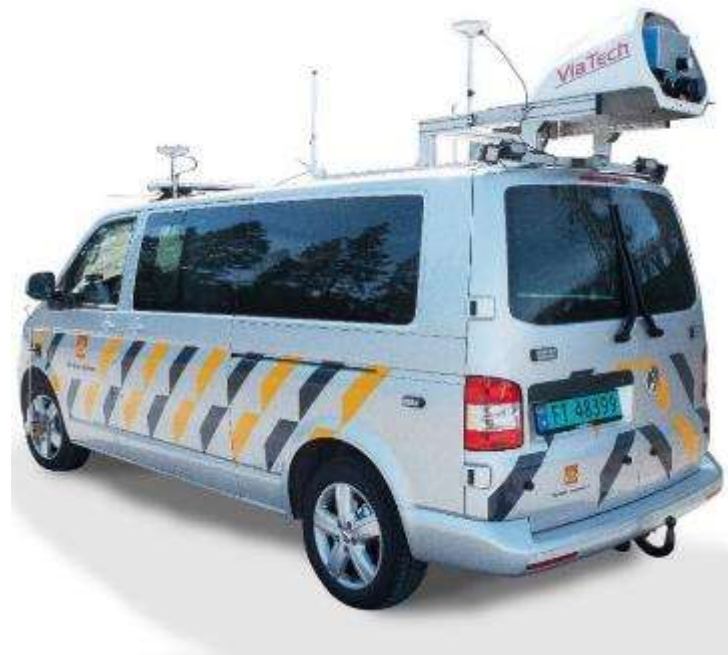
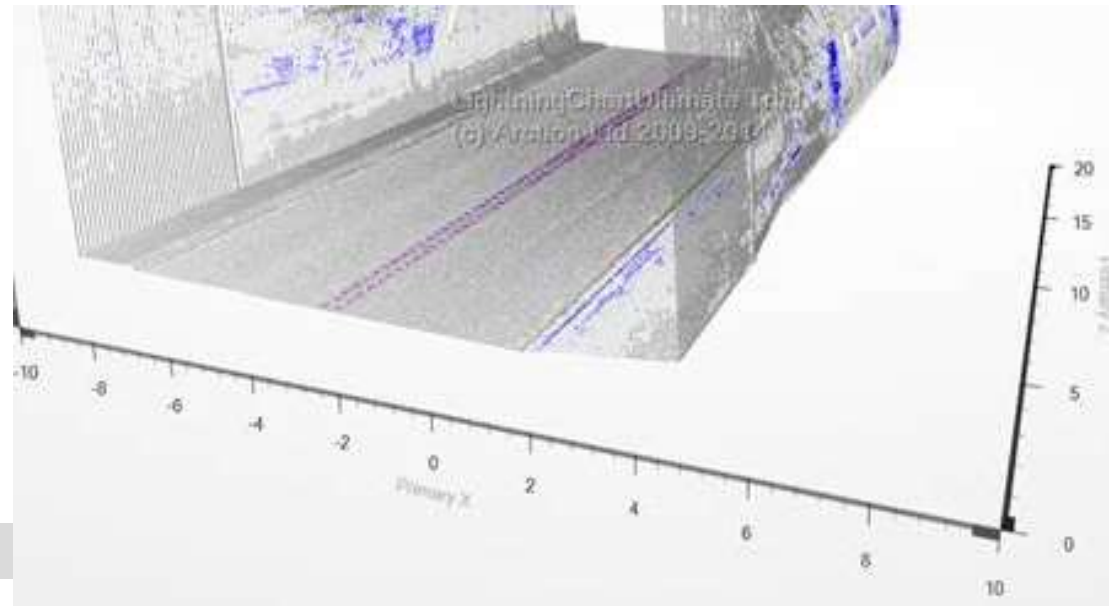
ViaPPS - NPRA's laser based road monitoring system

- 360 degree rotating laser scanning
- Resolution;
 - 1300 measuring points in each cross profile
 - Cross profile gap 8 cm (at 60 km/h)
- Detailed surface detection (rutting, texture, cracking etc.)
- New application; tunnel profiles

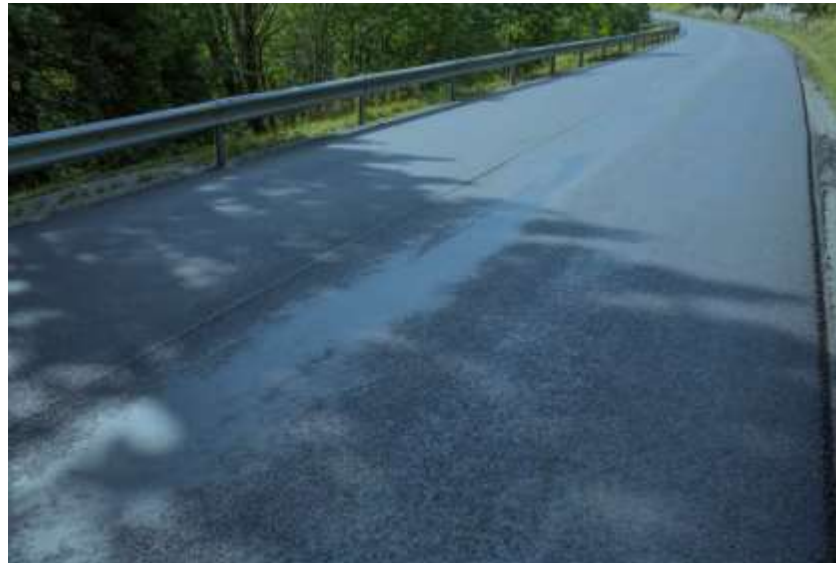
New module in ViaPPS: Homogeneity

Statistical texture analysis from laser data

Image of asphalt surface homogeneity

Extreme slippery and/or open textured areas can be detected instantly

«homogeneity mapping» from laser scanning data
(detecting bleeding and open textured areas)

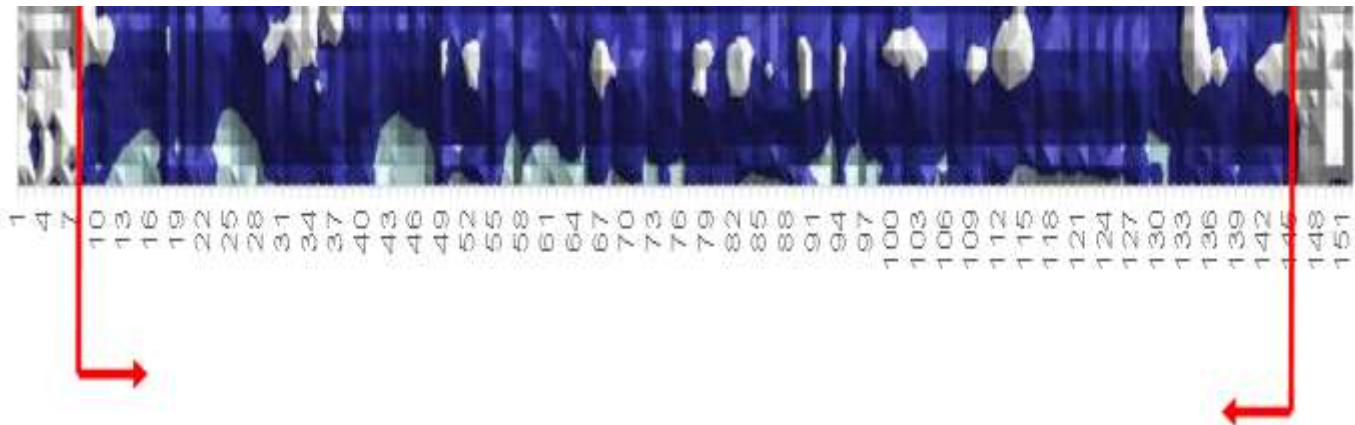
Start new paved section

Bleeding areas

End new paved section

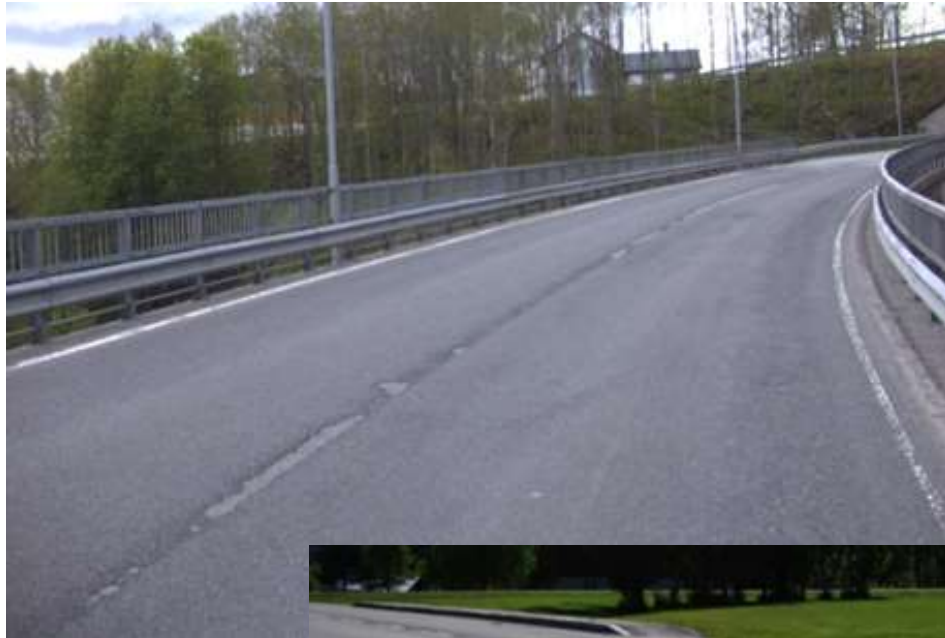
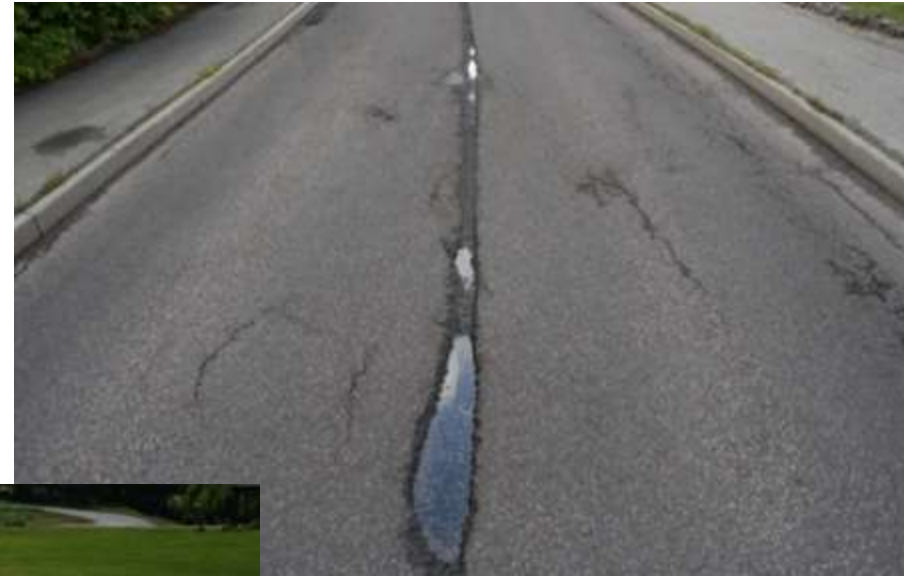
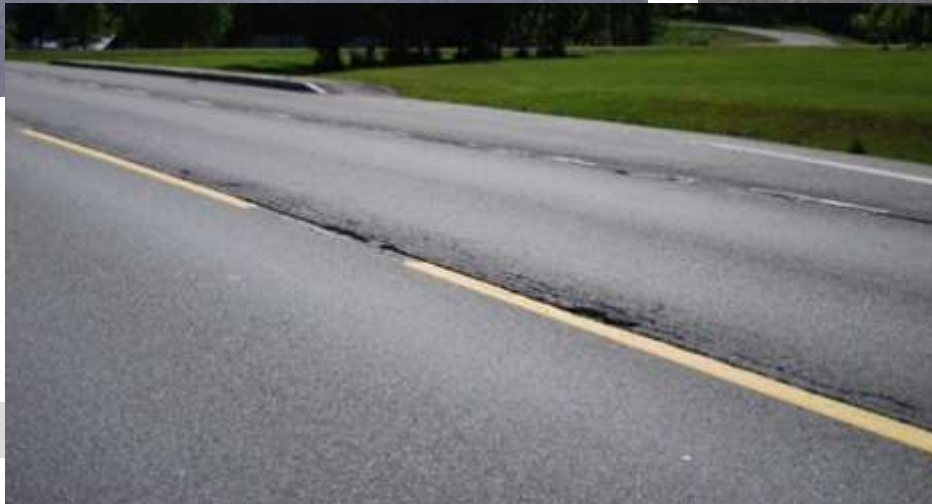
Many distresses because of open joints

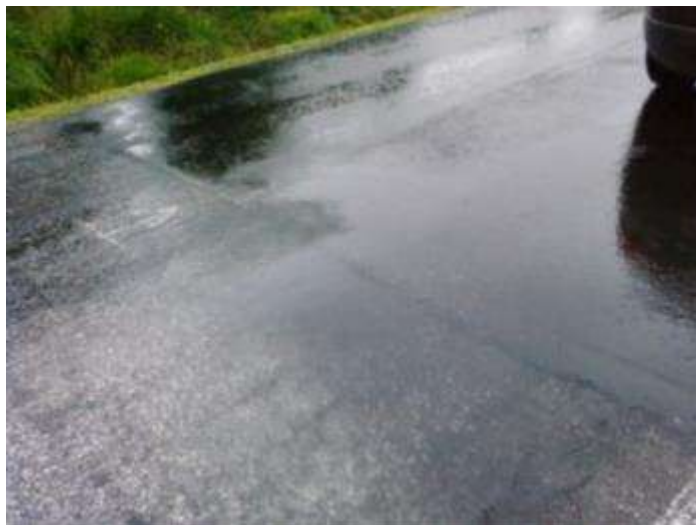
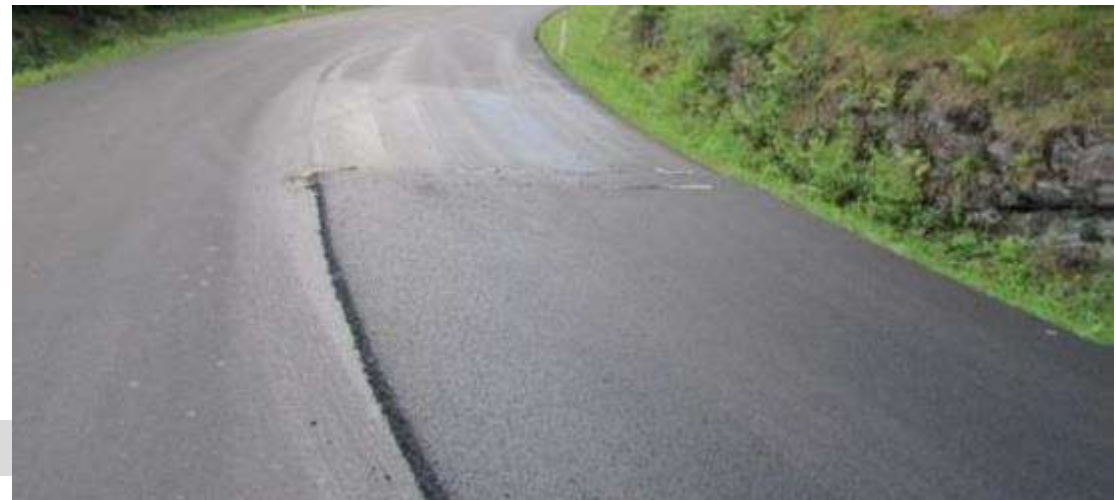
Tried out special measures in some contracts, e.g. **edge restraining devices.**

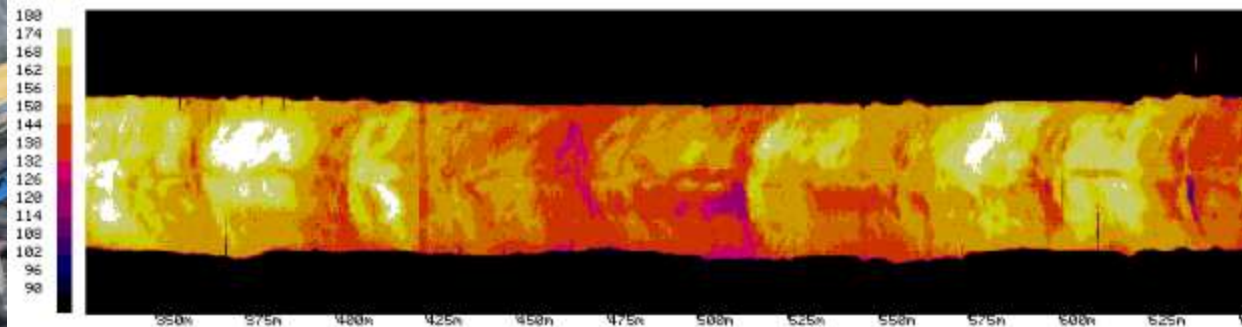
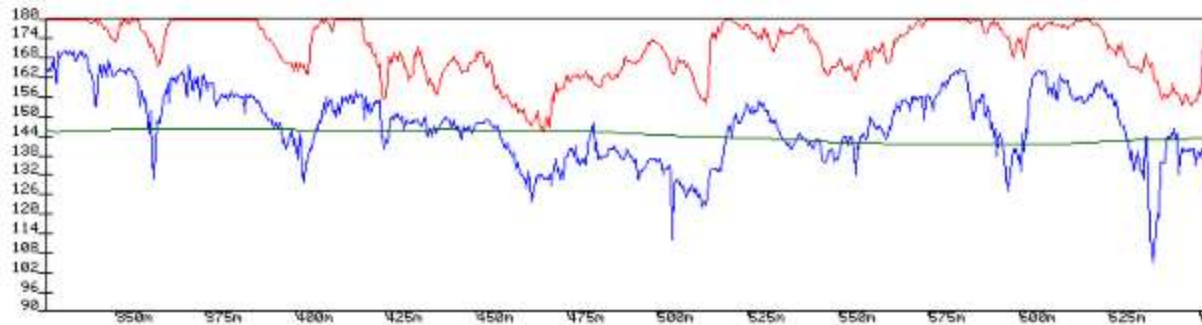
LOGNAMN: 2016-05-20-02.log
SIDA: 2/3

----- maks temp ----- min temp ----- risk temp

Typical temperature profile on the road after reloading from boat to truck and further on to paver. Cold materials in almost every truck load can be seen.

IR cameras have shown to be a very useful tool to detect inhomogeneities, especially in connection to **boat transport contracts**.

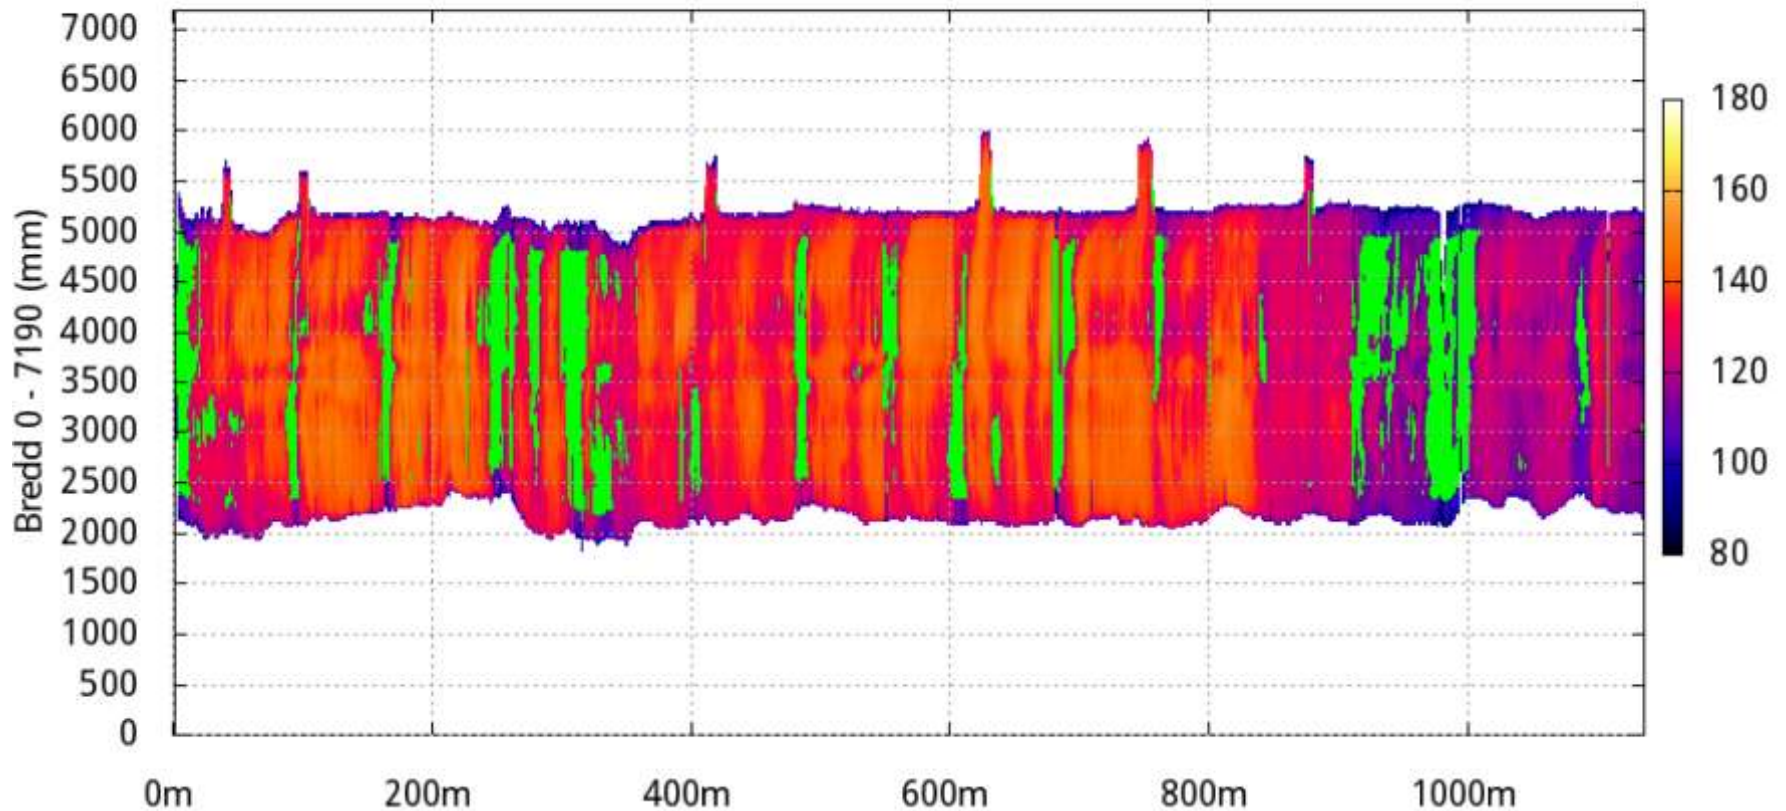
2016-08-17-02 - Temperaturkarta

Boat transport **without** feeder/Shuttle Buggy

Risk area 10,6 %

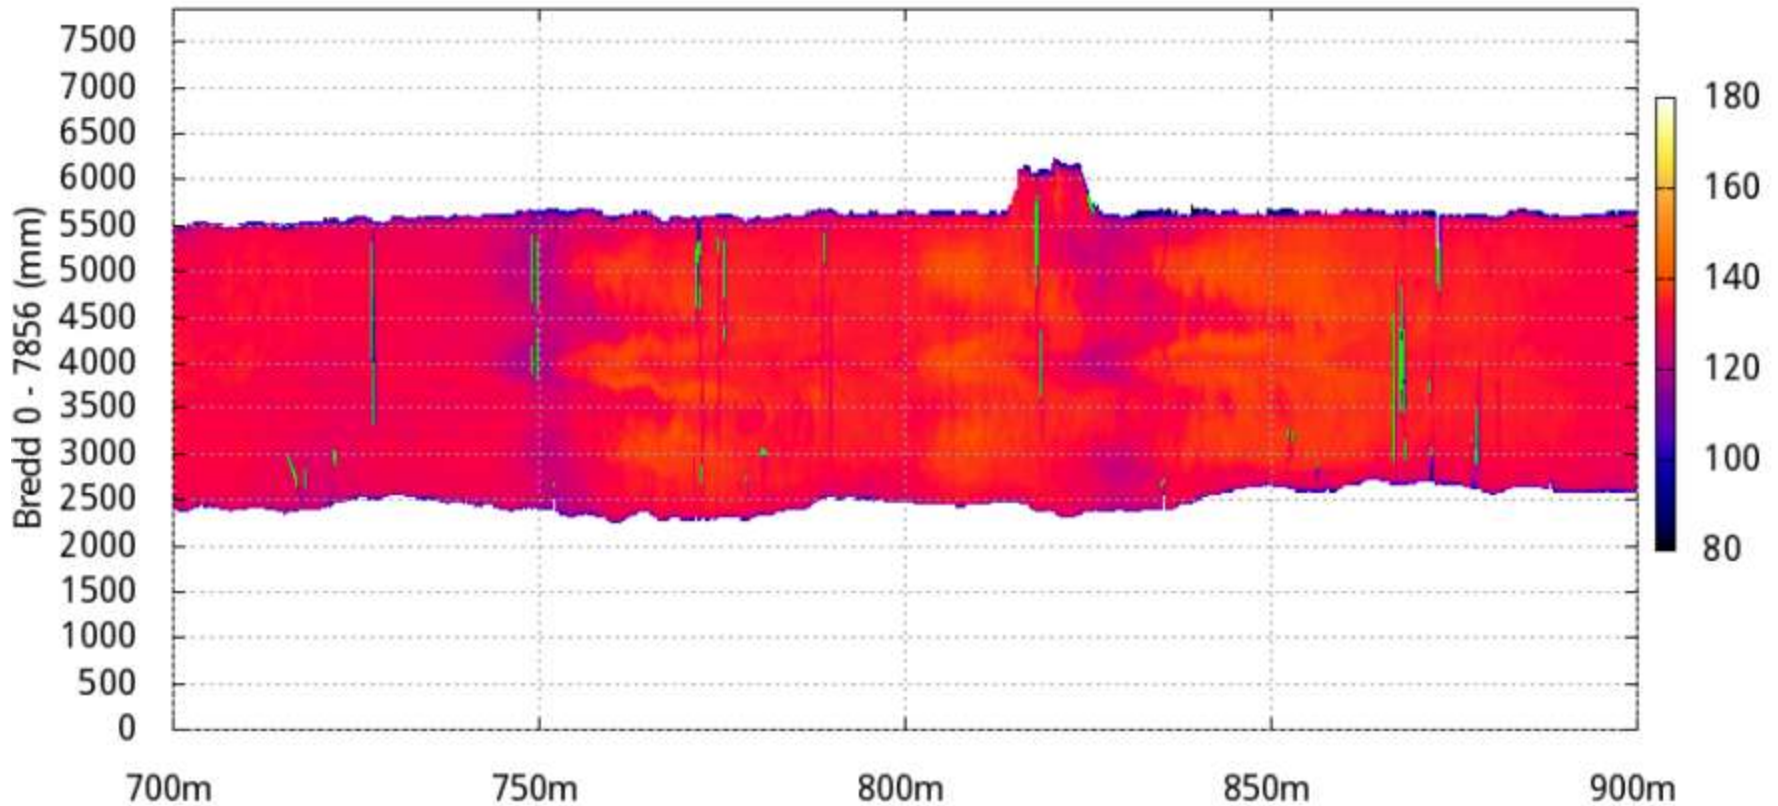
2016-06-24-01 - Temperaturkarta

Boat transport with feeder/Shuttle Buggy

Risk area 1,4 %

Boat contracts in 2016: Introduced extra loading/mixing equipment on the road (feeder or Shuttle Buggy)

Positive results; the effects can be read directly from the IR pictures (see next slides)

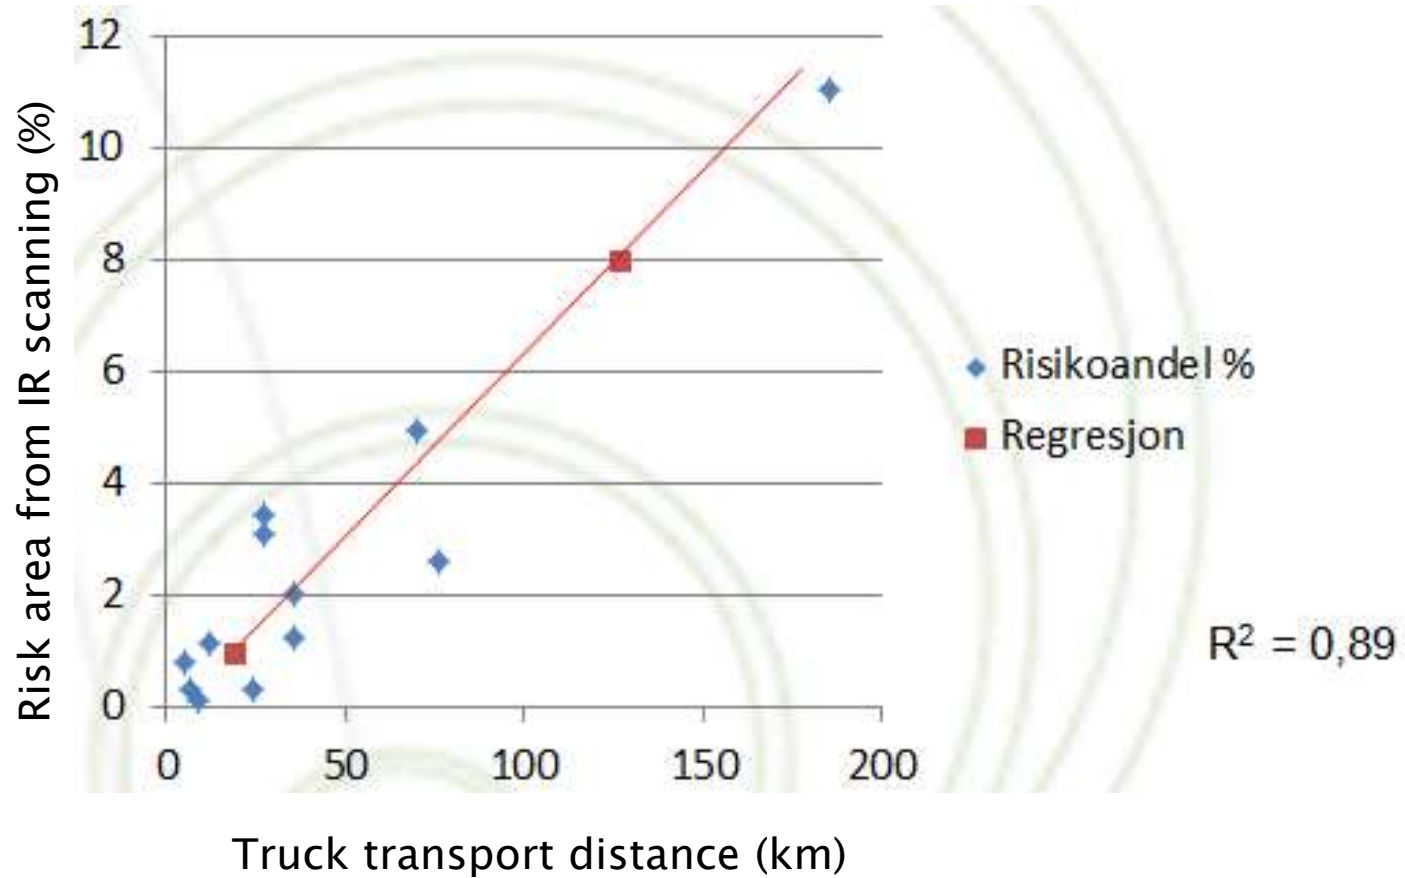
Risk area vs. transport distance (on truck)
