Monitoring The Condition of Surfacing Seals With Nondestructive Tests at Field

ABSTRACT

Keywords: Chip seals, Performance testing, Surface dressing

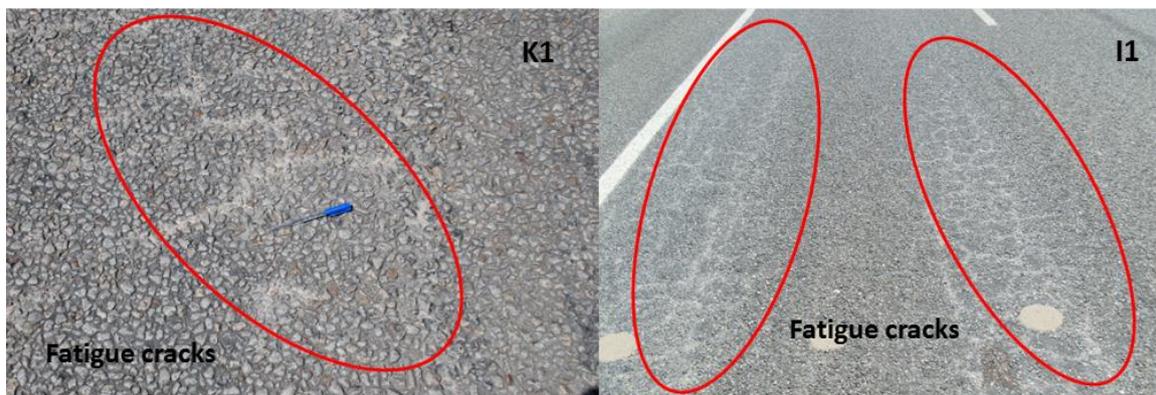
Figure 8: Fatigue cracks at some test points

Test roads that have collapses and settlement deterioration also have capillary cracks like fatigue cracks. These types of deteriorations 'photos (shown in K1 and I1), were given in Figure 8.
