Performance evaluation of fly ash asphalt pavement

This investigation was carried out to study the effect of fly ash on the field performance of asphalt pavement. Fly ash was used in stone mastic asphalt (SMA) during the construction of the wearing course of Gaziantep Ring Road. This SMA is the first application using fly ash in our country. The performance properties (rut depth and roughness and cracking in the pavement) were determined.

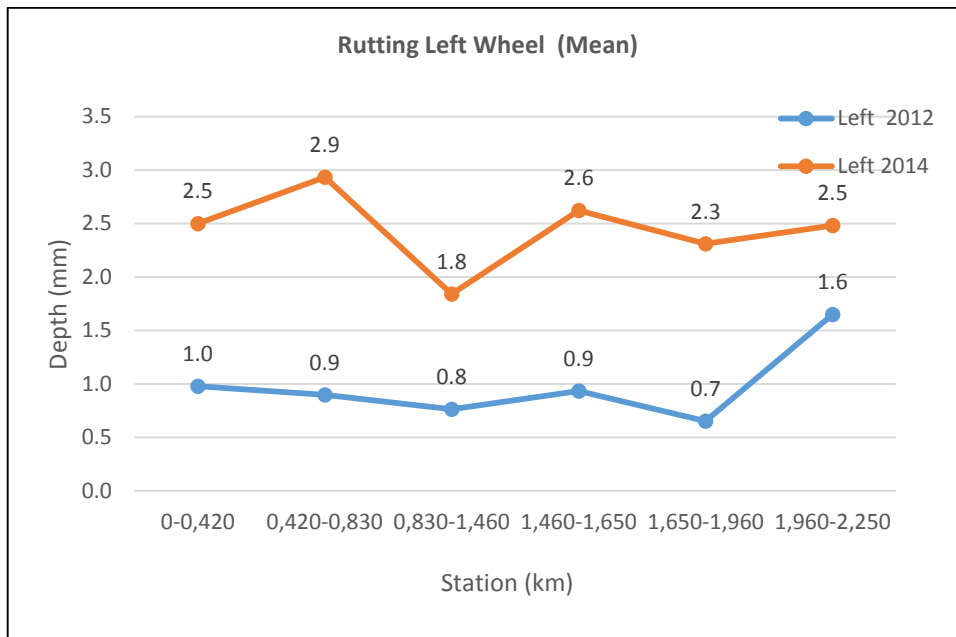
Figure 2: Rutting left wheel

- The changes (increases) in the left and left-max wheel values are between 0,8-2,0 mm and shown in Figure 2
- The changes (increases) in the right and right-max wheel values are between 0,6-2,8 mm and shown in Figure 3.

- The changes in the values of rut depths belonging to the years of 2012 and 2014 are increased in very low amounts as 0,8-2,0 mm in left wheel and 0,6-2,8 mm in right wheel.
- There has not occurred any cracking type and other pavement distress.

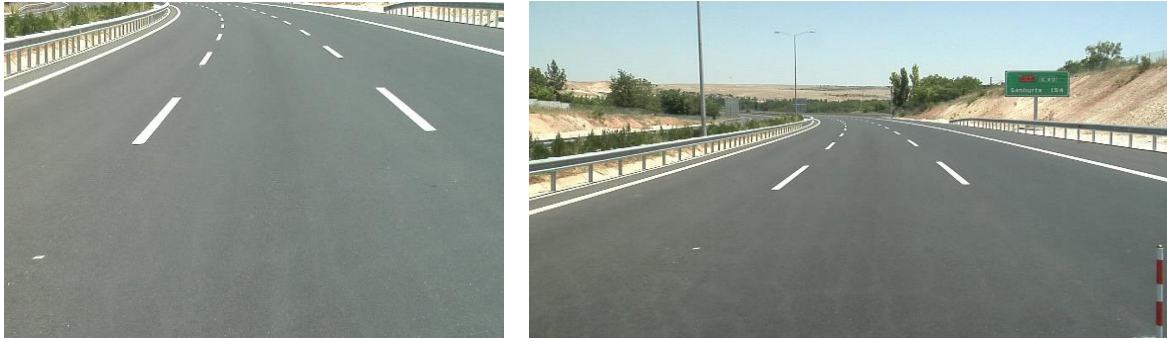
Figure 4: Surface images in 2012

Thanks to the photographs taken with RSP in every 10 meters and the on-site observations since 2012, it is determined that there has not been any cracking or other distresses types on the pavement.

The images belonging to the same part of the pavement (km: 0,280), of which surface condition is observed between 0,000-3,900 km and photographed with road surface and inventory cameras, can be seen in Figure 4 for 2012 and Figure 5 for 2014.
