GEOTEXTILE REINFORCED SEALS UNDER ASPHALT

Rod Fyfe, Geofabrics Australasia, South Australia

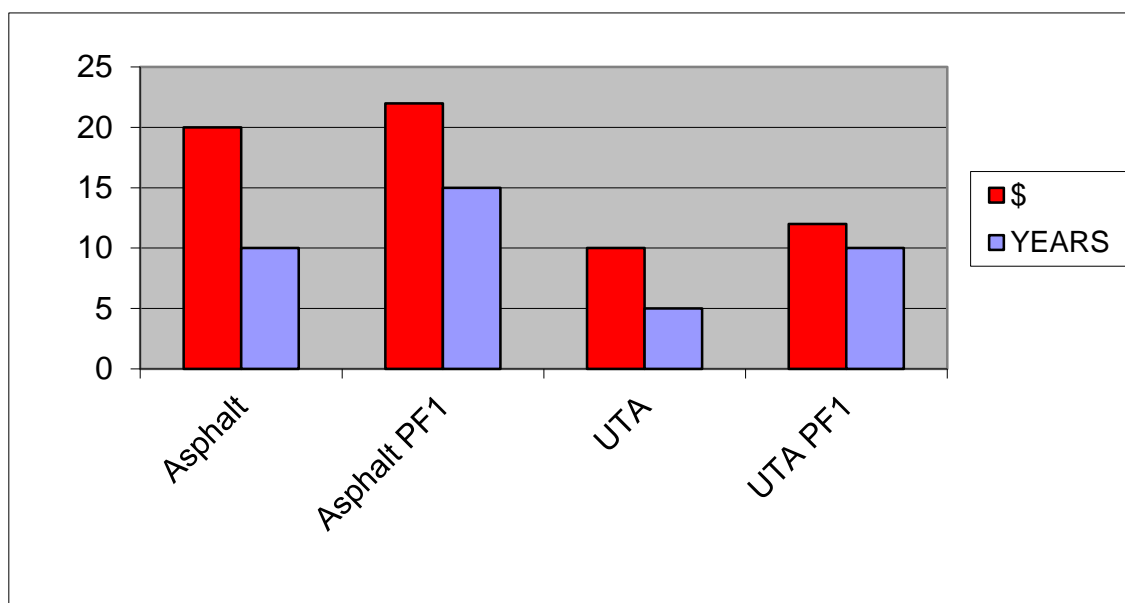
Figure 1 Paving Fabric Seal Life v Cost Benefits

Life span of treatments incorporating paving fabrics over cracked but stable pavements are detailed in case studies included in this paper. An overview of life span versus investment, for paving fabrics in various seal treatments, is shown in Figure 1. An overview of life span versus pavement condition is shown in Figure 2.

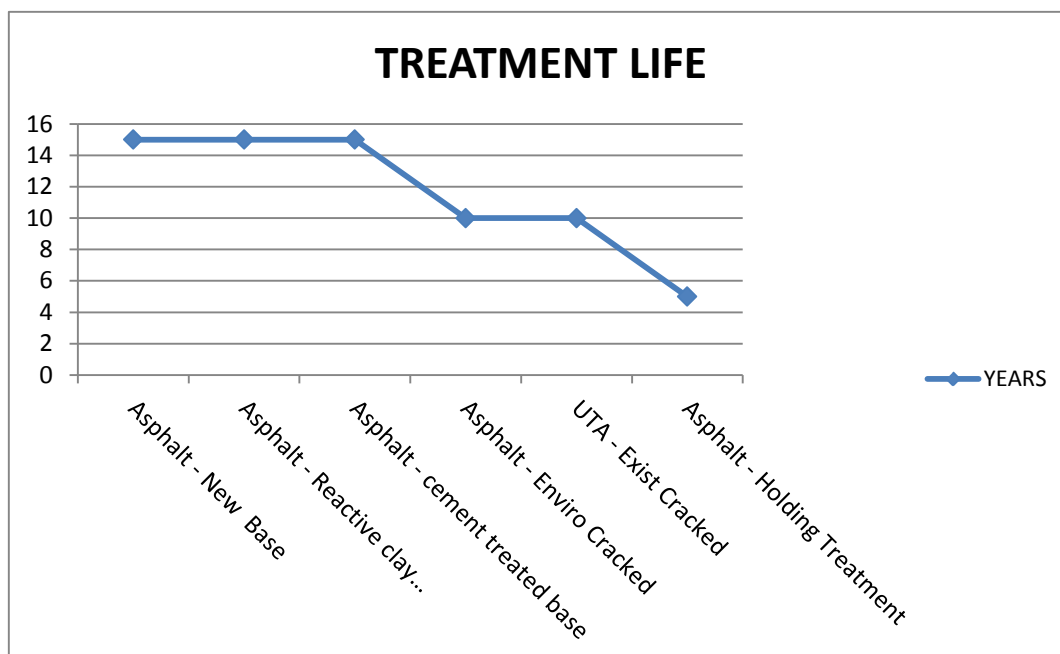
Figure 2. Paving Fabric Seal Life v Application

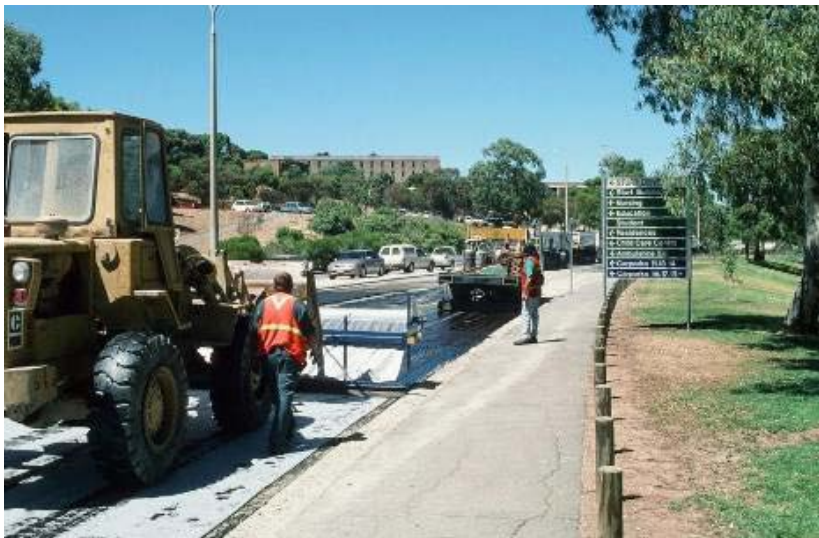
Figure 21: Laying fabric – 1999

Asset Owner;	University of South Australia
Design consultant;	KBR
Sealed;	1999 - 2001
Asphalt;	40mm (up to 100mm for correction)
Paving Fabric;	Sealmac PF1
Bond coat;	C170
Area;	20,000 sqm
Existing condition;	Reflective cracking resulting from environmental factors influencing reactive clay sub-grade and varying rock substrates. Sections of severe crocodile cracking planed and reinstated. Waterproofing critical to preventing wet road sub-grade encouraging tree root ingress.

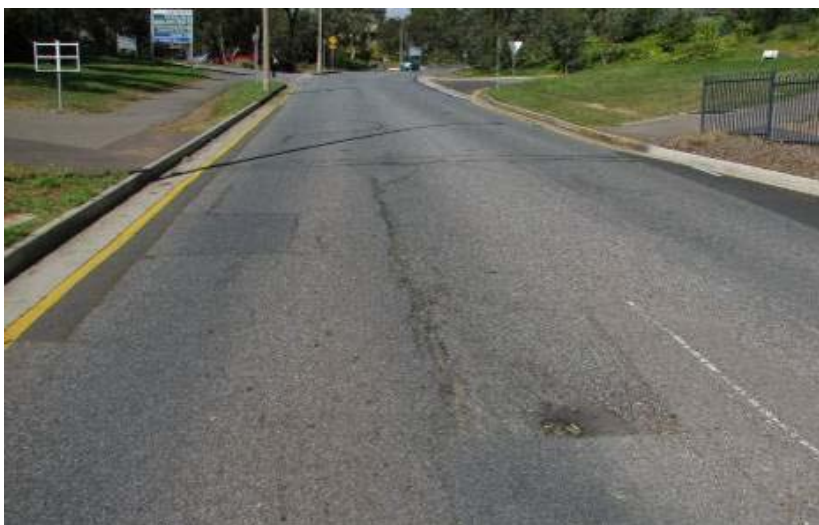
Figure 22: Pavement 2009; Old untreated pavement adjacent University Drive

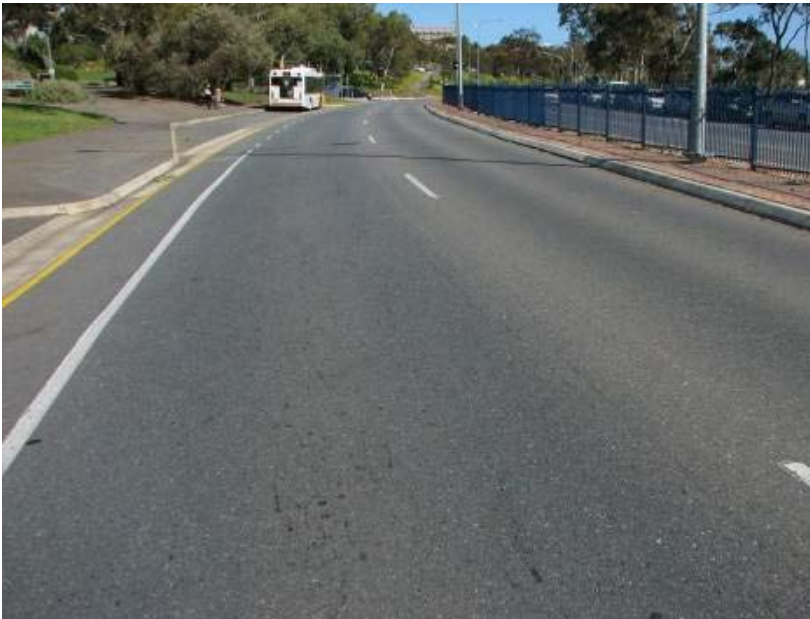
Figure 23: University Drive 2009

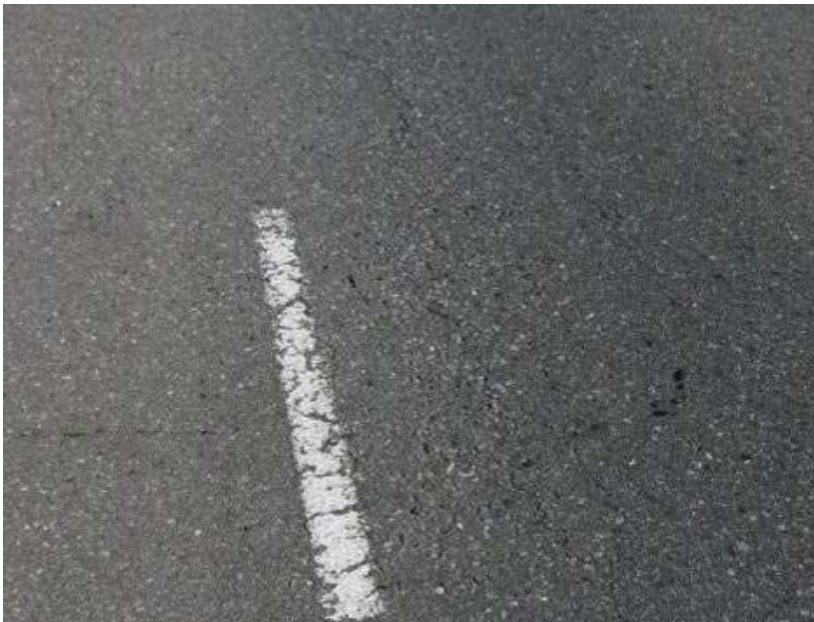
Figure 24: Pavement 2009

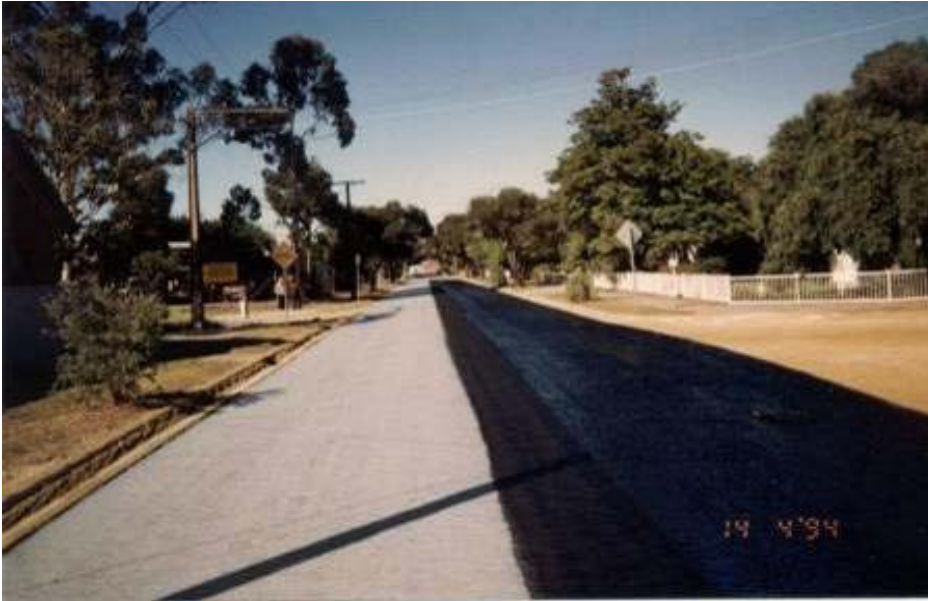
Figure 25: Sealing 1994

Asset Owner;	City Port Adelaide Enfield
Sealed;	1996
Asphalt;	30mm
Paving Fabric;	Sealmac PF1
Bond coat;	C170
Area;	4,000 sqm
Existing condition;	Reflective cracking resulting from environmental factors influencing reactive clay sub-grade and substrate. 30mm asphalt resurfacing laid over reconstructed 40mm FCR base course, typical construction by the council for this era, for achieving extra strength over reactive clay sub-grade.

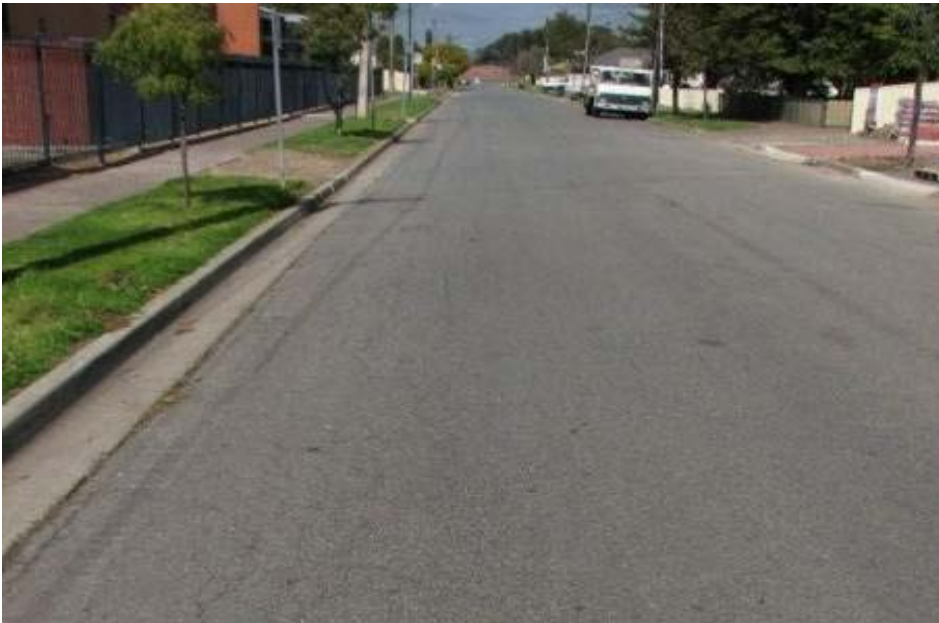
Figure 26: Pavement 2009

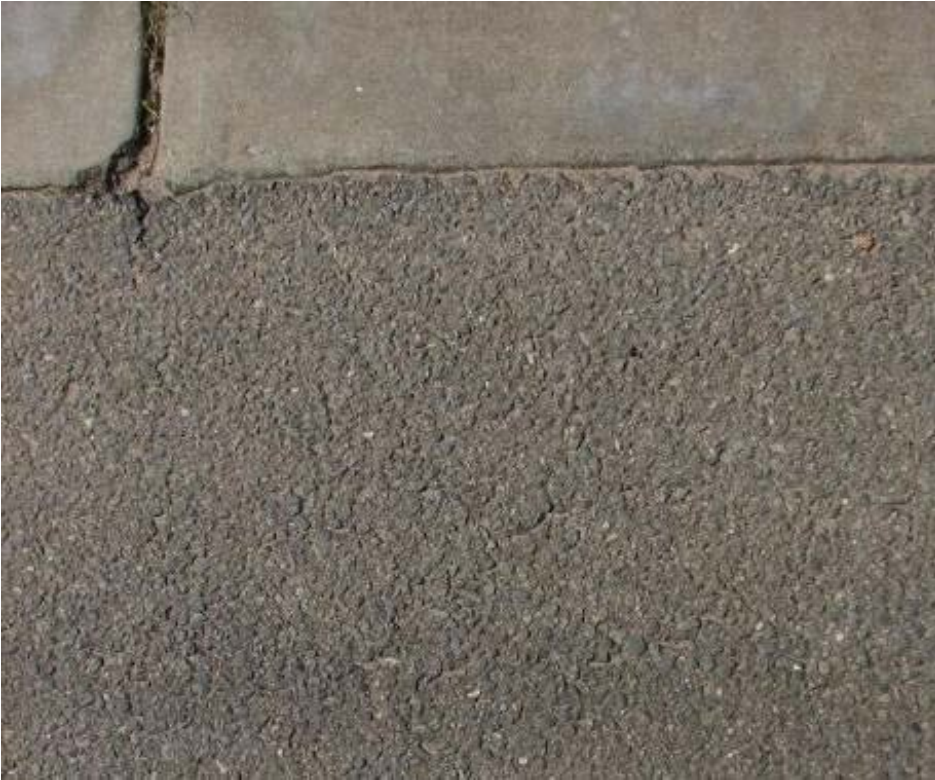
Figure 27: Pavement 2009

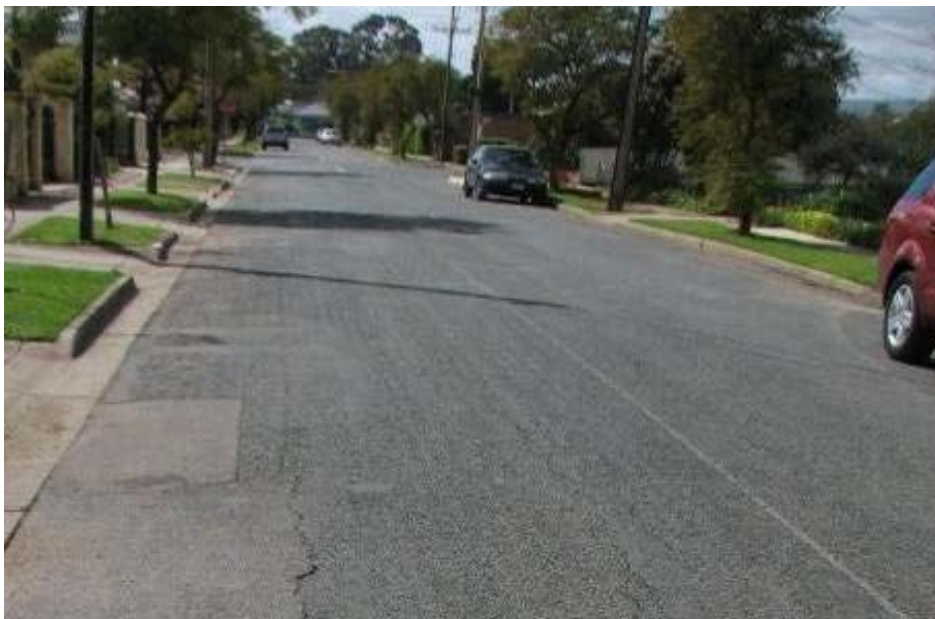
Figure 28: Adjacent area - Untreated pavement 2009

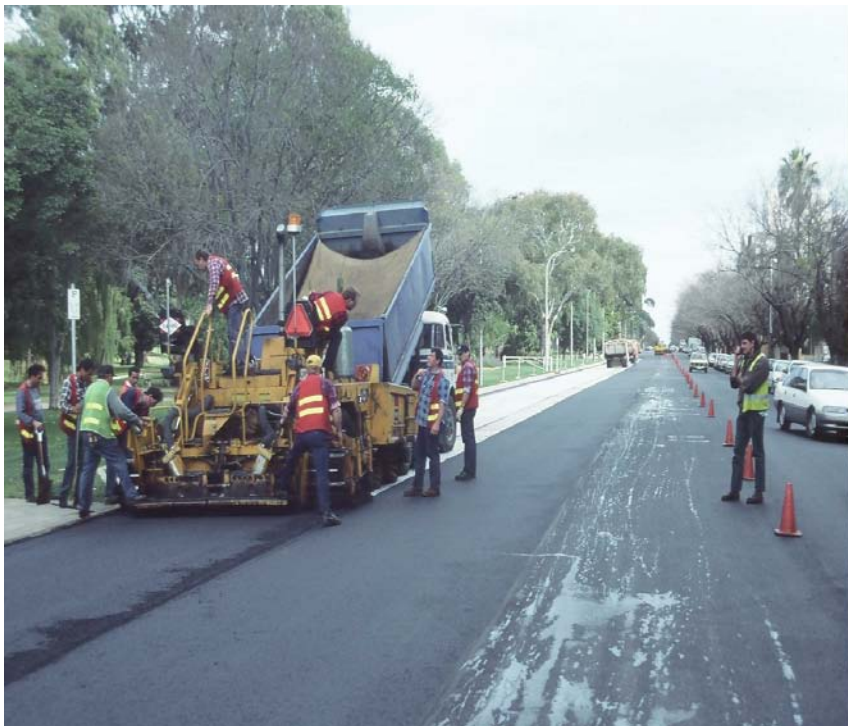
Figure 2... Paving 1996

Asset Owner;	Adelaide City Council
Sealed;	1996
Asphalt;	40mm
Paving Fabric;	Sealmac PF1
Bond coat;	C170
Area;	~30,000 sqm
Existing condition;	Poor surface with ... Underlying reactive clay sub-grade.

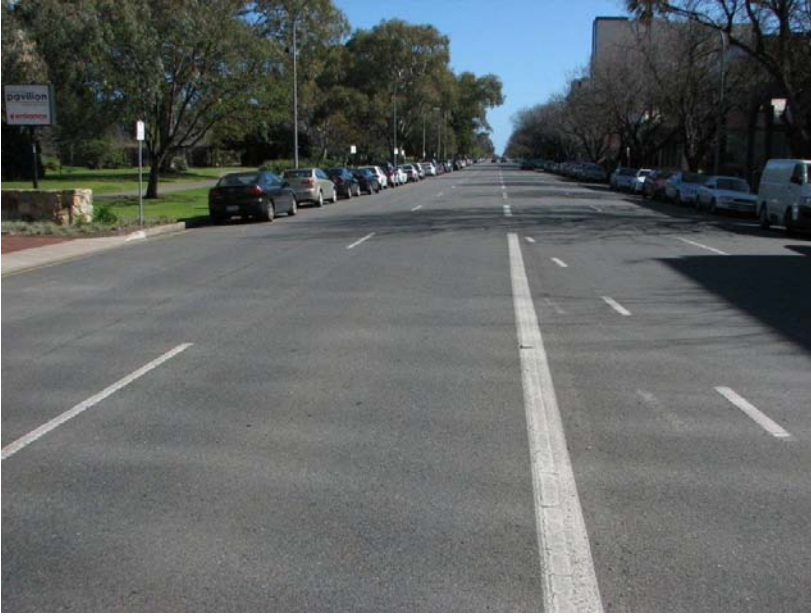
Figure 2... Pavement 2009

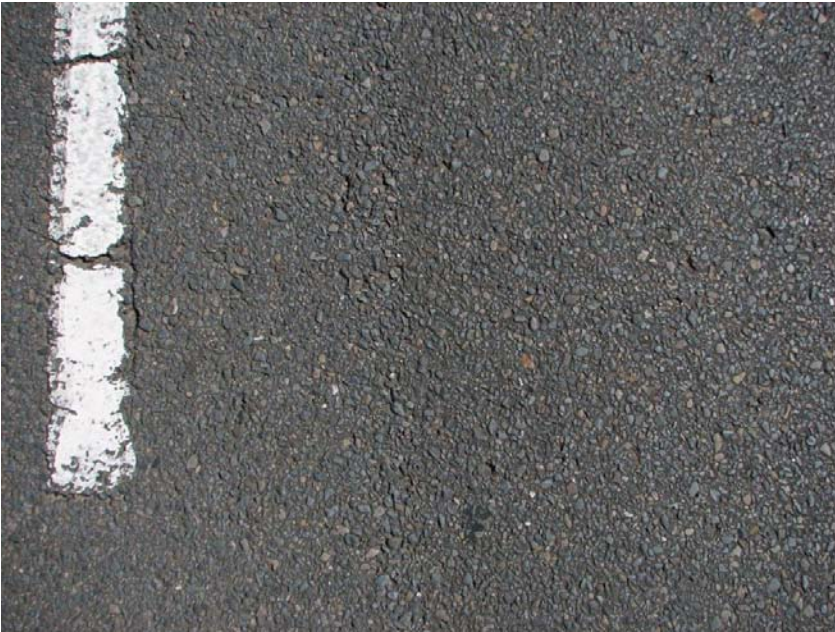
Figure 2... Pavement 2009

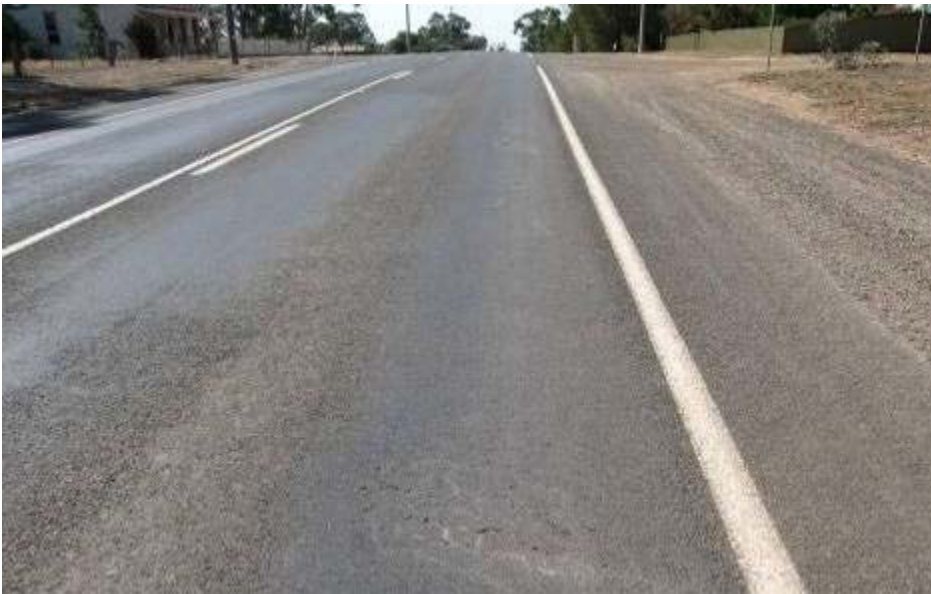
Figure 29: Midland Hwy. Adjacent untreated pavement - 2009

Asset Owner;	Vic Roads
Sealed;	2007
Asphalt;	15mm UTA
Paving Fabric;	Sealmac PF1
Bond coat;	C170
Area;	~5,000 sqm
Existing condition;	Poor surface with varied pavement and pavement construction due to lane widenings. Regulation and patching of weaker areas undertaken before resurfacing.

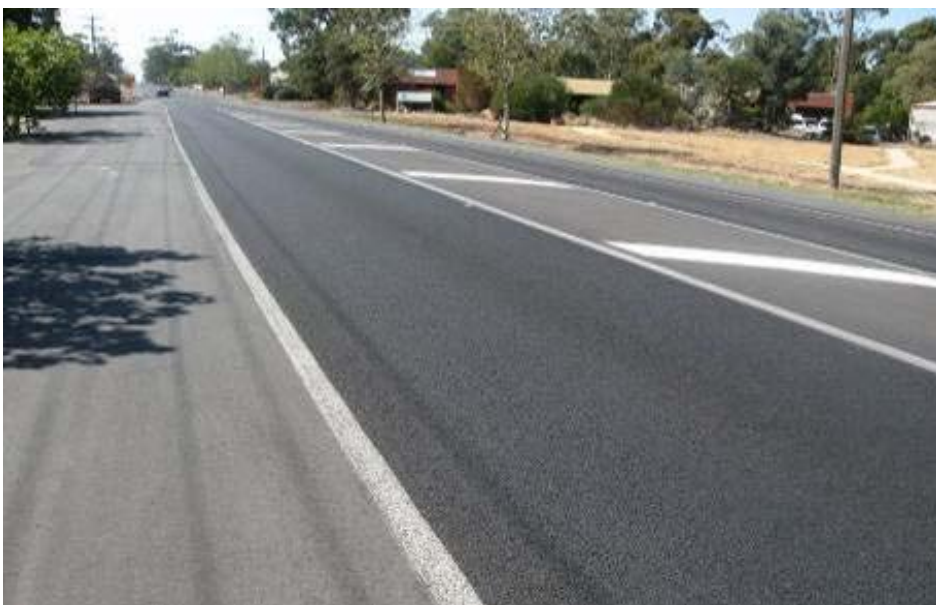
Figure 30: Midland Hwy pavement 2009

With a life expectancy of 10 years, UTA surface incorporating a paving fabric SAMI was chosen to provide a quieter surface than sprayed sealing, however, based on economical feasibility, UTA was an alternative to deeper asphalt, without the problems of matching fixed water table levels. A paving fabric SAMI was used as insurance to assist in control of reflective cracking from varied pavement construction over a period of years and protect from environmental influence.

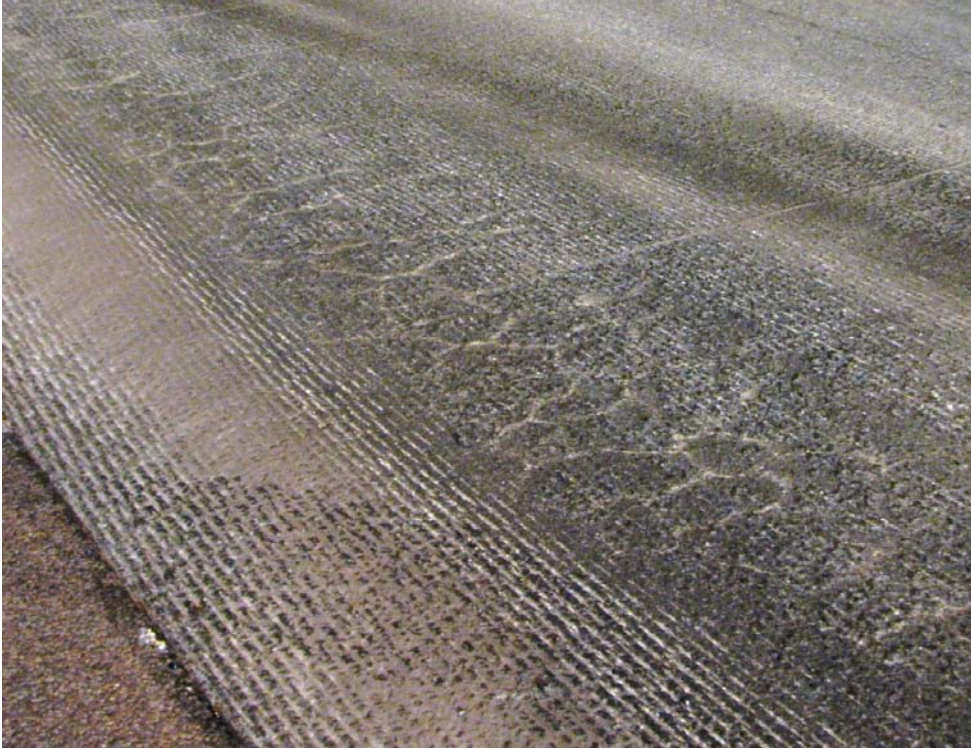
Figure 31: Existing Stabilised Pavement Base after milling

Asset Owner;	Main Roads WA
Asphalt;	30mm OGA
SAMI (D/D)	14/7mm
Paving Fabric;	Sealmac PF2
Bond coat;	C170
Area;	50,000 sqm
Existing condition;	Cement treated base in a cracked condition. Firm substrate with no loss of shape and no vertical movement.

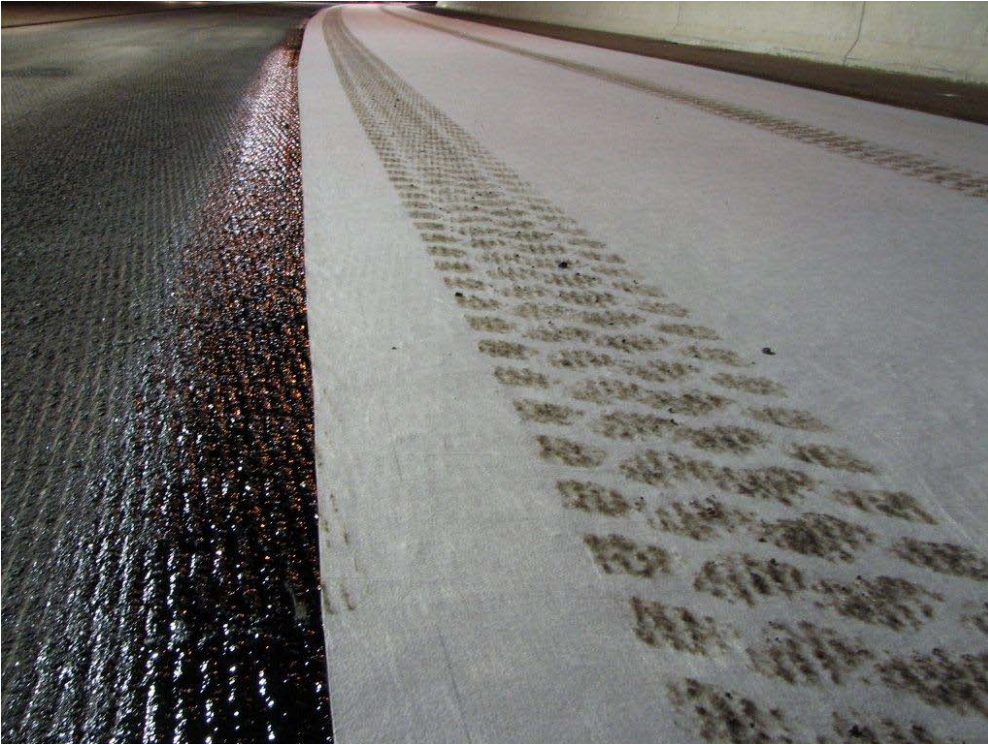
Figure 33: Paving fabric laid 2011

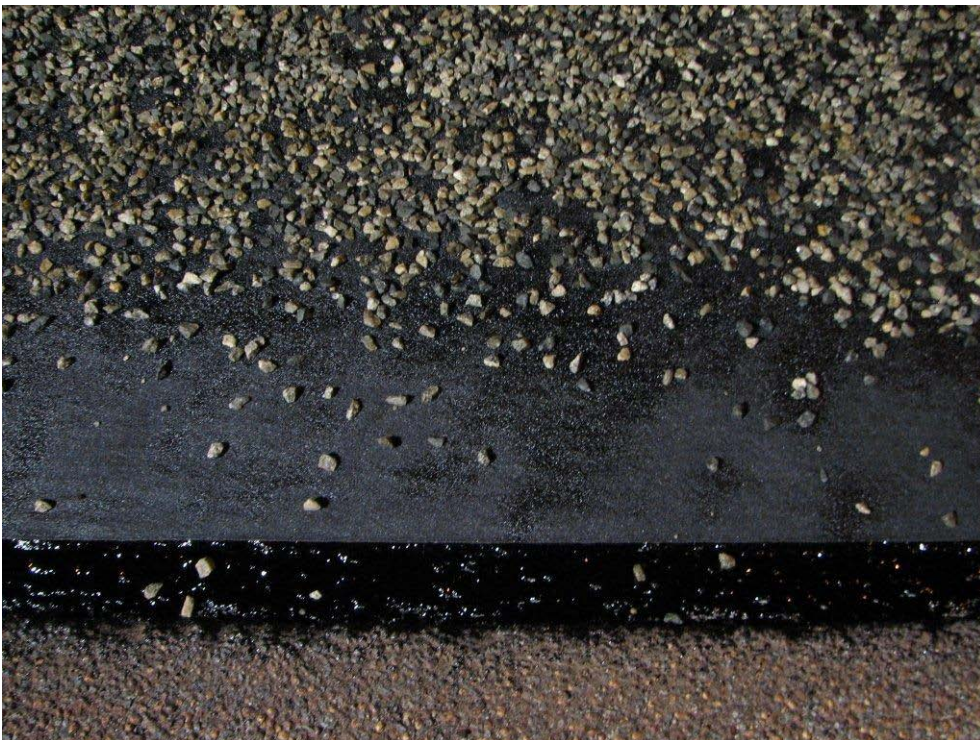
Figure 34: Paving Fabric with SAM 2011

WA Main roads philosophy is to incorporate as much binder into the SAM as possible to enhance the waterproofing function using a 180g/sqm paving fabric.

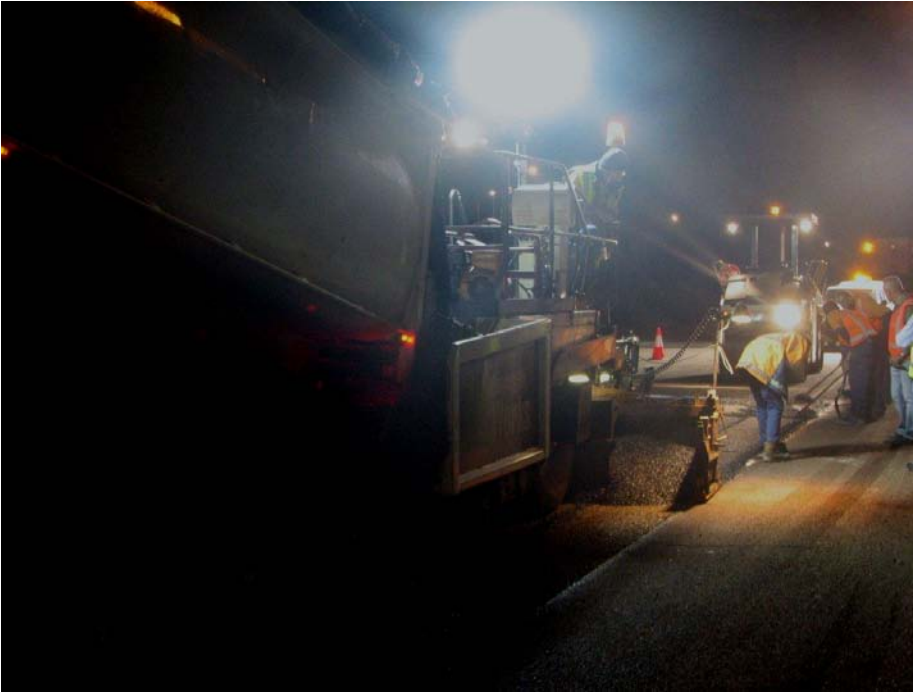
Figure 35: Laying Asphalt Pavement 2011

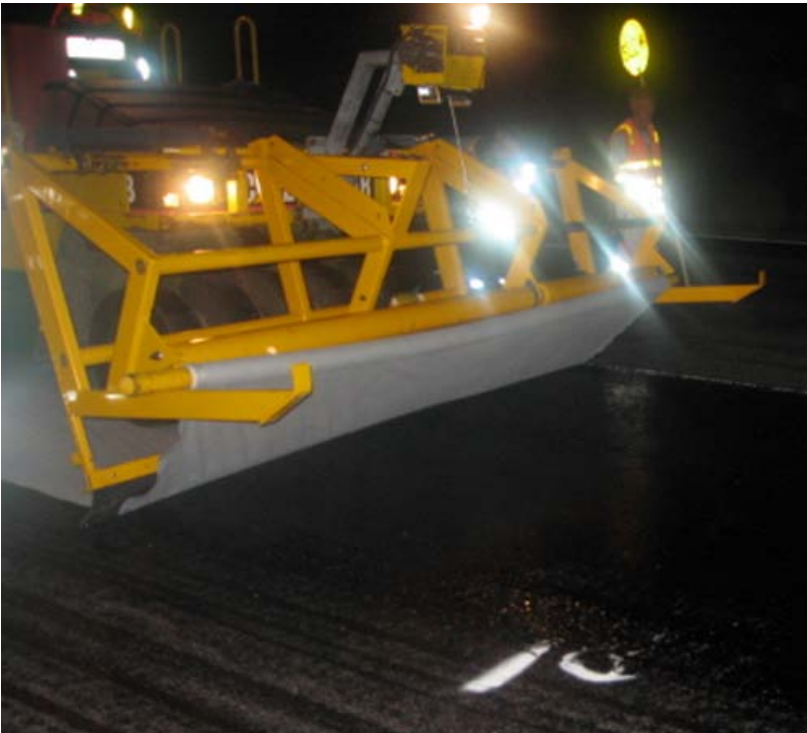
Figure 36: Laying PF1 Paving Fabric 2009

Asset Owner;	Vic Roads
Sealed;	2007 - 09
Paving Fabric;	Sealmac PF1
Bond coat;	C170
SAMI;	10mm
Asphalt;	20mm UTA
Area;	>500,000 sqm
VPD;	200,000 VPD

Existing condition; 2007 – 09 upgrade, existing cracking of unbound granular pavement, existing pavement 100mm Asphalt. A mixed patchwork of pavements over the length of the widening project with new lane widening constructed to provide increased traffic capacity.

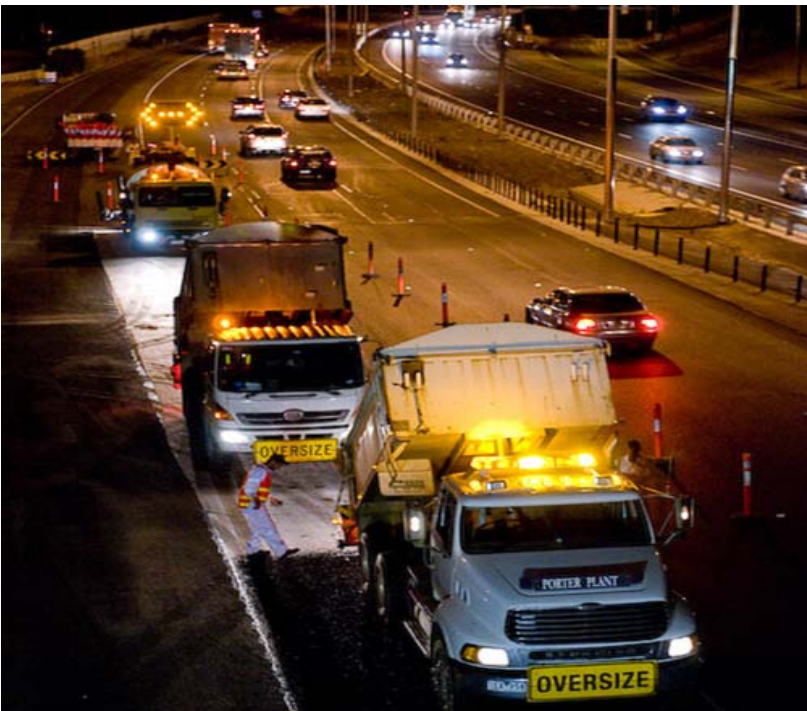
Figure 37: Laying Asphalt Pavement 2009

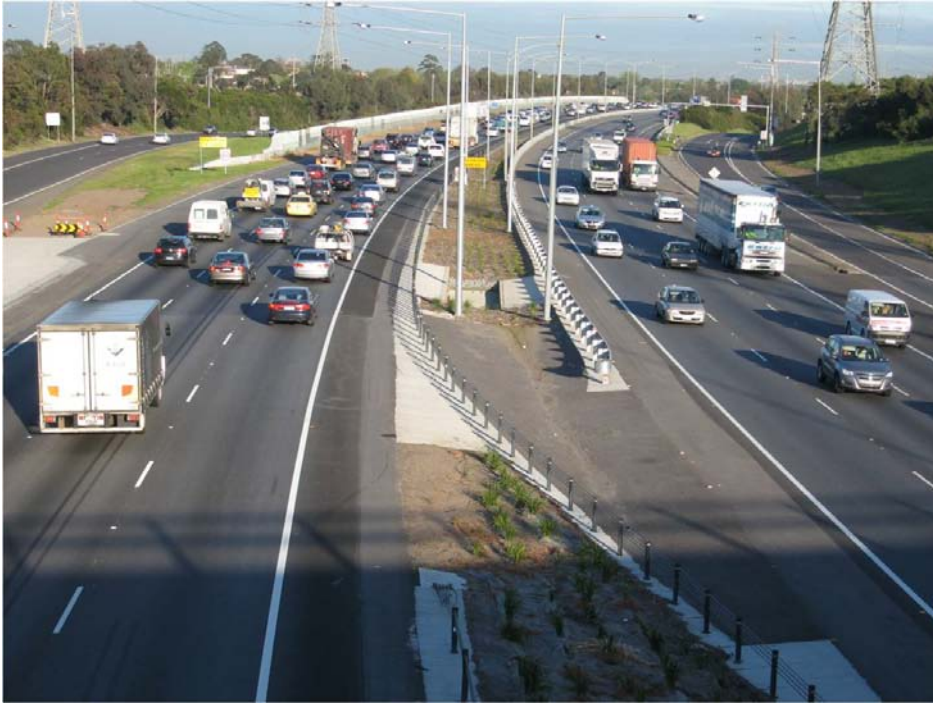
Figure 38: Monash Freeway 2009

Widening of lanes resulted in pavement joints where paving provided coverage and thorough waterproofing, utilizing a high level SAMI and Paving fabric PF1.
