GEOTEXTILE REINFORCED SEALS – THE WESTERN AUSTRALIAN COMING OF AGE

GARNET GREGORY, MAIN ROADS WESTERN AUSTRALIA, AUSTRALIA

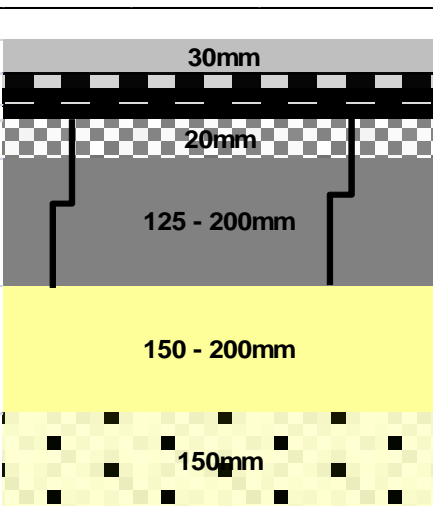
The heavy grade of fabric (170 – 200 g/m²) was chosen which can take up to 1.1L/m² of bitumen to saturate the cloth in accordance with the Austroads Technical Report AP-T37/05 Geotextile Reinforced Seals. In addition to this amount of binder absorbed into the cloth by adding a 14/7mm double double seal on top of the cloth can give a total bitumen content of up to 3.5L/m². With this level of binder within the SAMI one can be reasonably confident that if the processes of applying the GRS is conducted correctly then a robust water proof layer can be installed which will maintain its integrity for many years to come. Therefore the model for the repaired pavement now looks something more like the following:

10mm Open Grade Asphalt	30mm	
14/7mm Double double GRS

geotextile + bitumen
Remnant Dense Grade Asphalt	20mm	
Cement Treated Crushed Rock Base	125 - 200mm	
75mm Nominal Size Crushed Limestone	150 - 200mm	
Sand Subgrade	150mm

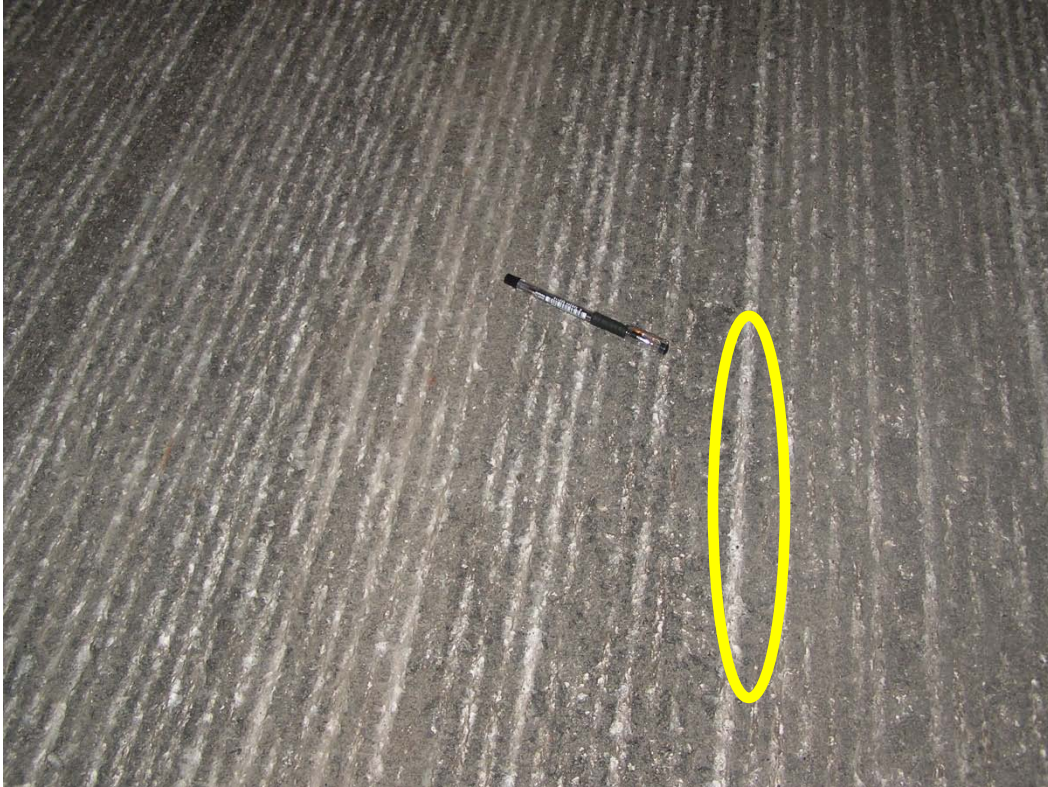
Photo 1 depicts a typical profiled surface using a fine milling drum with 8mm spacing. The surface is generally uniform in appearance and texture. However as individual cutting tools wear or become loose they can cause deeper grooves to appear such as is highlighted in the yellow oval shape in Photo 1. When this appears it is time to schedule the drum to undergo a service to replace or repair the errant cutting tool/s.

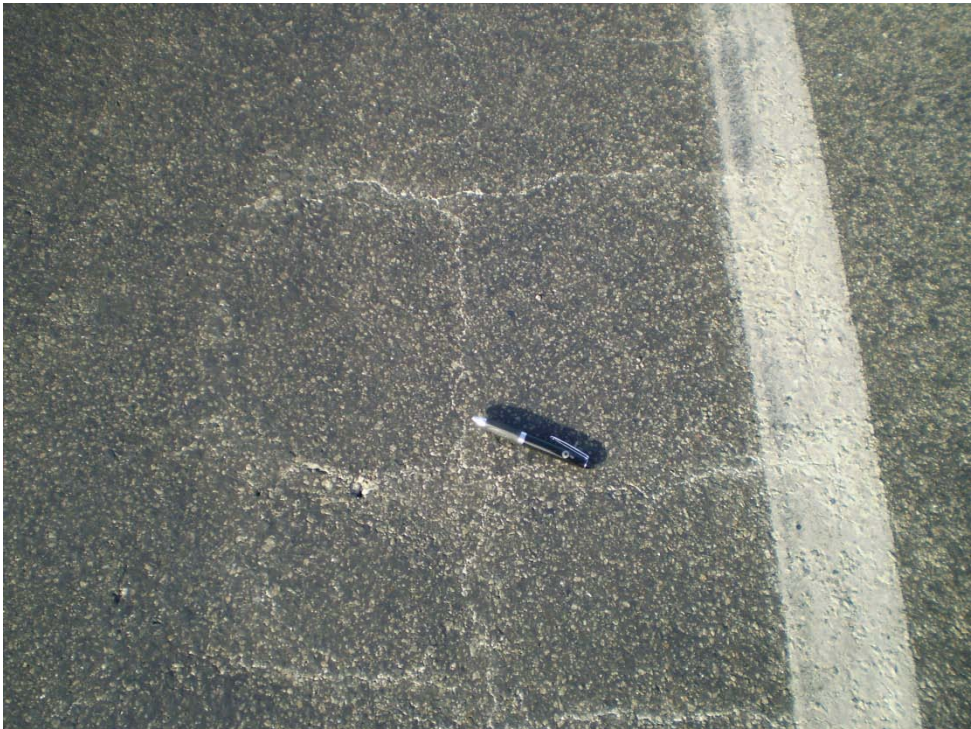
Photo 2

Applying a 14/7mm GRS in theory will prevent the underlying cracks (Photo 2) from seeing the light of day for many years.

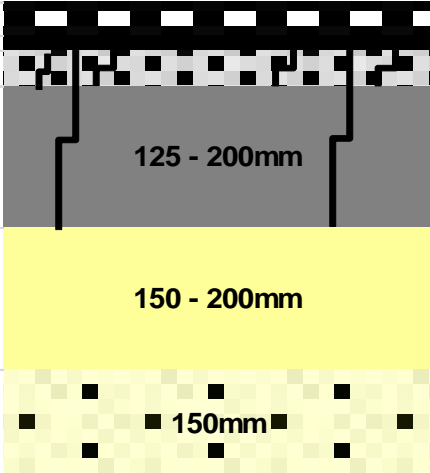
Again Main Roads WA elected to use the heavy grade of geotextile fabric as specified in Table 1 to maximise the volume of bitumen contained within the 14/7mm double double GRS that can be applied within the constraints of the seal design. Class 170 bitumen is the binder of choice and has very good visco-elastic properties which enable the bitumen membrane to remain flexible and relatively “self healing”. What I mean when I use the term “self healing” is that in warmer weather the Class 170 binder will flow and seal over any cracks trying to penetrate the seal. The binder will maintain this ability for many years before steric hardening and oxidation stiffen the binder to the point that it loses its visco-elastic qualities. Once the GRS is applied to the wearing course of the road the pavement structure looks more like:

14/7mm GRS

14mm or 14/7mm Existing Seal		
Cement Treated Crushed Rock Base	125 - 200mm	
75mm Nominal Size Crushed Limestone or gravel Sub Base	150 - 200mm	
Clay Sand Subgrade	150mm

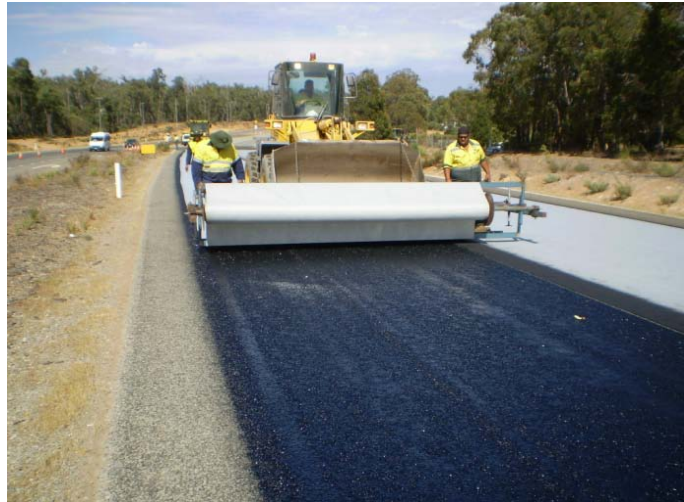
Photo 3

seal. The bond coat should provide enough binder to adequately bond the geotextile to the existing surface as can be seen in Photo 3.

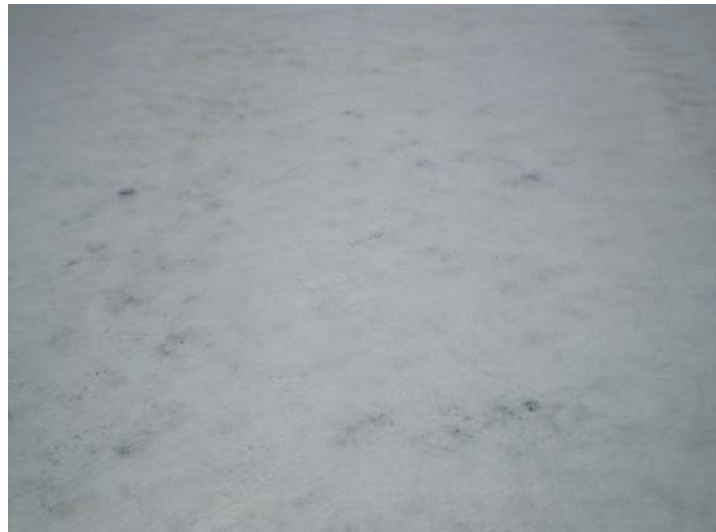
Photo 4

With adequate binder and rolling the geotextile surface should indicate a slightly mottled appearance where the bitumen is beginning to draw up through the geotextile as in Photo 4. However there should be very little or no free binder drawn to the upper surface of the geotextile.

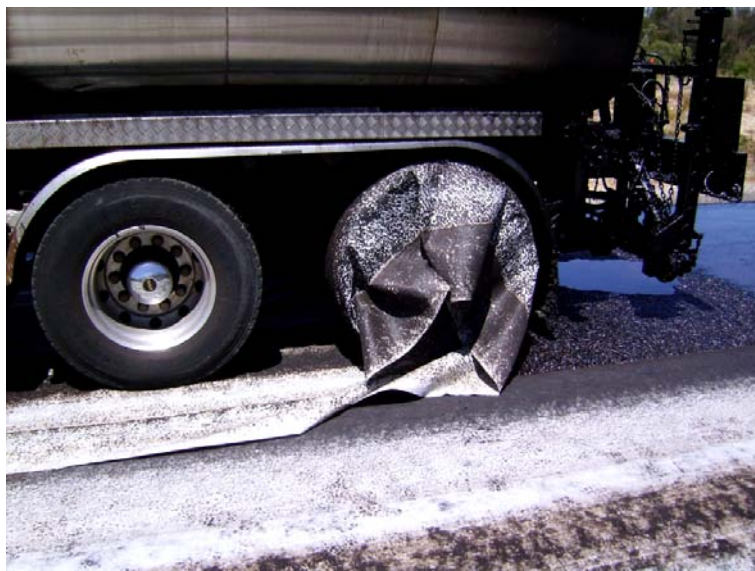
Photo 6

The longer the machinery sits on the cloth the more binder is drawn through the cloth and is picked up by the tyres which can lead eventually to the pick up of the geotextile as in Photo 6. This pick up of the geotextile occurred despite dropping the bond coat down to 0.4L/m^2 .

The essential practice in hot weather is not to traffic the geotextile by keeping all construction traffic off the cloth as much as possible. This can be facilitated by having all construction traffic such as spreader trucks arrive and leave always on the finished seal. When rolling the geotextile with a multi tyred roller it may take only one pass on a hot day to achieve the outcome as in Photo 2 whereas on a cool day it may take two or three passes to achieve the same outcome.

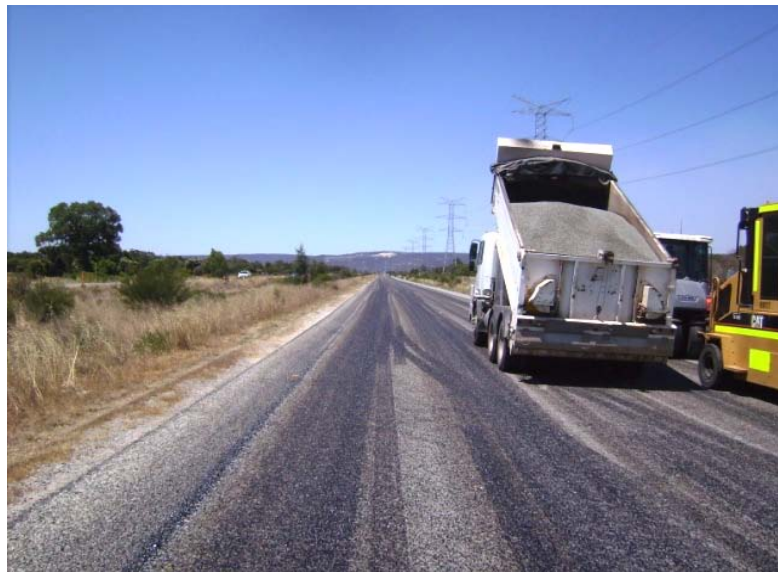
Photo 7 is showing a section of freshly placed GRS with a 14/7mm double double seal when pavement temperature reached 60°C.

With only construction traffic moving over the seal this was enough to pick up both the 7mm and 14mm stones off the geotextile. Within an hour of the photo being taken the whole 1.1km section of GRS applied on this day turned black as the bitumen began to flow coating all aggregate particles and causing aggregate pick up. To control the pickup, 7mm aggregate was re-applied at a rate of 200m²/m³ which is overspread to prevent the tyres from coming into contact with the binder.

subsequently exposing the 14mm aggregate to traffic which in turn can be picked up by tyres. To mitigate this problem the BAR of the 2nd Coat can be dropped down to 0.5L/m². However the decision to do this needs to be made in advanced so that the balance of the binder is added to the 1st coat in order to keep the total binder as per the design.

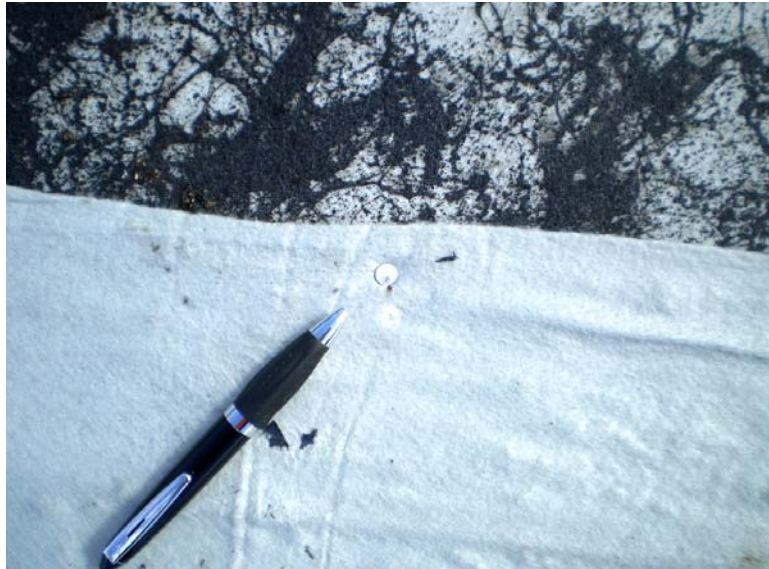
Photo 8

To prevent these issues at the overlap from causing problems a flat head nail is hammered into the overlapping geotextile at the centreline (Photo 8) at a frequency of approximately 5 – 10 metre intervals.

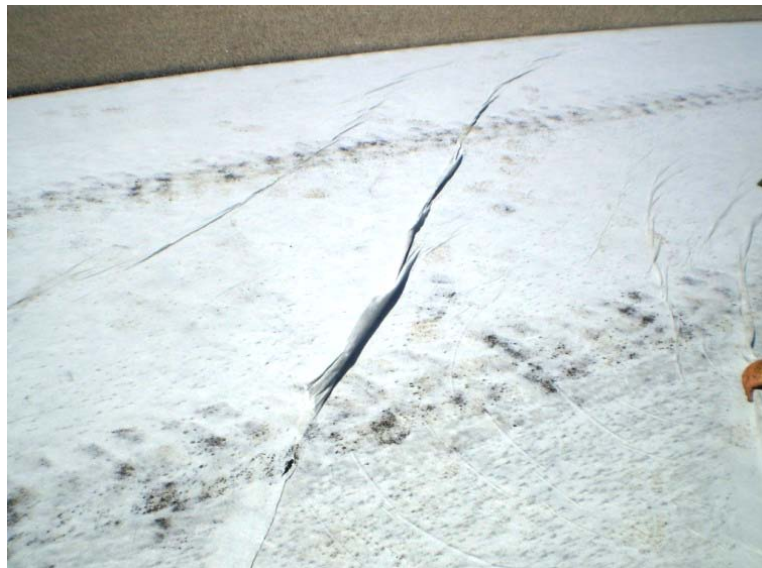
One issue not associated with hot weather that occurs frequently is creasing of the geotextile when being applied. This usually occurs due to uneven tension applied to the geotextile coming off the roll through the applicator. Usually the applicator has not been properly adjusted for elevation or the correct crossfall causing one half of the roll being under tension and the other half being tension free. Creasing can occur more often when negotiating a curve but with the correct tension and crossfall the cloth can be placed crease free.

Creasing as in Photo 9 can cause problems with the geotextile's ability to hold the aggregate in place at this spot due to a lack of binder. All creases above 20mm of height are hand cut out of the geotextile in a manner that will not overlap the cloth at this point. To achieve this a cut either side of the fold is made then the centre of the fold can then be removed leaving two edges butting together and not overlapping. Failure to remove creases in the geotextile will lead to localised stone loss as can be seen in Photo 10.

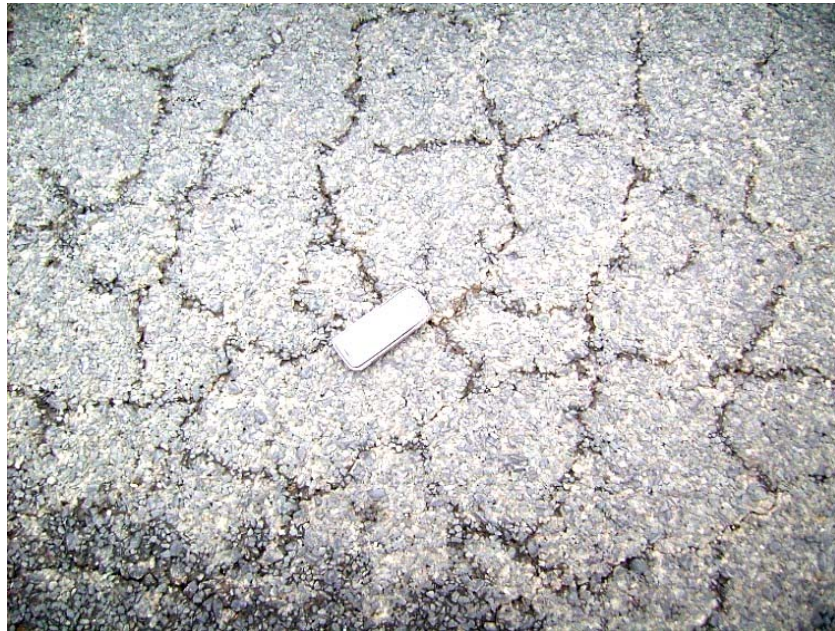
Photo 11 shows a severely cracked pavement with signs of pumping fines on the surface. This pavement is on a road leading to the Geelong Port and has subsequently failed very soon after remedial works involving the placement of GRS as a SAMI and new dense grade asphalt applied over the top.

What can be determined from this failure is that where the cracked pavement is very mobile and the individual plates of the cracked surface move independent of each other as a load is applied then a GRS would not be able to cope with the stress of this situation very long. Due to the mobility of the platelets of failed asphalt under the GRS the asphalt applied on top of the GRS is subject to high stress which in turn causes fatigue in this asphalt layer. Eventually due to the mobility of the pavement the GRS is also put under stress by the axle loading and eventually the binder within the GRS is stripped away which then allows water to ingress into the pavement.

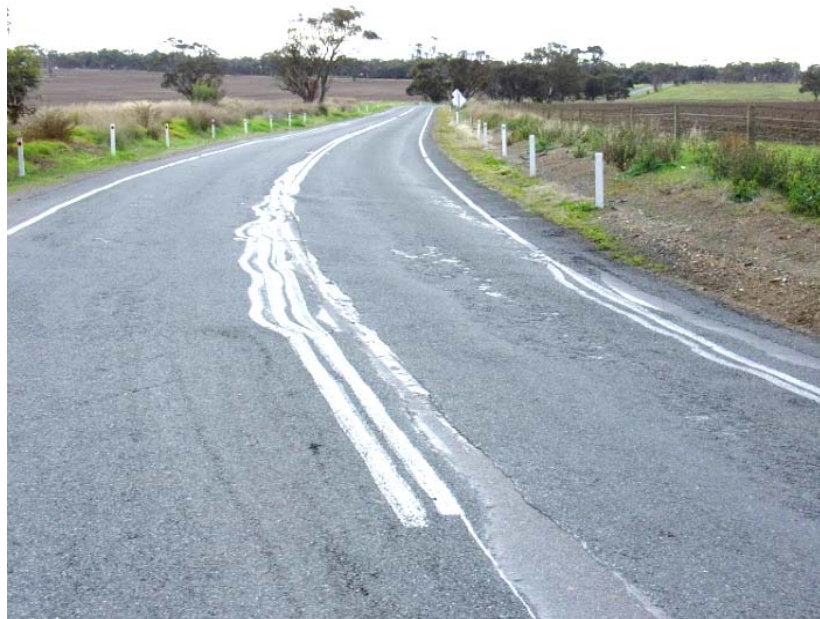
A second experience from our eastern states counterparts is from South Australia where GRS was applied to a rural road on a bend. Photo 12 is of a GRS SAM applied in 1999 that has suffered slippage under the horizontal shear forces of the traffic negotiating the bend.

The GRS was comprised of the light weight geotextile with a 14/5mm double double seal on top. The traffic loading now has an Average Annual Daily Traffic (AADT) of 2700 vehicles of which 5% are heavy vehicles.

The binders used were Class 170 bitumen for the Bond coat and 2nd coat and S35E for the 1st coat.
