COLD IN-PLACE RECYCLING OF MARGINAL MATERIALS IN MALAYSIA: HOW DOES IT FARE?

This paper describes pavement evaluation and structural design processes, mix design and construction methods, and presents the performance test results for two project sites, namely Felda Pekoti Timur and Felda Krau, in Pahang, Malaysia.

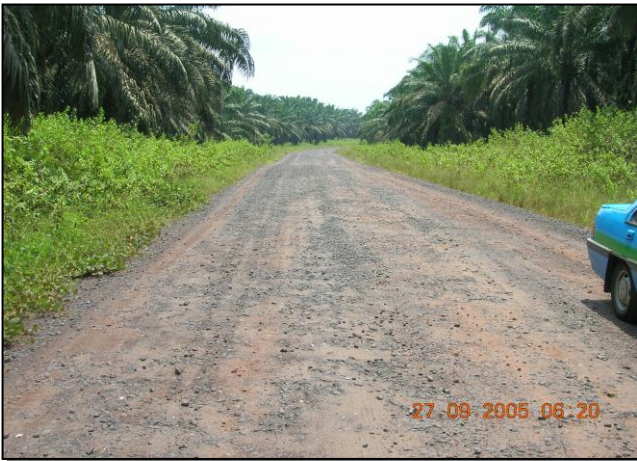
Figure 1 - Felda Pekoti Timur

Since the two sites consist of combination of laterite and gravel roads, Falling Weight Deflectometer (FWD) test and International Roughness Index (IRI) measurement were not carried out prior to construction stage. Based on the visual surface condition survey, several localized sections had recorded depression of more than 40mm. From Dynamic Cone Penetrometer (DCP) test, Subgrade's California Bearing Ratio (CBR) was found to be ranging from 6% to 16% during the dry season. **Figure 1** and **Figure 2** depict the photos taken from the two sites.

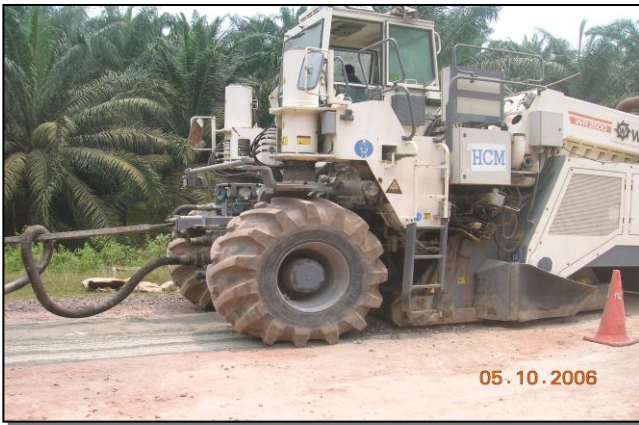
Figure 3 - Recycling machine

The area was thoroughly investigated and checked for the presence of any underground utilities especially cabling work to avoid being damaged during the recycling work. The percentages of stabilizing agents and/or water contents were first determined during the mix design stage at the laboratory. The required quantity of Ordinary Portland Cement (OPC) or lime was spread manually over the identified recycling sections. The area was then recycled using a recycling machine to a depth ranging from 150mm to 200mm depending on the pavement structural design. Figure 3 depicted the recycling machine used at one of the site.

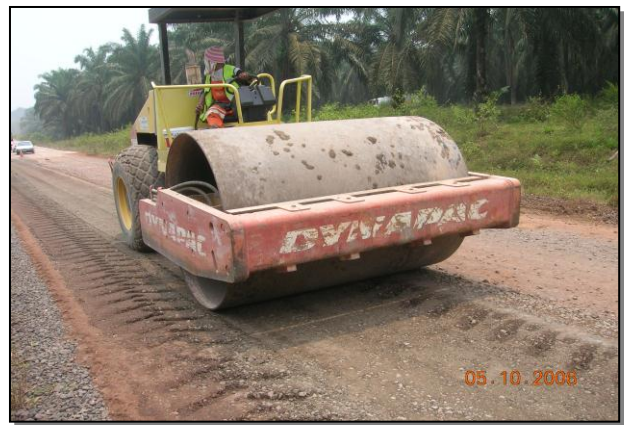
Figure 4 - Vibratory roller

Immediately after break-down compaction using a smooth drum roller, a grader was used to re-profile the finished recycled layer. Further compaction by vibratory roller (**Figure 4**) was carried out to achieve the required degree of compaction. The recycled materials that have been stabilized needs to be properly cured to achieve the minimum strengths prior to opening to traffic.

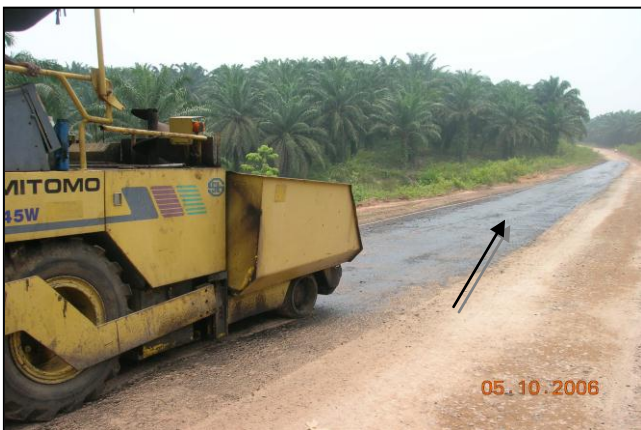
Figure 5 - Prime coating

The surface to receive the asphaltic concrete layer was to be cleaned, free from loose materials and standing water. It has been a standard practice in Malaysia, and as required by the specification that the bituminous overlay be carried out 3 days after recycling works is completed. Prior to overlaying of asphaltic concrete wearing course (ACWC), a layer of prime coat was applied and allowed for curing within 24 hours (**Figure 5**). After the specified ACWC thickness was laid, the road was not allowed to be trafficked until compaction has been completed and the material cooled thoroughly (**Figure 6**). This cooling down process normally takes about 4 hours from the initial compaction process.

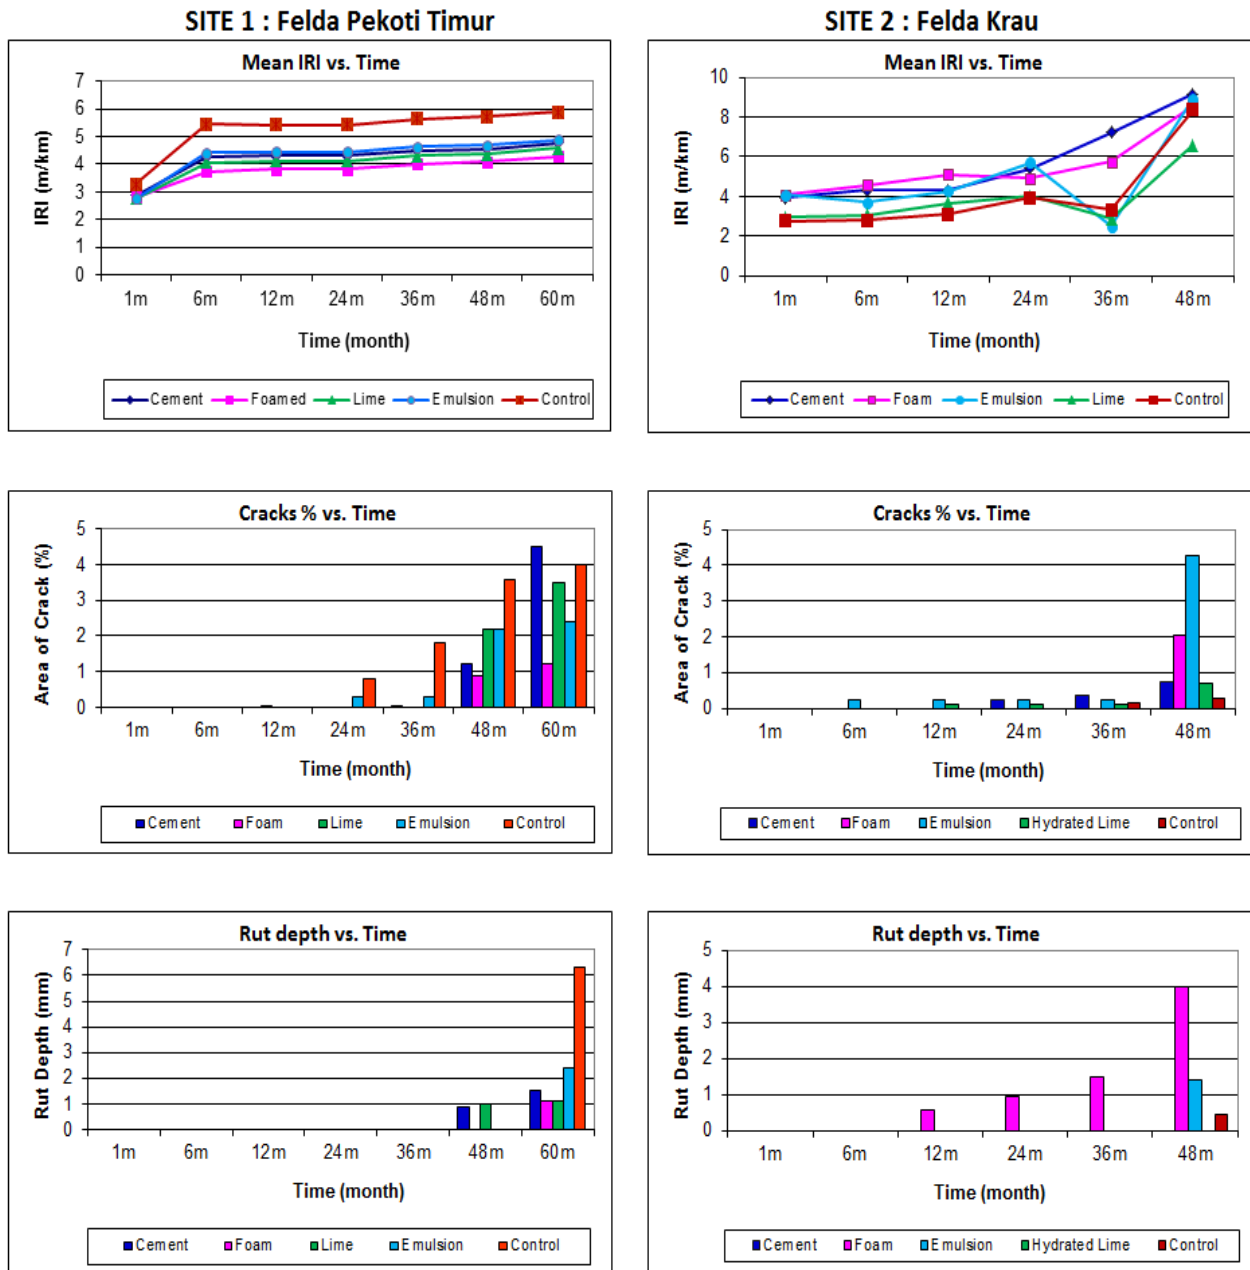
Figure 7 - Pavement Functional Performance

In general, the performance of cement and lime stabilized sections were superior than the other sections, with no fatigue cracking at least until 48 months for site 1 and less than 1% of crack recorded thus far for site 2. Figure 7 illustrates the functional performance of each section over 60 months and 48 months period for sites 1 and 2, respectively. Further monitoring is necessary to relate the long-term pavement functional performance to the treatment types.

The data from **site 1** indicated fair to poor riding quality in the form of International Roughness Index (IRI) with values ranging from 2.8 m/km to 3.3 m/km after rehabilitation. These IRI values gradually increased with varying rate of change. After 60 months, control section recorded the highest IRI value of 5.9 m/km, followed by emulsion, cement, lime and foamed sections. Cracks started to appear on control and emulsion sections after 24 months. For 60 months monitoring, cement section recorded the highest percentage of cracks area of 4.5% (majority C1 crack type), followed by control section with 4.0% area of cracks but majority with C4 crack type. Rutting was considered to be in good condition with cement, foamed, lime and emulsion sections recorded rut depth of less than 5 mm after 60 months. Control section recorded rut depth of 6 mm, considered to be in fair condition after 60 months.

For **site 2**, IRI values ranging from 2.0 m/km to 4.1 m/km were recorded after recycling. As at 48 months, cement section recorded the highest IRI value of 9.2 m/km. The high IRI values could be due to the existing profile, surface type and initial pavement roughness which are known to have a significant effect on the future roughness level of the pavement [6]. Cracks values were found to be ranging from 0.3 % to 4.3 % after 48 months, and considered to be in good condition. Similarly, rutting was considered to be in good condition with all sections recorded rut depth of less than 5 mm.

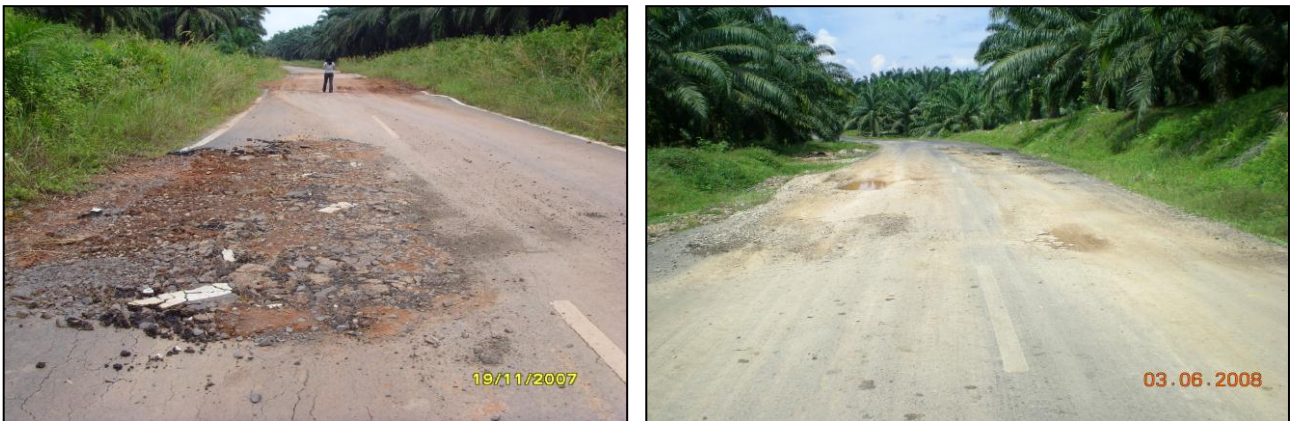
Figure 8 - Pavement defects

Based on the construction site records, rainy season experienced during the recycling process at site 2 could have resulted in higher than the optimum/ideal moisture content. As a result, the pavement at 2 sections namely foamed bitumen and emulsion might not gain the required strength and offer a satisfactory interfacing layer for the asphaltic course. With the marginal materials susceptibility to moisture, this could have led to a breakdown of materials, in which under heavy trafficking causes the materials to crack or shoved to the sides as shown in **Figure 8**. Inadequate drainage or poor drainage system might have aggravated failure at both sites.

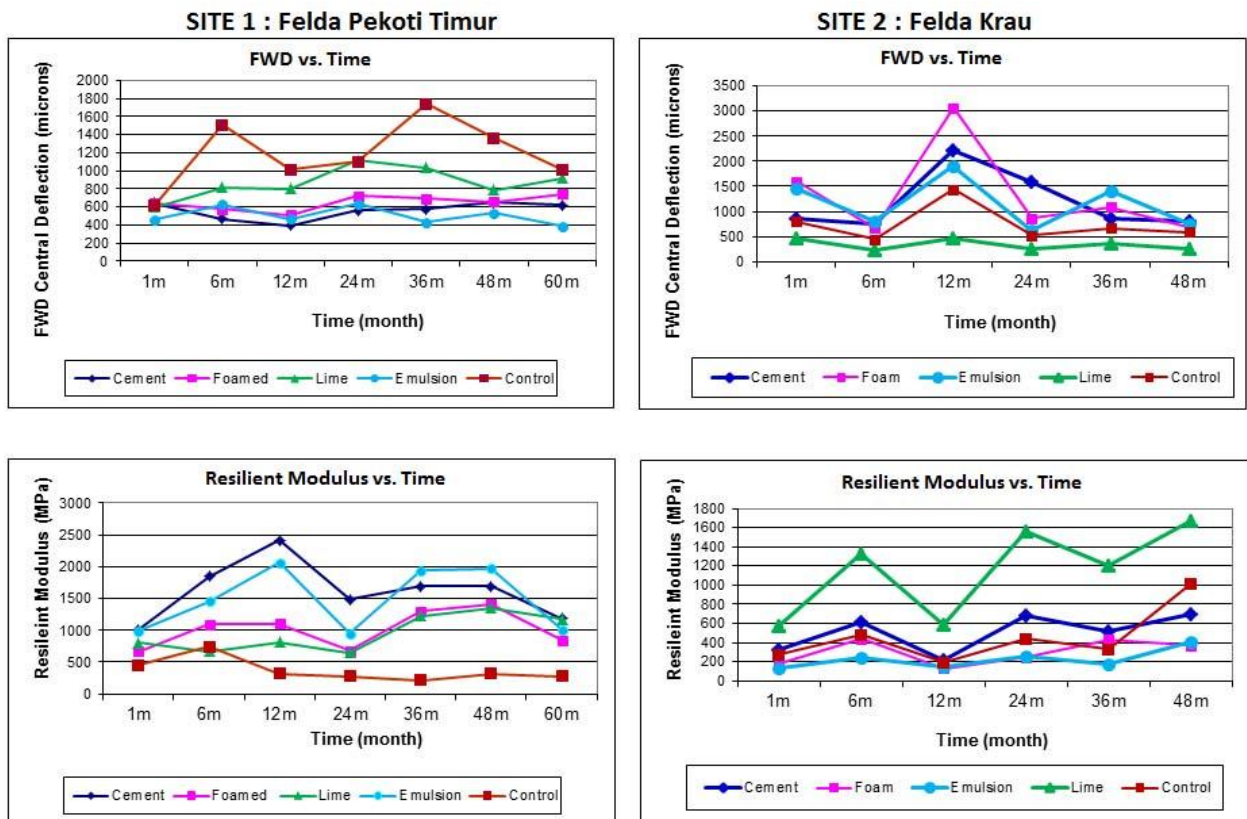
Figure 9 - Pavement Structural Performance

Figure 9 summarizes the structural performance of the 2 sites over 60 and 48 months period, respectively.

Most of the sections on site 1 were in relatively fair to poor structural condition based on the FWD central deflection data. Control section was observed to record the highest central deflection exceeding 700 microns after 6 months of recycling. On the contrary, emulsion section is the only section relatively in good condition with 388 microns after 60 months. From Elastic Modulus data, cement section was found to record the highest values at 1,187 MPa and the lowest was found to be in control section with 276 MPa.

It was also observed that majority of the sections on site 2 was in relatively fair to poor structural conditions with FWD central deflection values within 400 to 700 microns. Lime section recorded FWD central deflection value of 249 microns after 48 months for it to be

in good condition. With respect to the lime and control stabilized layers, high E-modulus values were recorded at both sites.

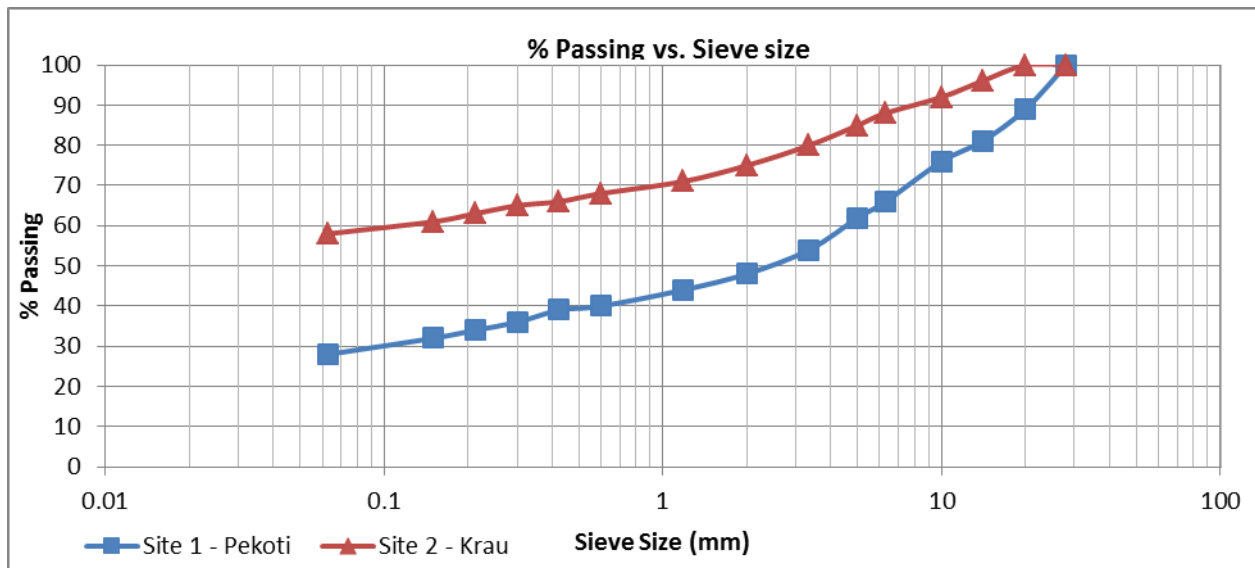
Figure 10 - Aggregate Gradation

From the sieve analysis, it was found that high clay/silt content of more than 55 percent was observed from site 2 as shown in **Figure 10**. Both samples were also observed to have a PI of 20 as tabulated in **Table 4**. The high PI readings generally indicated clayey soils that are known to be susceptible to moisture and consequently could have affected the performance of sections with high moisture content.

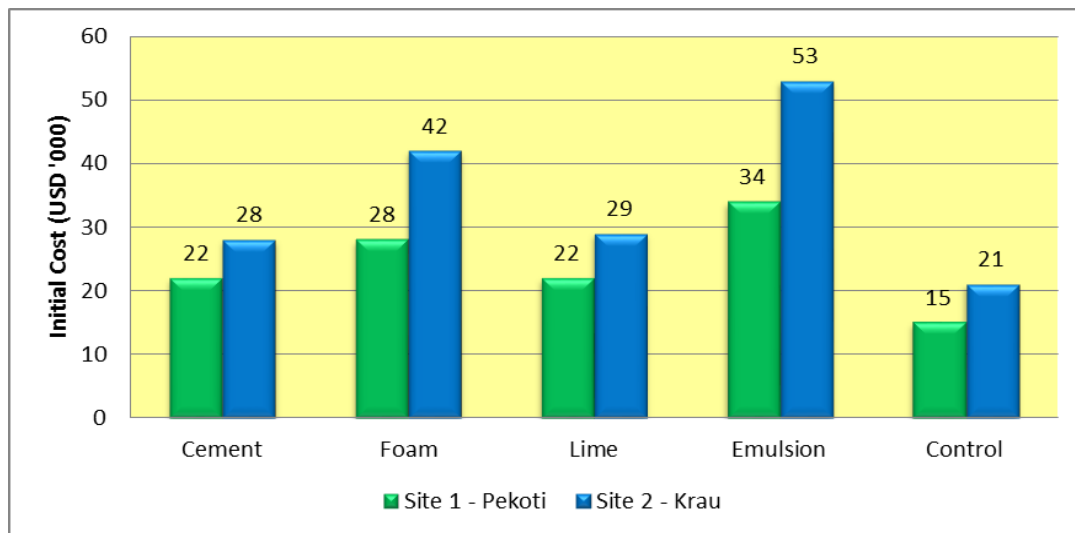
Since the deterioration models for CIPR pavement stabilized with various stabilizing agents have not been established up to this stage, the cost analysis was based on initial construction cost for different treatment types. Difference in cost is due to the different design, which varies in the thicknesses of asphaltic, crushed aggregate and recycled layers, as tabulated in **Table 1**. It was noted from both sites that control section produce the lowest cost, followed by CIPR with cement, lime, foamed bitumen and emulsion as shown in Figure 11. However, from the data collected, it was observed that the premature distress or failure on control, foamed bitumen and emulsion sections were high and this would in turn increase the maintenance cost in the long run.

Figure 11 - Initial Construction Cost (1 USD = 3.04 MYR)
