How do we improve the durability of porous asphalt?

Torbjoern Jacobson^{1, a}, Ulf Sandberg², Leif Viman²

² The Swedish National Road and Transport Research Institute (VTI), Linköping, Sweden

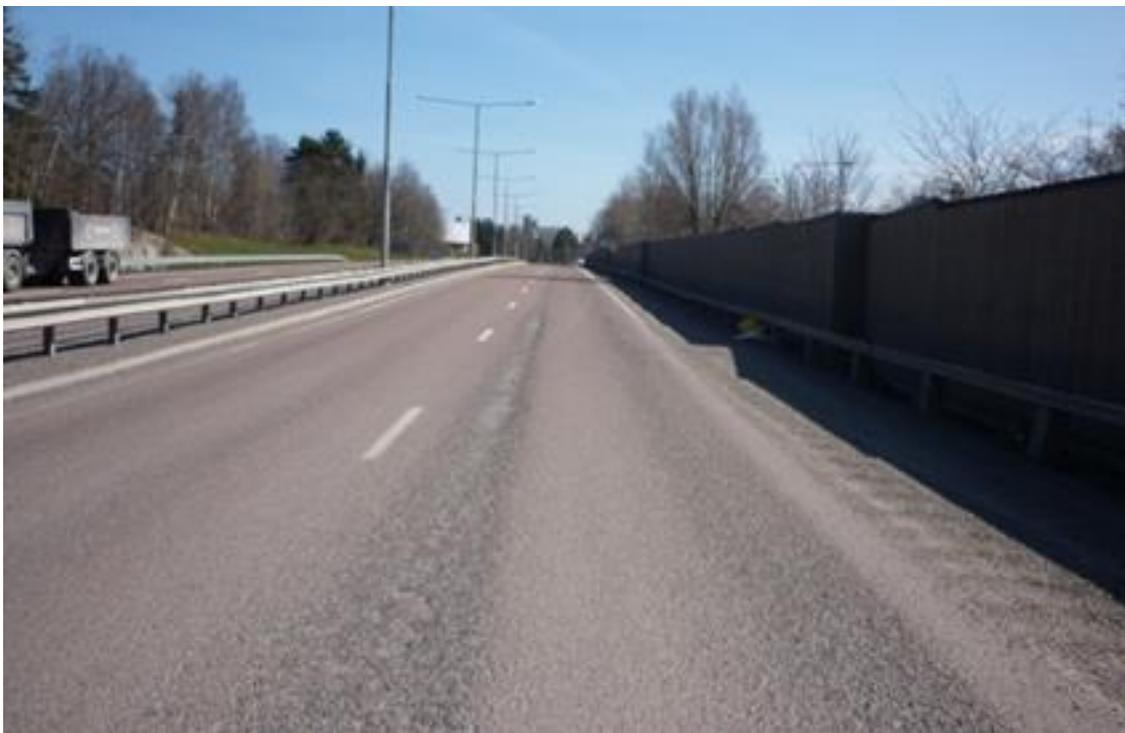
Figure 2: Severe raveling of double-layer PA after only one year of traffic.

Porous asphalt has a uniform material composition with a high proportion of coarse aggregate and a low proportion of fine aggregate/filler. In this way, the high void content with channeled pores can reduce the generation of tyre/road noise, absorb some of the noise and lead away water. The problem with porous pavements is that they age faster than dense pavements and that the water can become trapped. The consequence is that the risk of stone loss/potholes increases, with the result that the favorable noise characteristics deteriorate. In a relatively short time, raveling and potholes will require action. See the example in Figure 2, which is from an early trial section [1].

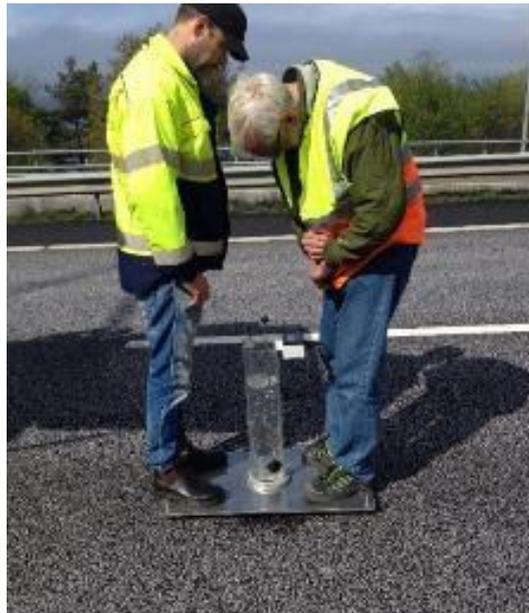
Figure 3: Measurement of the draining effect of a porous pavement according to EN 12697-40

The drainage ability of the pavements have been tested according to EN 12697-40 (Figure 3). The method is a field test of the drainage ability of asphalt pavements that are designed to have permeable properties. The outflow time for water is an indication of the pore capacity to drain water away from the pavement. The method can be used to check if the surface meets the demands on drainage and any deterioration of drainage capacity with time, for example clogging by road debris. No requirements on permeability are related to this method for PA.

Drainage performance has been measured in annual inspections using the drainage test according to EN 12697-40 (Figure 3). The results are shown in Figure 6. The sections with double layers generally have a high draining effect (permeability). The section with steel slag has, as expected, lower drainage capacity, because the void content is substantially lower than that of other sections. Notably, the sealed sections have not significantly poorer drainage capacity than those that were not sealed. The difference in outflow time is small between measurements in 2012 and 2013.

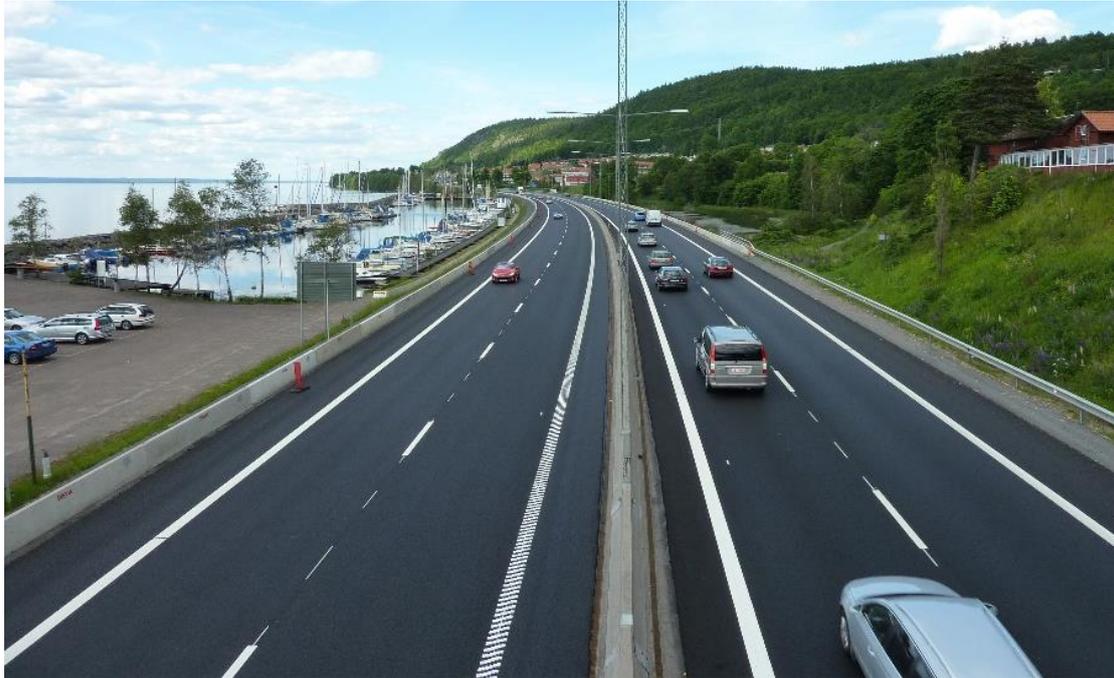
Figure 4: Test road on E4 in Huskvarna just after the pavement was laid in 2010.

- Length: 2.7 km
- Motorway, two lanes per direction, right lane designated K1, and left lane designated K2
- Posted speed limit: 90 km/h
- AADT: 20 000 - 30 000 vehicles (15 % heavy vehicles). Distribution between lanes: 70 % in K1 and 30 % in K2, the main part of the heavy traffic in K1
- Layer thickness of the PA: upper layer 30 mm, lower layer 50 mm
- Aggregates in the upper layer: in K1, rhyolite; in K2, diabase (north) and rhyolite (south), max. size 11 mm.
- Aggregates in the bottom layer: diabase in all lanes, max. size 16 mm.

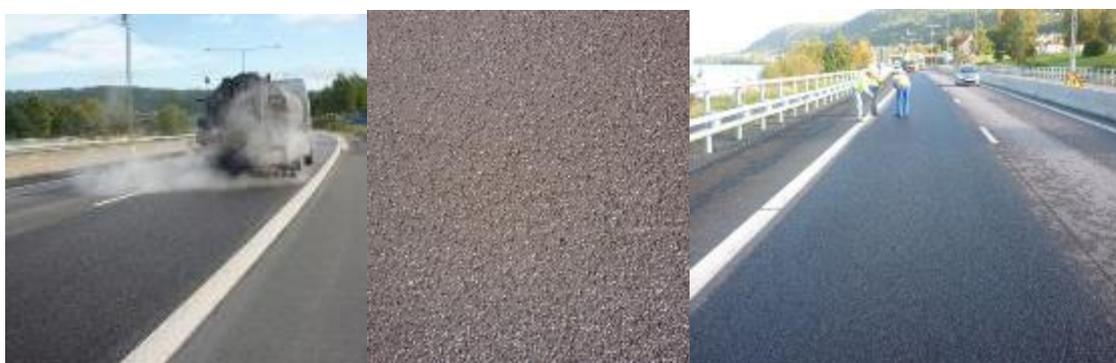
Figure 5: Sealing with Fog Seal of the PA on E4 in Huskvarna, September 2010.

A distance of about 200 m in K1, southbound direction, was sealed in the fall of 2010. Another seal was conducted in autumn 2011 on half of the section that was sealed in 2010. As reported previously, stone losses have been small on these sections. In the autumn of 2013, the entire K1 in both directions was sealed (Figure 5).

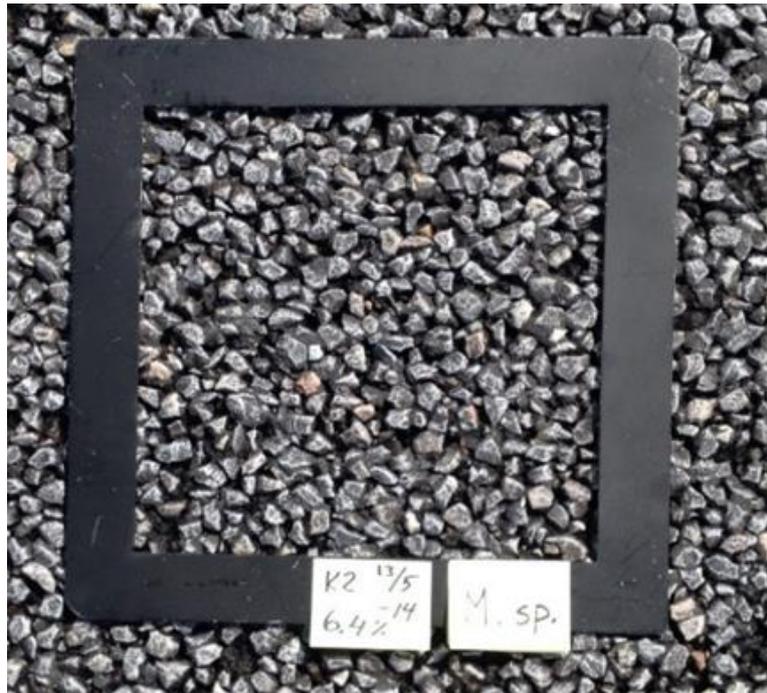
Figure 7: Stone content is high and the open pores are visible between the particles. The number of particles (8/11) within the frame is approximately 360 and three are lost. The pavement (K2 south with rhyolite) was four years old when this photo was shot.

At the inspections in 2013 and 2014, investigation of raveling was carried out by means of the so-called “French window”, stipulated in EN 12272-2 for calculation of stone loss for surface dressing (Figure 7). Over the four years, raveling has been small, besides some smaller parts in the beginning of the K1 south section, where raveling has been moderate. By means of a frame randomly placed on the road surface in the wheel tracks or the surface between the wheel tracks, the number of stones larger than 4 mm was calculated. When the entire surface is covered with stones there is about 300 pieces of stones with grading 8/11 mm within this frame.

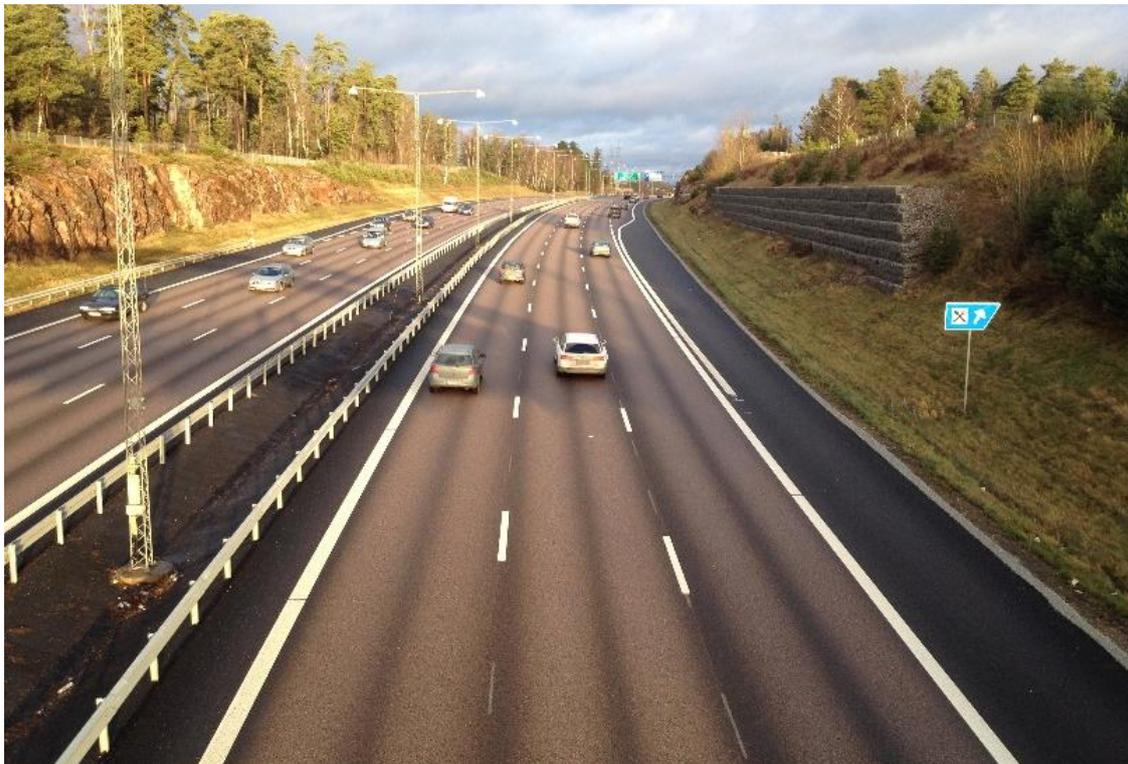
Figure 8: The test road E4 in Rotebro, Stockholm, after a few months of traffic.

The need for traffic noise reduction measures is great in Stockholm, including the approach roads, and one option of considerable interest is to use noise-reducing pavements. Based on the excellent results on E4 in Huskvarna, a test section on the E4 motorway in Rotebro (between Stockholm and Arlanda airport) was repaved with double-layer PA in the summer of 2014. This road has three lanes in each direction. See Figure 8.
