DURABILITY STUDY: FIELD EXPERIENCE OF LONG-TERM EVOLUTION OF SBS POLYMER MODIFIED BINDER

Sylvia Dreessen[1], Thibaud Gallet[1], André Gilles Dumont[2], Michel Pittet[2]
[1]S. Dreessen, T. Gallet, TOTAL Centre de recherche de Solaize, Bitumen department, Solaize, France
[2]Prof. A-G. Dumont, Prof. M. Pittet, Laboratory of traffic facilities, Ecole polytechnique fédérale de Lausanne, 1015 Lausanne, Switzerland

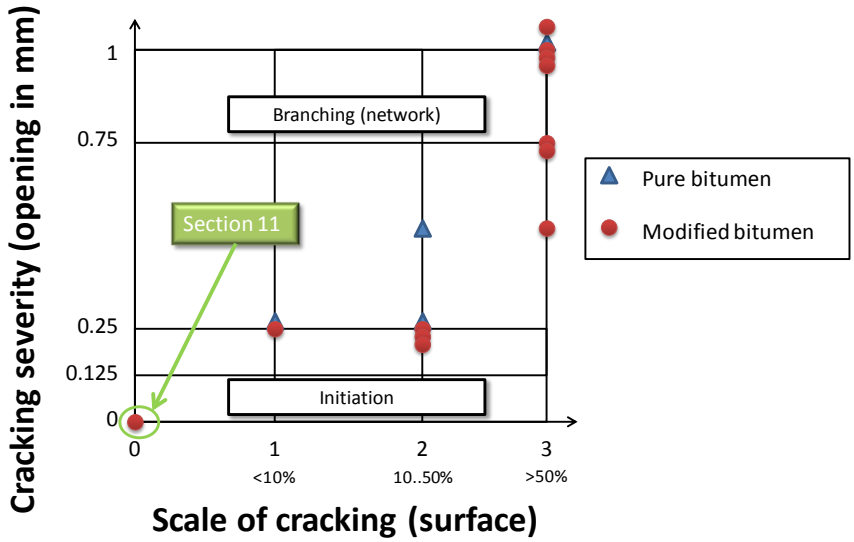
Figure 3: Position of products in terms of their individual state of cracking

The "cracking amplitude index" is defined as the combination of the extent and the severity values. The state of cracking after 14 years in operation of the sections placed for comparative testing purposes shows that section 11 does not show any signs of cracking. Its position in relation to the other products appears in figure 3.

Binder performance ranked from the very worse, with an important damage of the wearing course after one year, to the very good with no visible cracking after 14 years of service for the Styrelf 13/80.
Polymer modified bitumen performances showed also the importance of binder processing, and particularly base bitumen and polymer blending. Polymer modified bitumen with crosslinking of the SBS polymer chains is the process that proved its mechanical performance with a satisfactory durability. Styrelf 13/80 belongs to this category of PmBs and is selected for further investigations in parallel with straight bitumen of the same pen grade.

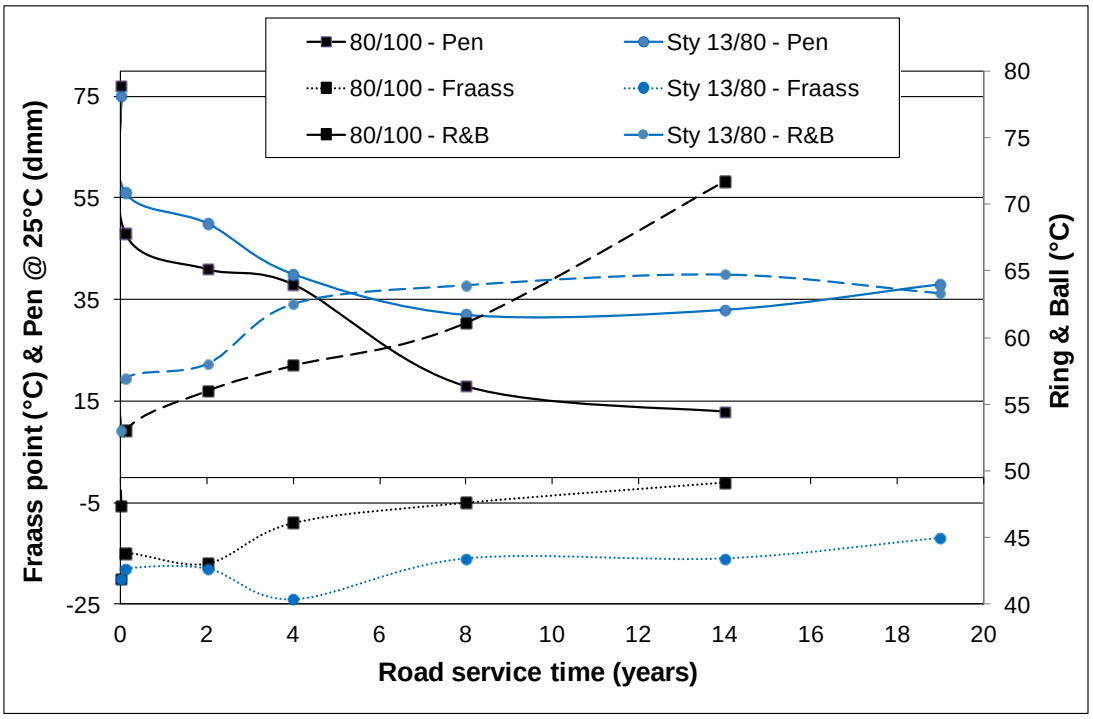
Figure 4: Evolution of penetration, R&B and Fraass during road service time

Both graphs confirm the strong binder aging effect during the mixing, transportation and paving steps. This is evidenced by a strong initial penetration drop (20 to 30 dmm), and a softening point increase (around 8°C). The conventional binder curve demonstrates a continuous rise in softening point and a constant decrease in penetration during road service. Contrarily, the PmB evolution stabilizes after 8 service years, as both penetration and ring and ball plateau. Aging effect seems much lower for the PmB than for the pure asphalt.

The pure binder Fraass brittle point loses about 14 °C during road life after 14 years, whereas the crosslinked PmB lost much less (6°C) during an even longer time period of 19 years.
The same tendency is found for BBR results. The increase in the temperature at which the stiffness is 300 MPa is limited to only 4 °C for the PmB, as opposed to 12 °C for the asphalt.
The limiting m-value temperature evolves more than the iso-stiffness one for the neat asphalt. This result indicates a lower cracking risk for the PmB and higher for the asphalt [16, 17, 18].

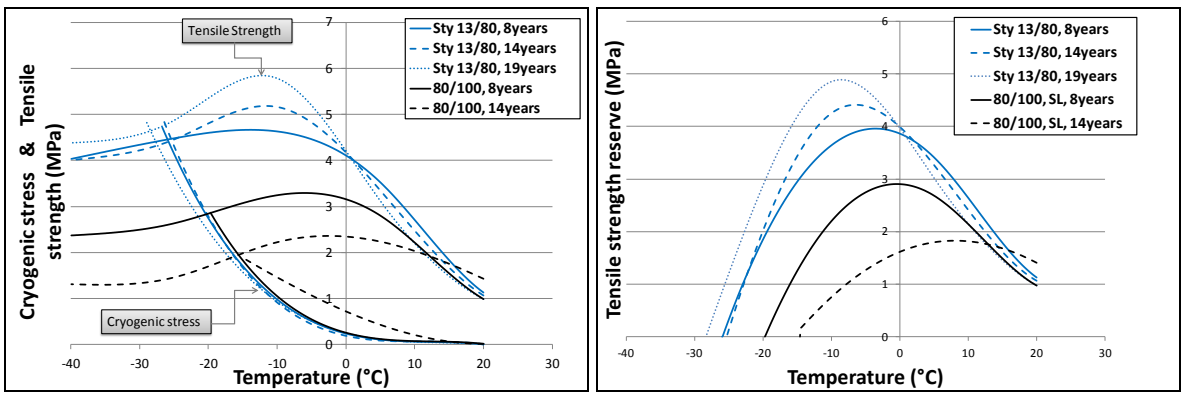
Figure 7: Evolution of cryogenic stress and tensile strength (Left) and Tensile strength reserve for 80/100 and Styrelf 13/80 during road service time.

Figure 7 shows low temperature measurements for 80/100 and Styrelf 13/80 at different ages. 80/100 reveals lower resistance to low temperature cracking: at every age, it has a higher failure temperature and smaller tensile strength. Moreover, at 14 years, 80/100 cryogenic stress curve is steep, which indicates that the binder gets really hard. Aging has a strong negative impact on the 80/100 mix. However, at the 3 ages, Styrelf 13/80 behaves almost identically with a failure temperature between -26 and -29.5°C. Those behaviours are consistent with BBR measurements and on site performances.

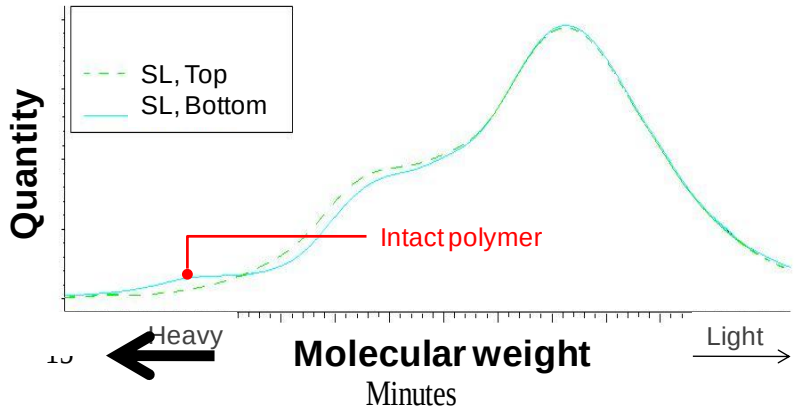
Figure 11: GPC profile of Styrelf 13/80 extracted from the top and bottom of the wearing course.

The GPC profile on SL reveals the presence of polymer almost intact in the lower layer and its complete disappearance in the top 15mm (figure 11). That observation explains the extended life span of section N°11bis: if in the upper layer (top 15mm) the bitumen underwent advanced ageing, it did however maintain its polymer network in most of the surface layer, keeping its mechanical resistance and cracking properties.
