# **REHABILITATION OF RUNWAYS, TAXIWAYS AND ASSOCIATED AIRSIDE INFRASTRUCTURE TO ICAO STANDARDS AT THE EAST LONDON AIRPORT – A PROJECT NARRATIVE**

**Authors : Simon Tetley<sup>1</sup> ; Arvind Jeewan<sup>2</sup> ; Michael Kernekamp<sup>3</sup> ; Samkelo Luyenge<sup>4</sup> ; Paullin Naidoo<sup>5</sup>**

<sup>1</sup> Senior Associate, Roads, Highways & Airports Sector, GIBB (Pty) Ltd

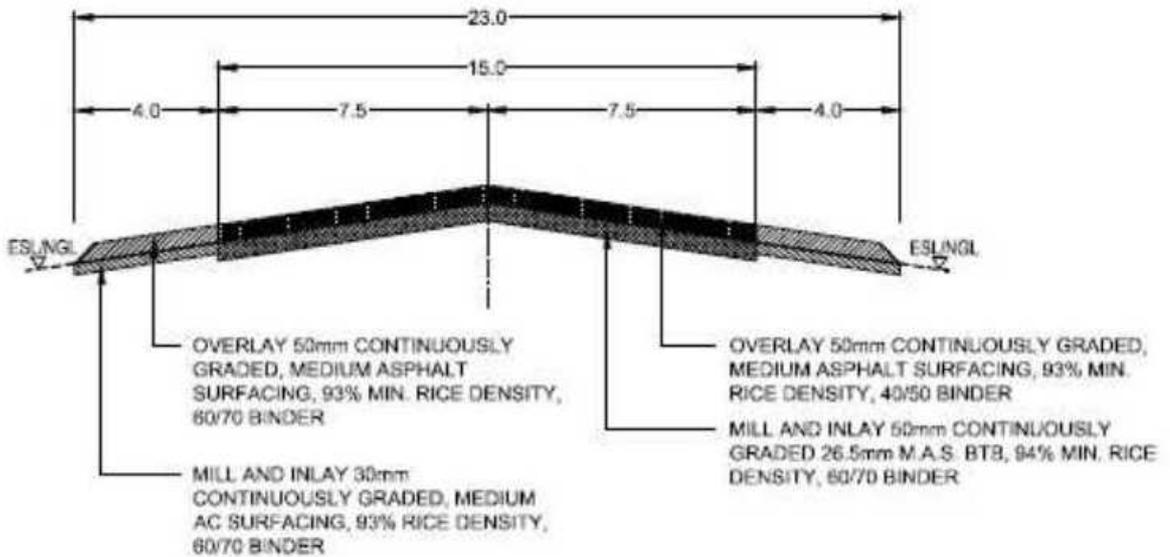
Figure 16 : Alpha Taxiway

The taxiways were found to be in varying stages of deterioration, with Alpha taxiway being in the worst condition as illustrated in Figure 6

Delta	<ul style="list-style-type: none"> <li>• 50mm Mill and Asphalt Inlay</li> <li>• 50mm Asphalt Overlay</li> </ul>	<ul style="list-style-type: none"> <li>• 40mm Mill and Asphalt Inlay</li> <li>• 50mm Asphalt Overlay</li> </ul>
Echo	<ul style="list-style-type: none"> <li>• Selective Mill (50mm) and Asphalt Inlay (20% of area)</li> <li>• 50mm Asphalt Overlay</li> </ul>	<ul style="list-style-type: none"> <li>• Selective mill (40mm) and Asphalt inlay (20% of Area)</li> <li>• 50mm Asphalt Overlay</li> </ul>
Foxtrot and Golf	<ul style="list-style-type: none"> <li>• Surface Rejuvenation</li> </ul>	<ul style="list-style-type: none"> <li>• Surface Rejuvenation</li> </ul>

The above remedial actions are further illustrated in Figure(s) 14 to 18

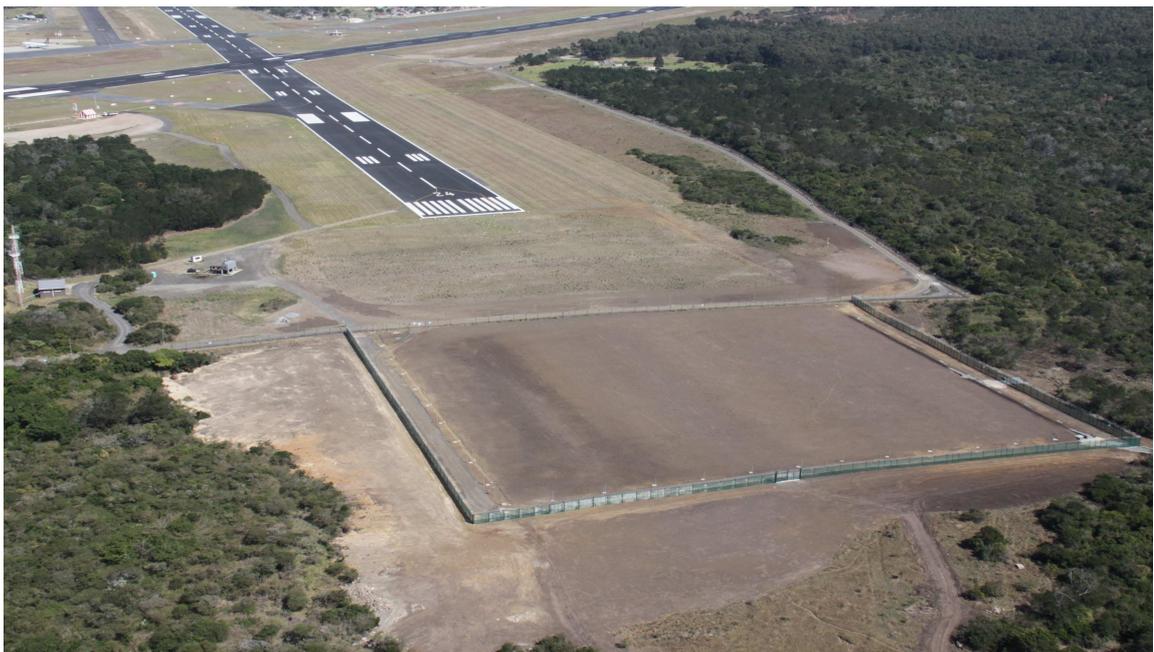
**Figure 25 : RESA 06 Extension**

In terms of dimensions, the existing RESA 11 was found to be 160m long and only 50m in width. The new design created the requisite surface area and significant mass earthworks and layerworks were required to achieve this. RESA 06 was found to be the correct width, but was only 155m in length, terminating at the airport security fence. It was subsequently discovered that ACSA owned the property beyond the fence and a new RESA extension was designed in this area to create the 300m length.

As the PIDS is still being installed, the existing fence etc remains in place until the new security system is operational as shown in Figure 25 below.

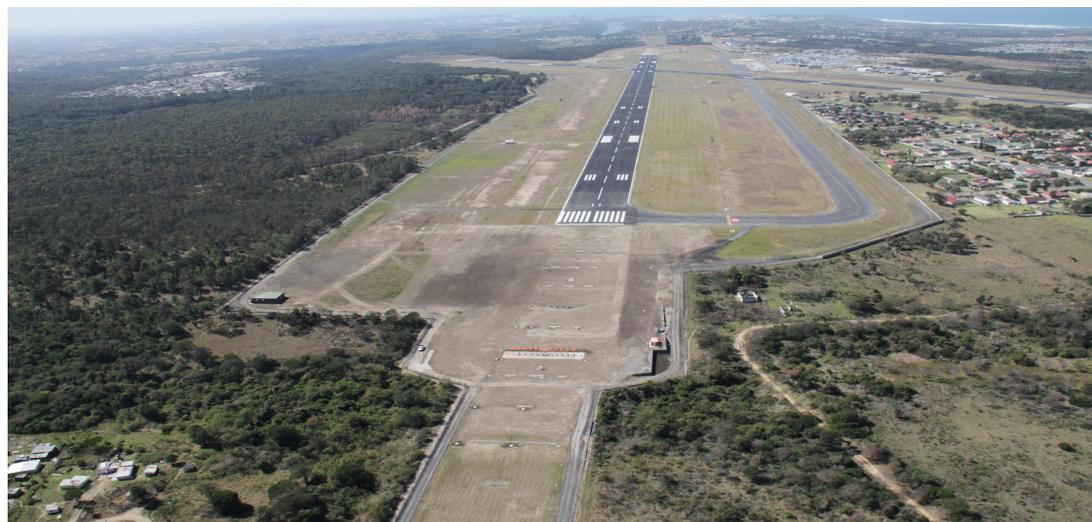
**Figure 29 : RESA 29 After Upgrade**

In terms of longitudinal and transverse slopes, the four (4) RESA’s were found to be generally compliant, the only exception being at RESA 29 where a substantial “hollow” was present at approximately 160m from the runway threshold. It is thought that the RESA was constructed in this way with the intention that the hollow would act as a stormwater drainage channel. A hydrological analysis was undertaken on the catchment areas for this channel, and it was established that no drainage measures were required. As such, the “dip” was eradicated by means of a “cut to fill” intervention

As for the other areas, RESA 29 required strengthening of the material between 0-150mm and, in addition, also required significant cut to fill earthworks to eradicate a large hollow in the middle of the RESA. Figures 28 and 29, over leaf, illustrate the during and after construction conditions
