# Paving Porous Asphalt under sub-zero conditions

Keywords: Porous Asphalt, Rejuvenators, Repair method, Compaction, Durability, Low temperature

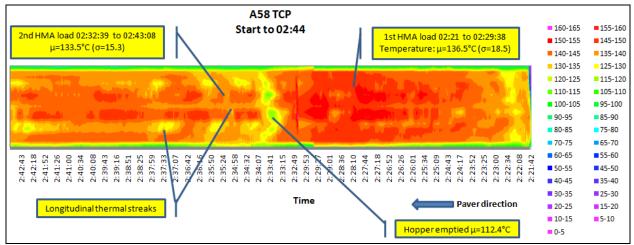
Figure 2: PA temperature contour plot.

The set up with Infra red line scanner in combination with GPS receiver proved to work well on one section and did not work on the other. The figure below shows a segment of the Temperature Contour Plot (TCP) (i.e. the initial temperatures beyond the screed plotted against time) of the section with the IR-line scanner working well. This type of measurement provided rich detail information.

The TCP shows for example longitudinal thermal streaks occurring during paving operations. These thermal streaks are visible in two forms. In the first, a longitudinal streak is visible near the centre of the paver with the temperature in the streak dropping by as much as 15°C when compared to the surrounding PA. In the second, longitudinal segregation is evident in thermal streaks running parallel to the centre-line in the area of the conveyor belts that transport asphalt through to the paver's augers. These temperatures differentials are greater than those in the centre with the surface temperature dropping appreciably in some places along the test section. The thermal streak phenomenon has previously been observed by this research team on other PQi's. In [5] was found that thermal streaks represents an area of weakness that has low resistance to thermal contractions. This type of failure results in the development of longitudinal cracks, appearing in the first few winters following construction work.

The IR-linescanner data was also used to compare joint warming mechanisms employed by Contractor 1 to improve the joint of the existing (cold layer) and newly laid PA surfacing. The joint warming resulted in the heated longitudinal joint area having a surface temperature 20°C higher (on average) than the non-heated open side.

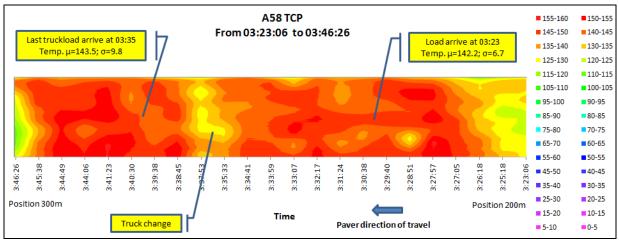
Figure 3: Typical Temperature Contour Plot for Contractor 2 - last 100m.

Unfortunately, is was not possible to gain the same range of insights for Contractor 2 whose paver was fitted with the rental IR-linescanner. With no prior testing of the IR-linescanner, the combination of a rental IR-linescanner and a "foreign" laptop not normally used on PQi's, resulted in problems for the Direct Data Exchange facility that allows automatic data transfer and thus, no consistent IR-linescanner data or data stream files could be recorded. Fortunately, a backup methodology used on earlier PQi's during the formative stages of this research [6] was put in place just in case using a (rental) IR-linescanner proved problematic. Images taken with a hand-held infrared camera, every five metres behind the paver screed, provided sufficient data to determine the extent of temperature homogeneity of the test section (see Figure ) and to visualise the truck changes. The incident log compiled during construction operations revealed the same operational behaviour found with Contractor 1, that the paver stopped every time a new load of asphalt arrived with the result that the surface temperature dropped depending on the length of the stop. The incident log and paver GPS data showed that no prolonged stops occurred ( $\mu = 1.8$  minutes) and hence the stops had little effect on the overall cooling of the mix. In addition, the contractor limited the mixing of colder PA that normally falls from the sides of the hopper and remixed with the warmer mix, by keeping the hopper flaps open. An additional strategy employed by the contractor was to remove the first 2 to 3 tons of PA from the truck and dispose of it, before unloading the rest of the mix into the hopper. Joint warming was also employed for this test section. However, the resolution of the hand-held infrared camera is rather limited when compared to the IRlinescanner and hence does not show the same level of detail. Hence, no inferences could be made regarding the joint warming or the presence of the thermal streak phenomenon found with Contractor 1.

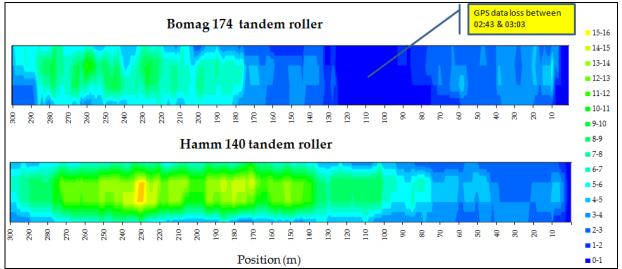
Figure 5: Compaction Contour Plots for Contractor 1.

The rollers and their movements were all registered except one for contractor 1. To avoid roller damage a small tandem roller was used to compact the joint without being fitted with a GPS receiver. That small roller could therefore not be tracked during its operations. This small roller was not part of the original operational plan devised by the contractor prior to construction operations being carried out. The decision to use the small roller was taken shortly after construction commenced. The initial strategy to use a special single drum mounted on the 10 ton tandem for the joint, was abandoned in order to limit the damage to the adjoining existing surfacing layer. The construction team was not happy with the result and therefore mobilised the small tandem (without mounting a GPS receiver first). The Compaction Contour Plots (CCP) for the two heavier tandem rollers is given in figure 5. Furthermore, 20 minutes of GPS data loss occurred between 02:43 and 03:03 resulting in an incomplete view of the Bomag tandem roller's compaction operations. It is clear from the CCP, that from position 180m onwards, the operator has tended to concentrate on the middle of the paved lane where the average number of passes are almost double that of the sides.

The lack of compaction passes on the longitudinal joint side has been compensated by using the 2.5 ton small tandem roller for joint compaction. It is difficult to determine whether this additional joint compaction was adequate given the absence of GPS data. A similar pattern to that observed for breakdown rolling emerges for the Hamm 14 ton tandem roller used for finishing operations (see bottom of figure 6. Also, two zones of compaction are clearly visible over the length of the test section. The first 100m has received significantly less compaction passes compared to the rest of the test section.

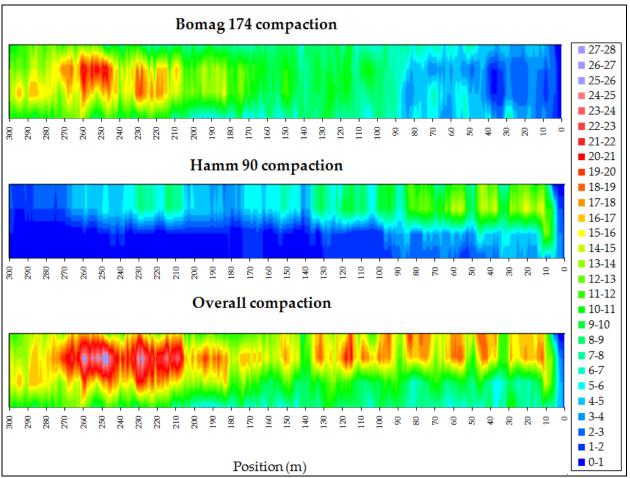
Figure 6: Compaction Contour Plots for Contractor 2

For Contractor 2, the compaction operational strategy appears to be quite different (see Figure ). The contractor uses similar weighted rollers (to that of the other contractor) with breakdown rolling undertaken using a Bomag 10 ton tandem roller and final rolling using a Hamm 14 ton three-drum deadweight roller. The tandem roller operator covers the entire test section tending to concentrate on the middle of the lane. Two zones of compaction are visible with the start of the test section receiving less passes than the end and the number of compaction passes steadily increases from the start to the end. Whilst the operating strategy of the tandem roller operator appears to be clear, the role of the three-drum roller is unclear. The operator starts off compacting the whole width of the lane, then after approximately 90m tends to only compact the longitudinal join area. The overall result is that there is significant variability in the number of compaction passes applied to the test section with the area next to the longitudinal join having received the most compaction passes.

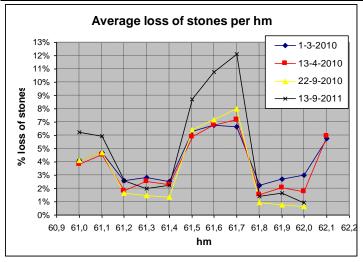
Figure 7: Results ARAN laser measurements.

ARAN laser measurements are carried out after laying (1 March 2010), after 6 weeks (13 April 2010) and after 28 weeks (22 September 2010) to investigate if raveling developed in time. The results of the laser measurements are summarised in table 2. Before, in between en after the test site also old consisting PA was measured. Light ravelling means that 6 to 10% of the original amount of stones is driven out, moderate ravelling means that 11 to 20% of the original amount of stones is driven out, moderate ravelling means that 11 to 20% of the original amount of stones is driven out and serious raveling means that more than 20% of the original amount of stones is driven out. Supplementary is from the Stoneway data the average percentage loss of stones calculated per 10 meter for the left and right wheel track (see figure 7).

From the ARAN laser results it can be seen that the light raveling on the test sites is considerably lower than in the old existing PA road sections. The percentage moderate and serious raveling is for both test sites close to zero. The general careful conclusion is that more than half a year after laying no sign is to be seen of premature raveling in the test sites laid under sub-zero conditions. To build these conclusions stronger it is recommended to follow the degree of raveling with laser measurements of these test sites in time.
