# **EVALUATION OF THE DURABILITY OF EMULSION BASED AC MIXTURES FOR WEARING COURSES**

**XAVIER CARBONNEAU, COLAS**

# SELECTED JOBSITES MAINE AND LOIRE (49)

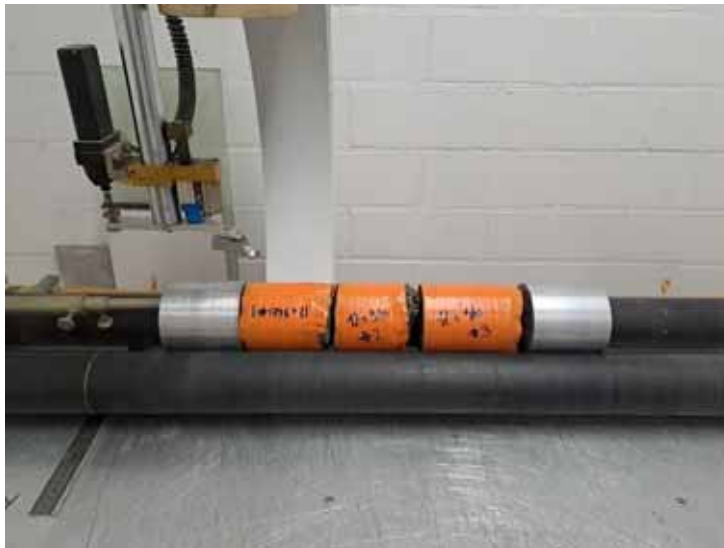
Homogeneity of cores  
Difference WheelPath /Axle
